Profile/Photo Observation Report

Street:	W 3RD ST	Flow Control:	Not Controlled
City:	Hobart, IN	Year Renewed:	
Location:	Yard	Tape/Media #:	
Purpose:	Routine Assessment	Dia/Height:	10"
Use:	Sanitary	Material:	VCP
Drain Area:	NA	Lining:	
Category:	NA		
Comment:	R_M at 10 ft nothing visible		
Location Details:		Direction of Survey:	Downstream
US MH:	M-305-057	DS MH:	M-305-044
		Total Length Surveyed (ft):	12.4

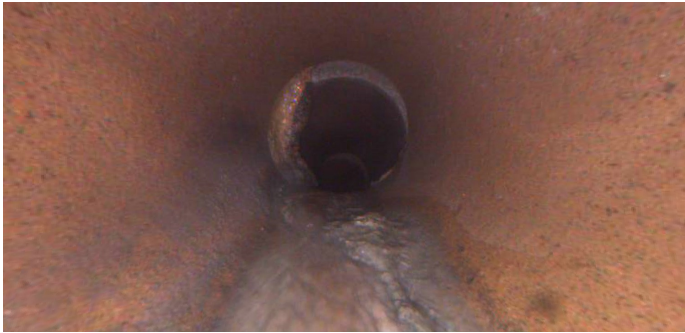
Code:	MWL
Description:	Water Level

Distance (ft):	.0
Structural Grade:	0
O&M Grade:	0
Clock Start/From:	
Clock To:	
1st Value:	
2nd Value:	
Value Percent:	5.000
Continuous Index:	
Within 8" of Joint:	NO
Remarks:

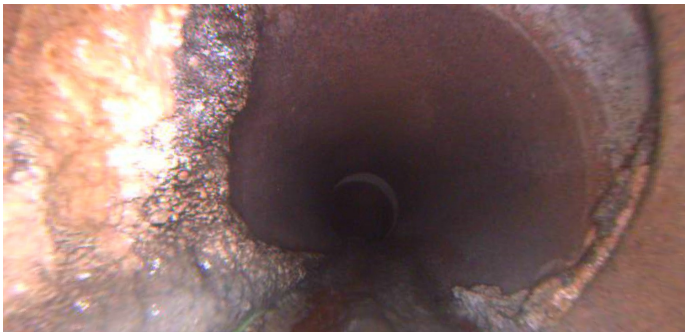
Code:	DAE
Description:	Deposits Attached Encrustation

Distance (ft):	2.6
Structural Grade:	0
O&M Grade:	2
Clock Start/From:	7
Clock To:	12
1st Value:	
2nd Value:	
Value Percent:	10.000
Continuous Index:	
Within 8" of Joint:	YES
Remarks:

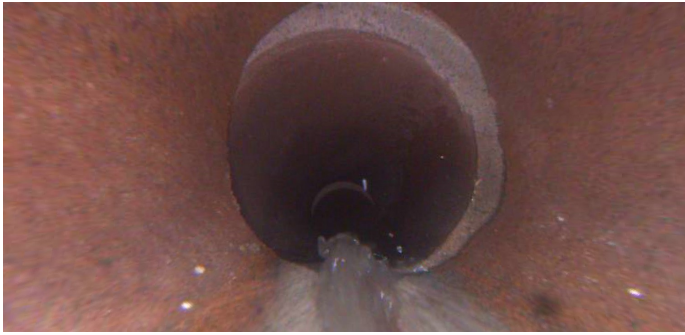
Code: **JAL**
Description: **Joint Angular Large**

Distance (ft): **5.1**
Structural Grade: **2**
O&M Grade: **0**
Clock Start/From:
Clock To:
1st Value:
2nd Value:
Value Percent:
Continuous Index:
Within 8" of Joint: **NO**
Remarks:

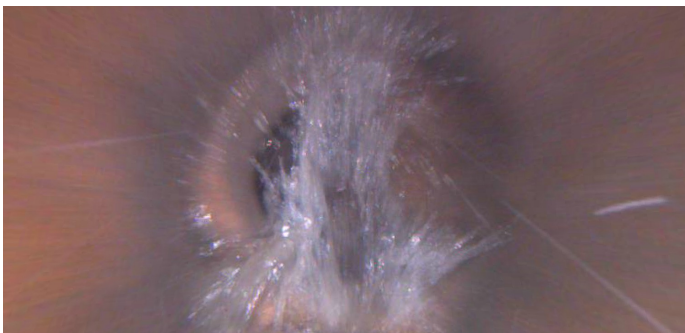
Code: **IG**
Description: **Infil Gusher**

Distance (ft): **10.4**
Structural Grade: **0**
O&M Grade: **5**
Clock Start/From: **11**
Clock To: **1**
1st Value:
2nd Value:
Value Percent:
Continuous Index:
Within 8" of Joint: **YES**
Remarks:
