Profile/Photo Observation Report

Street:	FOXCROFT STREET	Flow Control:	Not Controlled
City:	Hobart, IN	Year Renewed:	
Location:	Yard	Tape/Media #:	
Purpose:	Routine Assessment	Dia/Height:	10"
Use:	Sanitary	Material:	VCP
Drain Area:	NA	Lining:	
Category:	NA		
Comment:	R_M at 10 ft nothing visible		
Location Details:		Direction of Survey:	Downstream
US MH:	M-305-057	DS MH:	M-305-044
		Total Length Surveyed (ft):	12.4

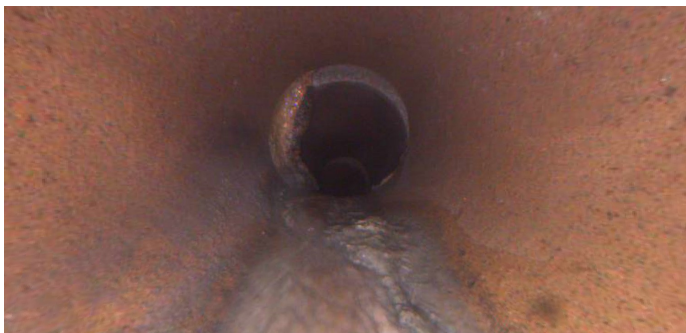
Code: **AMH**
Description: **Manhole**

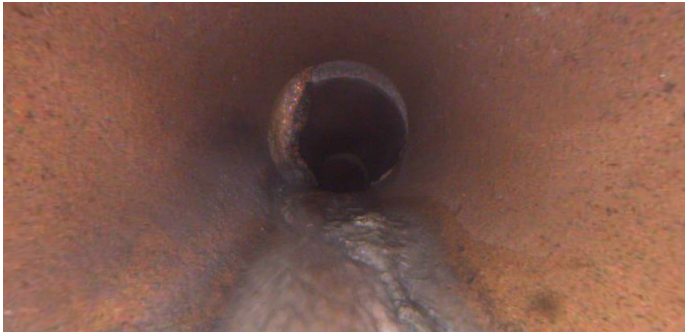
Code:	MWL
Description:	Water Level

Distance (ft):	.0
Structural Grade:	0
O&M Grade:	0
Clock Start/From:	
Clock To:	
1st Value:	
2nd Value:	
Value Percent:	5.000
Continuous Index:	
Within 8" of Joint:	NO
Remarks:

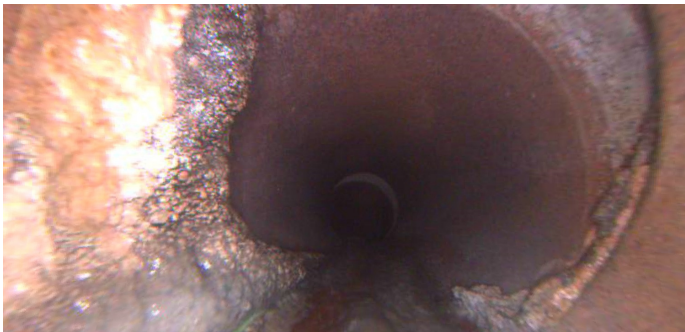
Code:	DAE
Description:	Deposits Attached Encrustation

Distance (ft):	2.6
Structural Grade:	0
O&M Grade:	2
Clock Start/From:	7
Clock To:	12
1st Value:	
2nd Value:	
Value Percent:	10.000
Continuous Index:	
Within 8" of Joint:	YES
Remarks:

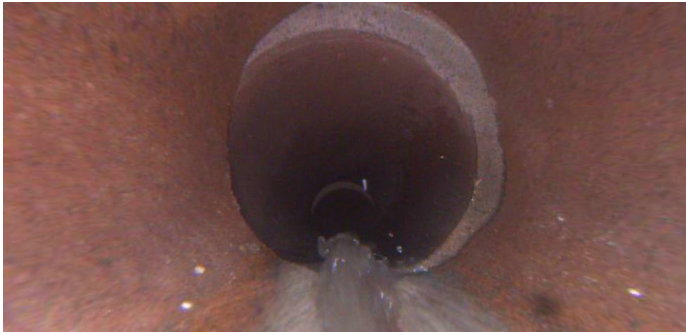
Code: **JAL**
Description: **Joint Angular Large**

Distance (ft): **5.1**
Structural Grade: **2**
O&M Grade: **0**
Clock Start/From:
Clock To:
1st Value:
2nd Value:
Value Percent:
Continuous Index:
Within 8" of Joint: **NO**
Remarks:

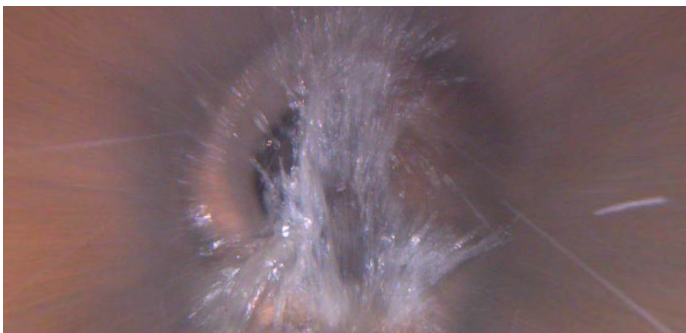
Code: **IG**
Description: **Infil Gusher**

Distance (ft): **10.4**
Structural Grade: **0**
O&M Grade: **5**
Clock Start/From: **11**
Clock To: **1**
1st Value:
2nd Value:
Value Percent:
Continuous Index:
Within 8" of Joint: **YES**
Remarks:
