## Profile/Photo Observation Report

Street:	<b>DIAMOND DR</b>	Flow Control:	<b>Not Controlled</b>
City:	<b>Hobart, IN</b>	Year Renewed:	
Location:	<b>Light Highway</b>	Tape/Media #:	
Purpose:	<b>Routine Assessment</b>	Dia/Height:	<b>8"</b>
Use:	<b>Sanitary</b>	Material:	<b>PVC</b>
Drain Area:	<b>NA</b>	Lining:	
Category:	<b>NA</b>		
Comment:	<b>P_C at 102 ft nothing visible . Flow direction wrong</b>		
Location Details:		Direction of Survey:	<b>Downstream</b>
US MH:	<b>M-308-011</b>	DS MH:	<b>M-308-019</b>
		Total Length Surveyed (ft):	<b>103.8</b>

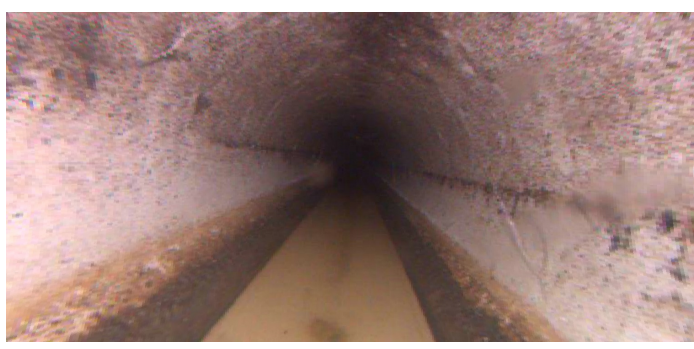
Code: **AMH**  
Description: **Manhole**

Distance (ft): **.0**  
Structural Grade: **0**  
O&M Grade: **0**  
Clock Start/From:  
Clock To:  
1st Value:  
2nd Value:  
Value Percent:  
Continuous Index:  
Within 8" of Joint: **NO**  
Remarks: **M-308-011**

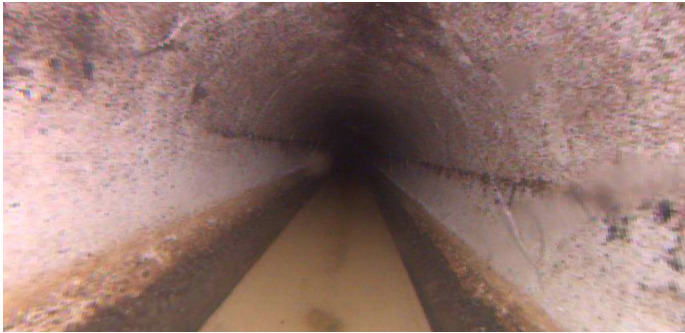
Code:	<b>MWL</b>
Description:	<b>Water Level</b>

Distance (ft):	<b>.0</b>
Structural Grade:	<b>0</b>
O&M Grade:	<b>0</b>
Clock Start/From:	
Clock To:	
1st Value:	
2nd Value:	
Value Percent:	<b>5.000</b>
Continuous Index:	
Within 8" of Joint:	<b>NO</b>
Remarks:

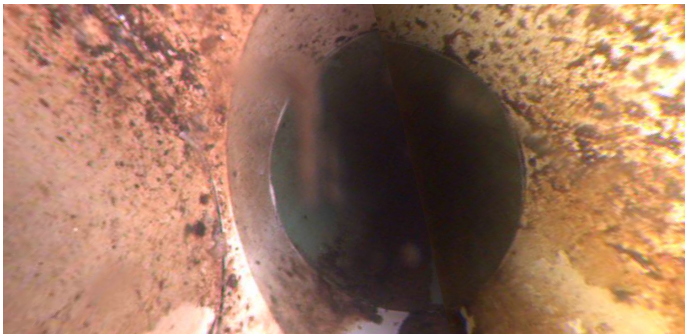
Code:	<b>TF</b>
Description:	<b>Tap Factory</b>

Distance (ft):	<b>25.5</b>
Structural Grade:	<b>0</b>
O&M Grade:	<b>0</b>
Clock Start/From:	<b>2</b>
Clock To:	
1st Value:	<b>4.000</b>
2nd Value:	
Value Percent:	
Continuous Index:	
Within 8" of Joint:	
Remarks:

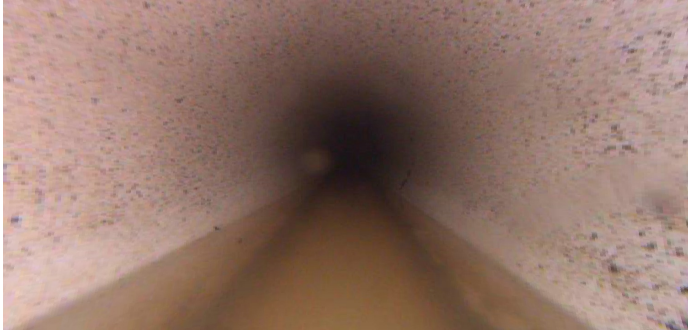
Code:	<b>MSA</b>
Description:	<b>Abandoned Survey</b>
Distance (ft):	<b>103.8</b>
Structural Grade:	<b>0</b>
O&M Grade:	<b>0</b>
Clock Start/From:	
Clock To:	
1st Value:	
2nd Value:	
Value Percent:	
Continuous Index:	
Within 8" of Joint:	<b>NO</b>
Remarks:	<b>camera stopped</b>
