Profile/Photo Observation Report

Street:	FOXCROFT STREET	Flow Control:	Not Controlled
City:	Hobart, IN	Year Renewed:	
Location:	Light Highway	Tape/Media #:	
Purpose:	Routine Assessment	Dia/Height:	8"
Use:	Sanitary	Material:	PVC
Drain Area:	NA	Lining:	
Category:	NA		
Comment:	P_C at 102 ft nothing visible . Flow direction wrong		
Location Details:		Direction of Survey:	Downstream
US MH:	M-308-011	DS MH:	M-308-019
		Total Length Surveyed (ft):	103.8

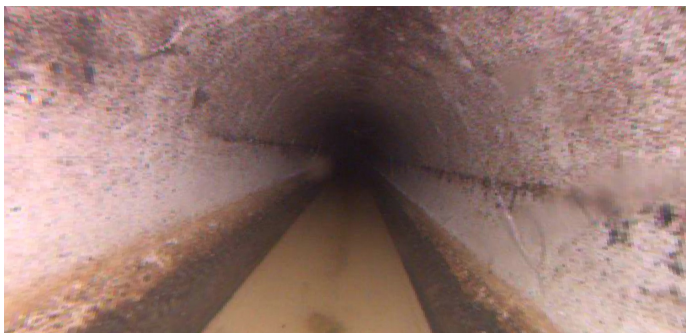
Code: **AMH**
Description: **Manhole**

Distance (ft): **.0**
Structural Grade: **0**
O&M Grade: **0**
Clock Start/From:
Clock To:
1st Value:
2nd Value:
Value Percent:
Continuous Index:
Within 8" of Joint: **NO**
Remarks: **M-308-011**

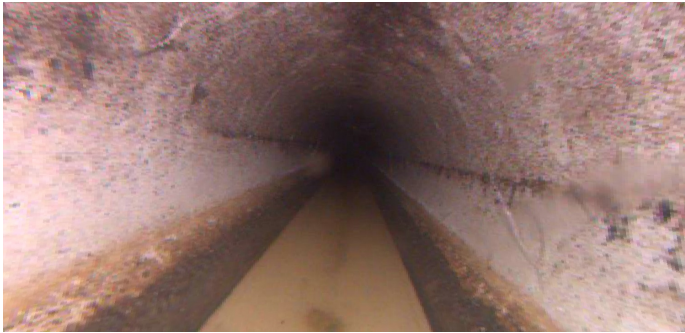
Code:	MWL
Description:	Water Level

Distance (ft):	.0
Structural Grade:	0
O&M Grade:	0
Clock Start/From:	
Clock To:	
1st Value:	
2nd Value:	
Value Percent:	5.000
Continuous Index:	
Within 8" of Joint:	NO
Remarks:

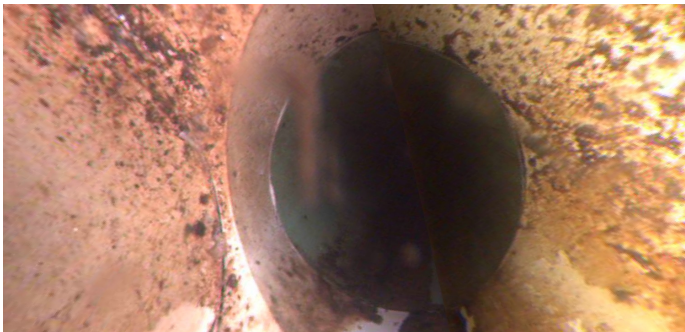
Code:	TF
Description:	Tap Factory

Distance (ft):	25.5
Structural Grade:	0
O&M Grade:	0
Clock Start/From:	2
Clock To:	
1st Value:	4.000
2nd Value:	
Value Percent:	
Continuous Index:	
Within 8" of Joint:	
Remarks:

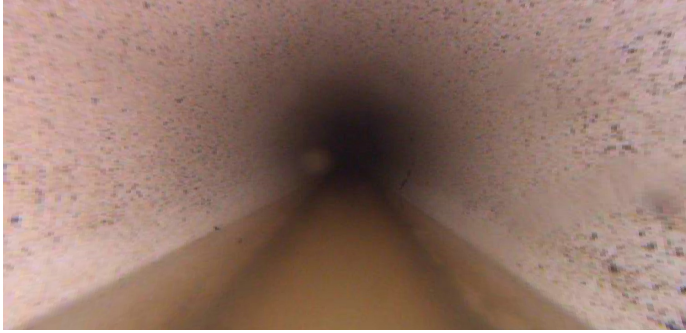
Code:	MSA
Description:	Abandoned Survey
Distance (ft):	103.8
Structural Grade:	0
O&M Grade:	0
Clock Start/From:	
Clock To:	
1st Value:	
2nd Value:	
Value Percent:	
Continuous Index:	
Within 8" of Joint:	NO
Remarks:	camera stopped
