## Profile/Photo Observation Report

Date:	<b>03/21/2018</b>	Weather:		Coding:	<b>PACP 6.0</b>
Pipe Length (ft):	<b>165.1</b>	Owner:	<b>NA</b>	Pre Clean:	<b>No Pre-Cleaning</b>
P.O.#:		Surveyor:	<b>Selasie Honu</b>	PSR:	<b>P-308-013-012</b>
Customer:		Clean Date:	<b>01/01/1900</b>	Shape:	<b>C</b>

Street:	<b>FOXCROFT STREET</b>	Flow Control:	<b>Not Controlled</b>
City:	<b>Hobart, IN</b>	Year Renewed:	
Location:	<b>Light Highway</b>	Tape/Media #:	
Purpose:	<b>Routine Assessment</b>	Dia/Height:	<b>10"</b>
Use:	<b>Sanitary</b>	Material:	<b>PVC</b>
Drain Area:	<b>NA</b>	Lining:	
Category:	<b>NA</b>		
Comment:			
Location Details:		Direction of Survey:	<b>Downstream</b>
US MH:	<b>M-308-013</b>	DS MH:	<b>M-308-012</b>
		Total Length Surveyed (ft):	<b>171.6</b>

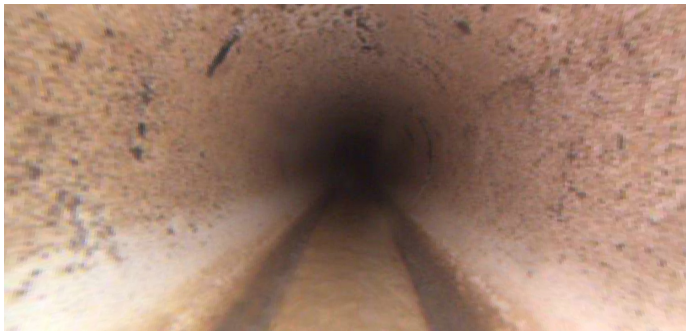
Code: **AMH**  
Description: **Manhole**

Distance (ft): **.0**  
Structural Grade: **0**  
O&M Grade: **0**  
Clock Start/From:  
Clock To:  
1st Value:  
2nd Value:  
Value Percent:  
Continuous Index:  
Within 8" of Joint: **NO**  
Remarks: **M-308-013**

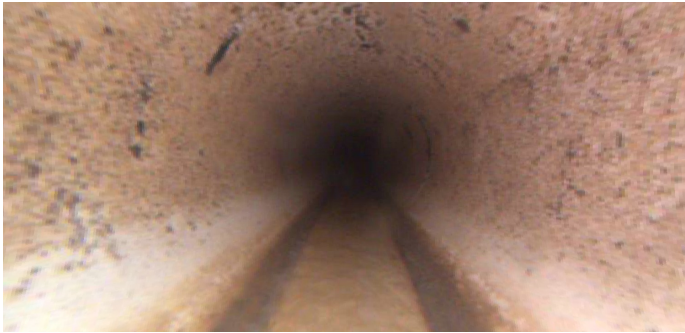
Code:	<b>MWL</b>
Description:	<b>Water Level</b>

Distance (ft):	<b>.0</b>
Structural Grade:	<b>0</b>
O&M Grade:	<b>0</b>
Clock Start/From:	
Clock To:	
1st Value:	
2nd Value:	
Value Percent:	<b>5.000</b>
Continuous Index:	
Within 8" of Joint:	<b>NO</b>
Remarks:

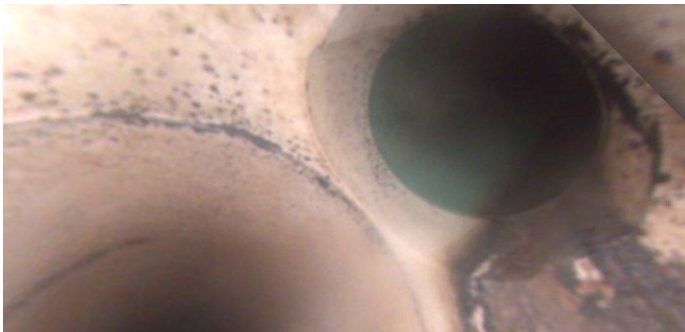
Code:	<b>TF</b>
Description:	<b>Tap Factory</b>

Distance (ft):	<b>20.0</b>
Structural Grade:	<b>0</b>
O&M Grade:	<b>0</b>
Clock Start/From:	<b>10</b>
Clock To:	
1st Value:	<b>4.000</b>
2nd Value:	
Value Percent:	
Continuous Index:	
Within 8" of Joint:	
Remarks:

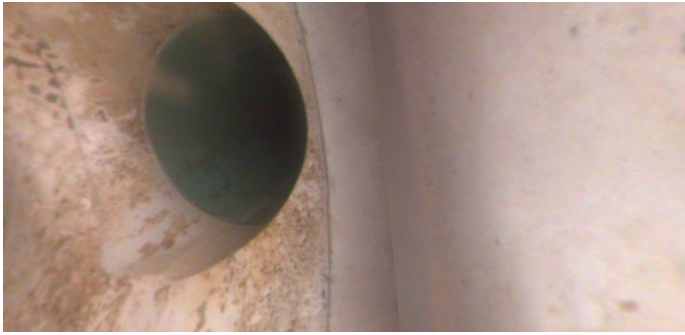
Code: **TF**  
Description: **Tap Factory**

Distance (ft): **60.5**  
Structural Grade: **0**  
O&M Grade: **0**  
Clock Start/From: **2**  
Clock To:  
1st Value: **4.000**  
2nd Value:  
Value Percent:  
Continuous Index:  
Within 8" of Joint:  
Remarks:

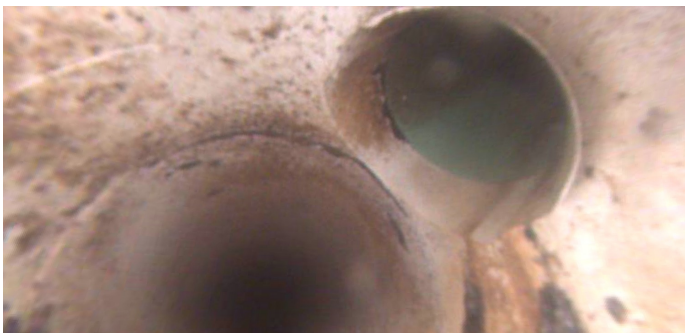
Code: **TF**  
Description: **Tap Factory**

Distance (ft): **130.0**  
Structural Grade: **0**  
O&M Grade: **0**  
Clock Start/From: **10**  
Clock To:  
1st Value: **4.000**  
2nd Value:  
Value Percent:  
Continuous Index:  
Within 8" of Joint:  
Remarks:

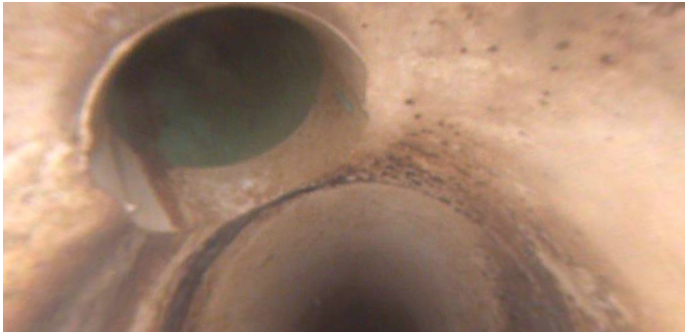
Code: **TF**  
Description: **Tap Factory**

Distance (ft): **143.8**  
Structural Grade: **0**  
O&M Grade: **0**  
Clock Start/From: **1**  
Clock To:  
1st Value: **4.000**  
2nd Value:  
Value Percent:  
Continuous Index:  
Within 8" of Joint:  
Remarks:

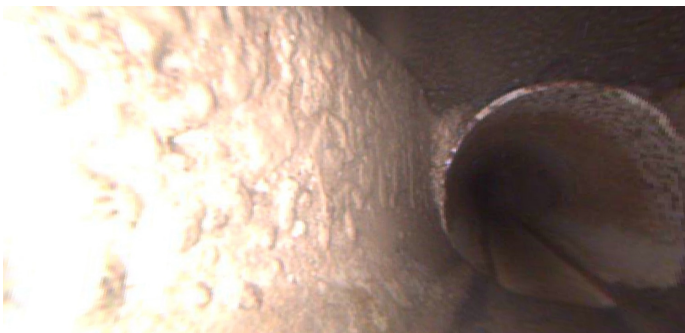
Code: **AMH**  
Description: **Manhole**

Distance (ft): **171.6**  
Structural Grade: **0**  
O&M Grade: **0**  
Clock Start/From:  
Clock To:  
1st Value:  
2nd Value:  
Value Percent:  
Continuous Index:  
Within 8" of Joint: **NO**  
Remarks: **M-308-012**
