Profile/Photo Observation Report

Street:	EMERALD DR	Flow Control:	Not Controlled
City:	Hobart, IN	Year Renewed:	
Location:	Light Highway	Tape/Media #:	
Purpose:	Routine Assessment	Dia/Height:	8"
Use:	Sanitary	Material:	PVC
Drain Area:	NA	Lining:	
Category:	NA		
Comment:	P_C at 122 ft nothing visible rocks in the tracks \nFlow direction wrong		
Location Details:		Direction of Survey:	Upstream
US MH:	M-308-016	DS MH:	M-308-015
		Total Length Surveyed (ft):	123.5

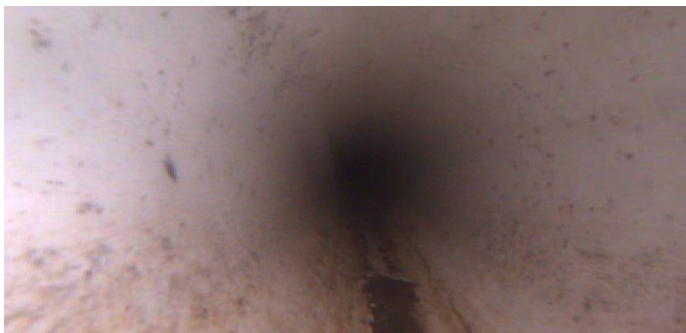
Code: **AMH**
Description: **Manhole**

Distance (ft): **.0**
Structural Grade: **0**
O&M Grade: **0**
Clock Start/From:
Clock To:
1st Value:
2nd Value:
Value Percent:
Continuous Index:
Within 8" of Joint: **NO**
Remarks: **M-308-015**

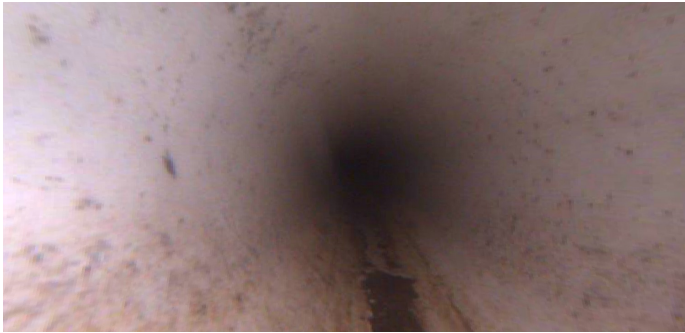
Code:	MWL
Description:	Water Level

Distance (ft):	.0
Structural Grade:	0
O&M Grade:	0
Clock Start/From:	
Clock To:	
1st Value:	
2nd Value:	
Value Percent:	5.000
Continuous Index:	
Within 8" of Joint:	NO
Remarks:

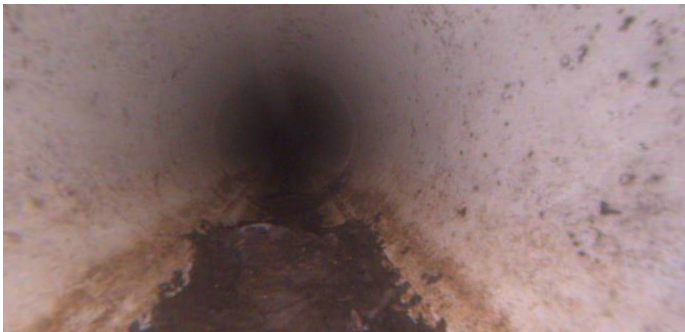
Code:	DSF
Description:	Deposits Settled Fine

Distance (ft):	4.7
Structural Grade:	0
O&M Grade:	2
Clock Start/From:	6
Clock To:	
1st Value:	
2nd Value:	
Value Percent:	5.000
Continuous Index:	
Within 8" of Joint:	NO
Remarks:

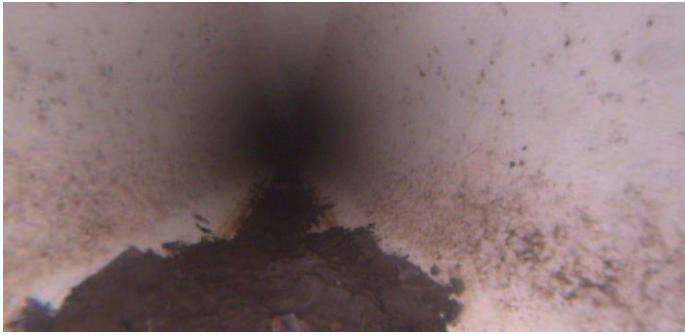
Code: **DSF**
Description: **Deposits Settled Fine**

Distance (ft): **12.6**
Structural Grade: **0**
O&M Grade: **2**
Clock Start/From: **6**
Clock To:
1st Value:
2nd Value:
Value Percent: **5.000**
Continuous Index:
Within 8" of Joint: **NO**
Remarks:

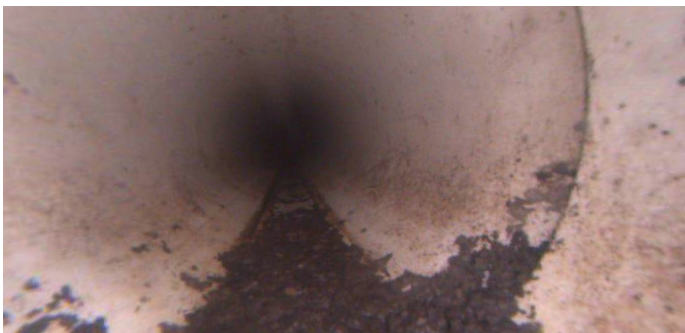
Code: **DSF**
Description: **Deposits Settled Fine**

Distance (ft): **18.8**
Structural Grade: **0**
O&M Grade: **2**
Clock Start/From: **6**
Clock To:
1st Value:
2nd Value:
Value Percent: **5.000**
Continuous Index:
Within 8" of Joint: **NO**
Remarks:

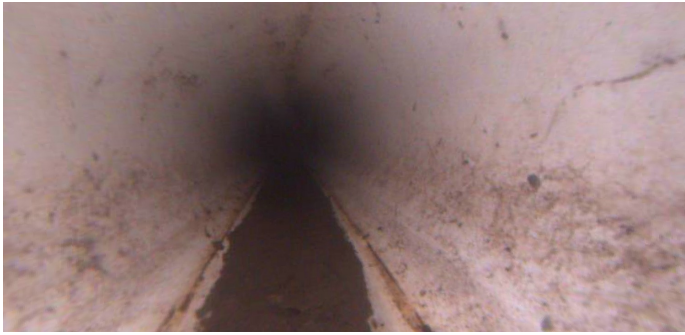
Code: **DSF**
Description: **Deposits Settled Fine**

Distance (ft): **27.7**
Structural Grade: **0**
O&M Grade: **2**
Clock Start/From: **6**
Clock To:
1st Value:
2nd Value:
Value Percent: **5.000**
Continuous Index: **S01**
Within 8" of Joint: **NO**
Remarks:

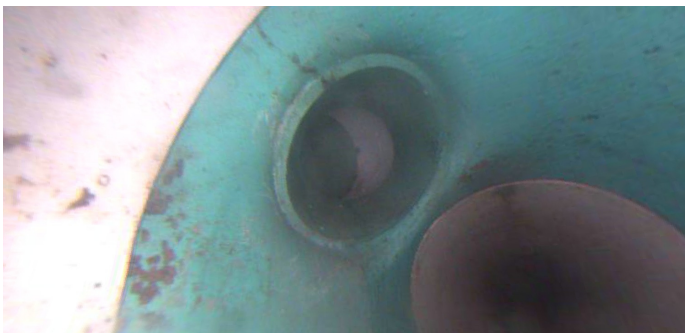
Code: **TF**
Description: **Tap Factory**

Distance (ft): **33.1**
Structural Grade: **0**
O&M Grade: **0**
Clock Start/From: **2**
Clock To:
1st Value: **4.000**
2nd Value:
Value Percent:
Continuous Index:
Within 8" of Joint:
Remarks:

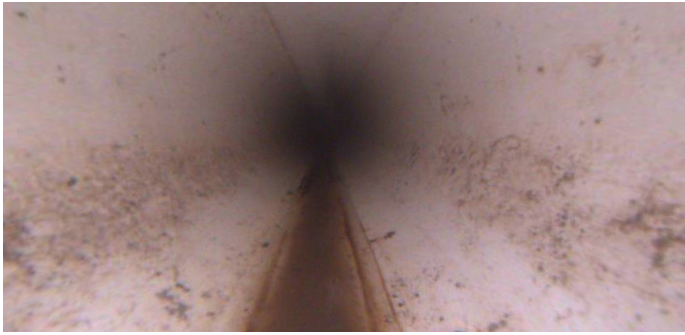
Code: **DSF**
Description: **Deposits Settled Fine**

Distance (ft): **35.8**
Structural Grade: **0**
O&M Grade: **2**
Clock Start/From: **6**
Clock To:
1st Value:
2nd Value:
Value Percent: **5.000**
Continuous Index: **F01**
Within 8" of Joint: **NO**
Remarks:

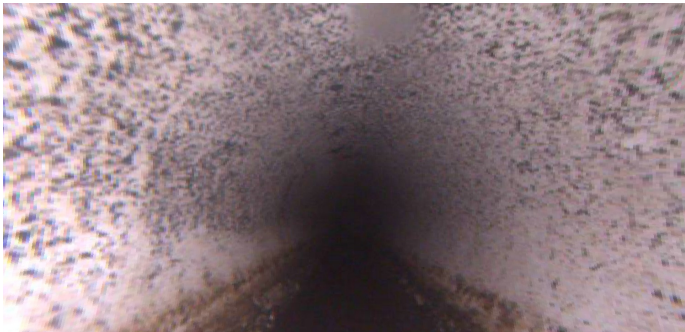
Code: **MSA**
Description: **Abandoned Survey**

Distance (ft): **123.5**
Structural Grade: **0**
O&M Grade: **0**
Clock Start/From:
Clock To:
1st Value:
2nd Value:
Value Percent:
Continuous Index:
Within 8" of Joint: **NO**
Remarks: **DSF**
