Profile/Photo Observation Report

Street:	EMERALD DR & RUBY CT	Flow Control:	Not Controlled
City:	Hobart, IN	Year Renewed:	
Location:	Light Highway	Tape/Media #:	
Purpose:	Routine Assessment	Dia/Height:	8"
Use:	Sanitary	Material:	PVC
Drain Area:	NA	Lining:	
Category:	NA		
Comment:	R_M at 370 ft debris . Flow direction wrong		
Location Details:		Direction of Survey:	Downstream
US MH:	M-308-018	DS MH:	M-308-017
		Total Length Surveyed (ft):	371.2

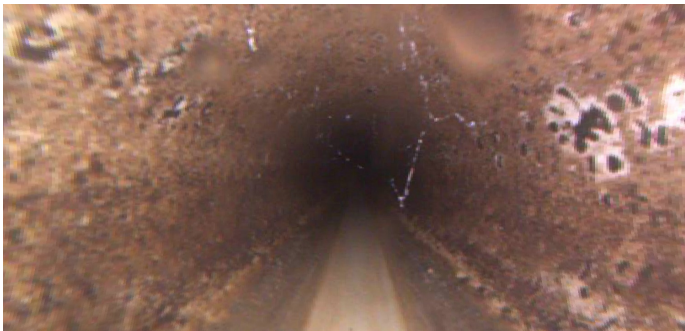
Code: **AMH**
Description: **Manhole**

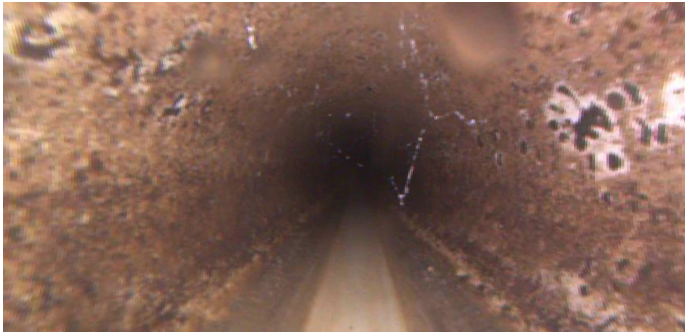
Code:	MWL
Description:	Water Level

Distance (ft):	.0
Structural Grade:	0
O&M Grade:	0
Clock Start/From:	
Clock To:	
1st Value:	
2nd Value:	
Value Percent:	5.000
Continuous Index:	
Within 8" of Joint:	NO
Remarks:

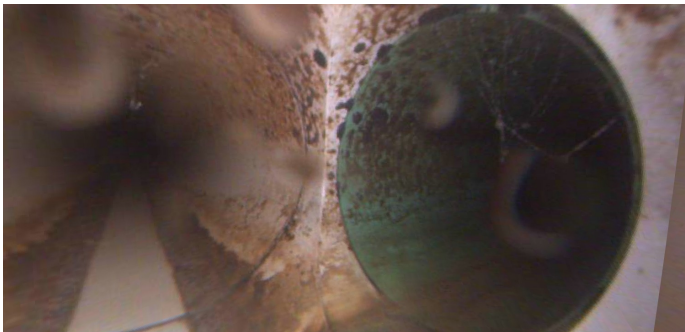
Code:	TFA
Description:	Tap Factory Active

Distance (ft):	134.0
Structural Grade:	0
O&M Grade:	0
Clock Start/From:	3
Clock To:	
1st Value:	4.000
2nd Value:	
Value Percent:	
Continuous Index:	
Within 8" of Joint:	
Remarks:

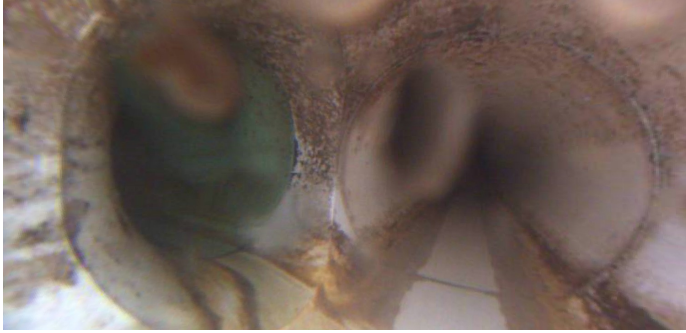
Code: **TFA**
Description: **Tap Factory Active**

Distance (ft): **241.9**
Structural Grade: **0**
O&M Grade: **0**
Clock Start/From: **9**
Clock To:
1st Value: **4.000**
2nd Value:
Value Percent:
Continuous Index:
Within 8" of Joint:
Remarks:

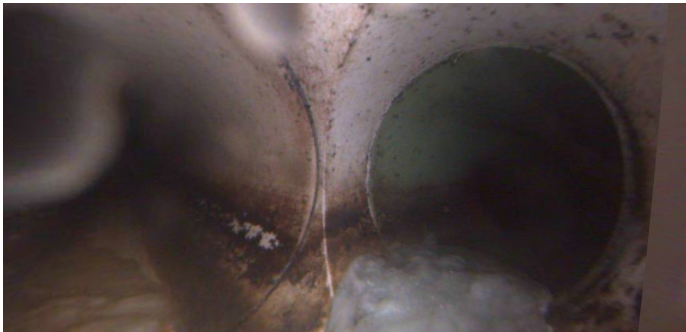
Code: **TFA**
Description: **Tap Factory Active**

Distance (ft): **336.8**
Structural Grade: **0**
O&M Grade: **0**
Clock Start/From: **3**
Clock To:
1st Value: **4.000**
2nd Value:
Value Percent:
Continuous Index:
Within 8" of Joint:
Remarks:

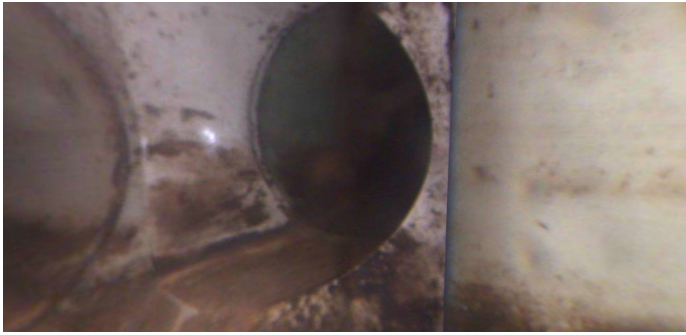
Code: **TFA**
Description: **Tap Factory Active**

Distance (ft): **351.3**
Structural Grade: **0**
O&M Grade: **0**
Clock Start/From: **9**
Clock To:
1st Value: **4.000**
2nd Value:
Value Percent:
Continuous Index:
Within 8" of Joint:
Remarks:

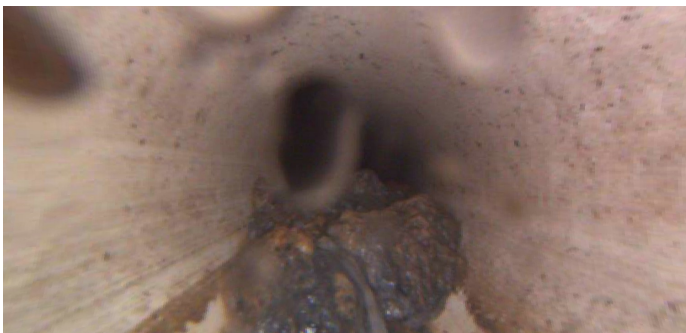
Code: **DSZ**
Description: **Deposits Settled Other**

Distance (ft): **369.0**
Structural Grade: **0**
O&M Grade: **2**
Clock Start/From: **3**
Clock To: **9**
1st Value:
2nd Value:
Value Percent: **10.000**
Continuous Index:
Within 8" of Joint: **NO**
Remarks: **mixed material**

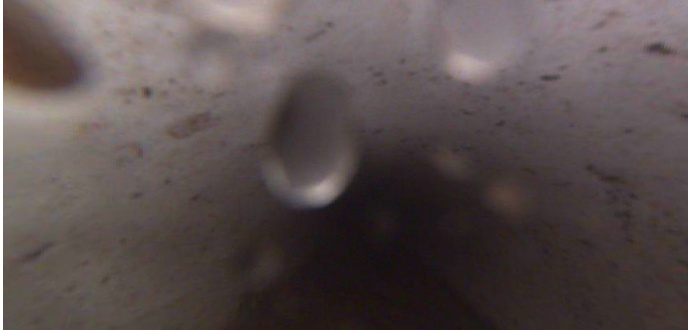
Code:	MSA
Description:	Abandoned Survey
Distance (ft):	371.2
Structural Grade:	0
O&M Grade:	0
Clock Start/From:	
Clock To:	
1st Value:	
2nd Value:	
Value Percent:	
Continuous Index:	
Within 8" of Joint:	NO
Remarks:	DSZ
