Profile/Photo Observation Report

Street:	FOXCROFT STREET	Flow Control:	Not Controlled
City:	Hobart, IN	Year Renewed:	
Location:	Light Highway	Tape/Media #:	
Purpose:	Routine Assessment	Dia/Height:	8"
Use:	Sanitary	Material:	PVC
Drain Area:	NA	Lining:	
Category:	NA		
Comment:	R_M at 370 ft debris . Flow direction wrong		
Location Details:		Direction of Survey:	Downstream
US MH:	M-308-018	DS MH:	M-308-017
		Total Length Surveyed (ft):	371.2

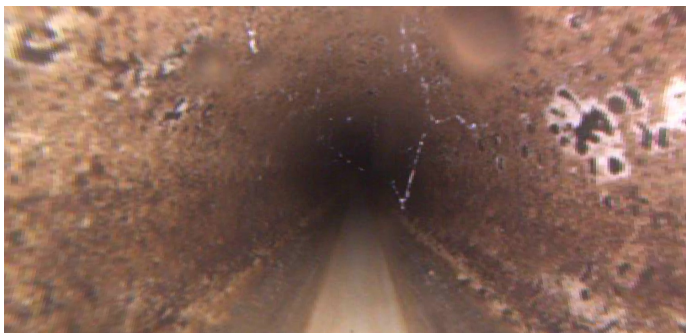
Code: **AMH**
Description: **Manhole**

Distance (ft): **.0**
Structural Grade: **0**
O&M Grade: **0**
Clock Start/From:
Clock To:
1st Value:
2nd Value:
Value Percent:
Continuous Index:
Within 8" of Joint: **NO**
Remarks: **M-308-018**

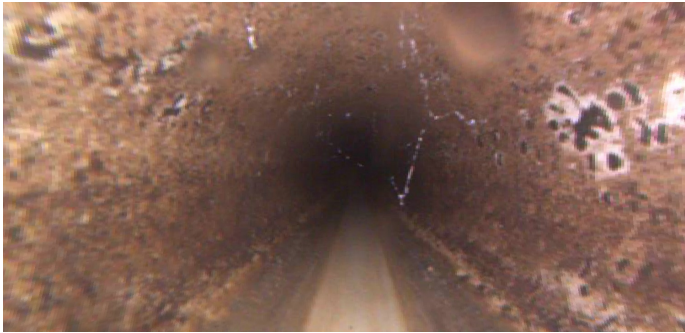
Code: **MWL**
Description: **Water Level**

Distance (ft): **.0**
Structural Grade: **0**
O&M Grade: **0**
Clock Start/From:
Clock To:
1st Value:
2nd Value:
Value Percent: **5.000**
Continuous Index:
Within 8" of Joint: **NO**
Remarks:

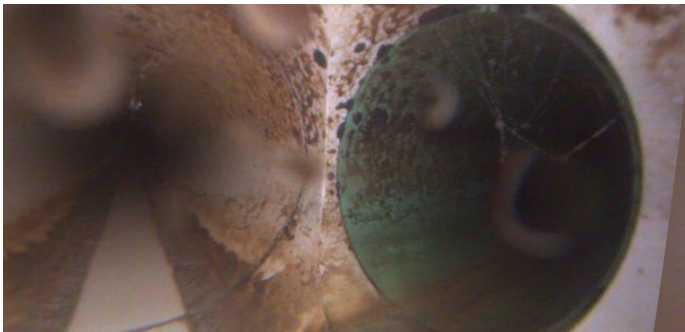
Code: **TFA**
Description: **Tap Factory Active**

Distance (ft): **134.0**
Structural Grade: **0**
O&M Grade: **0**
Clock Start/From: **3**
Clock To:
1st Value: **4.000**
2nd Value:
Value Percent:
Continuous Index:
Within 8" of Joint:
Remarks:

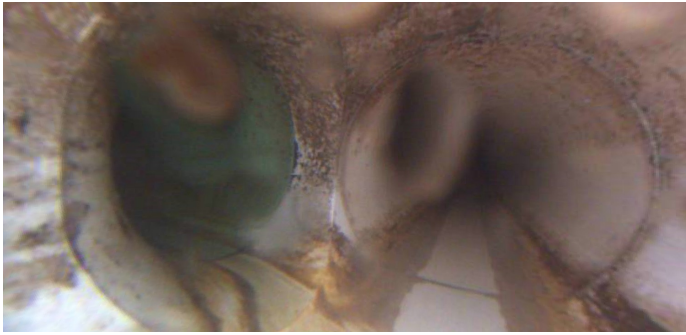
Code: **TFA**
Description: **Tap Factory Active**

Distance (ft): **241.9**
Structural Grade: **0**
O&M Grade: **0**
Clock Start/From: **9**
Clock To:
1st Value: **4.000**
2nd Value:
Value Percent:
Continuous Index:
Within 8" of Joint:
Remarks:

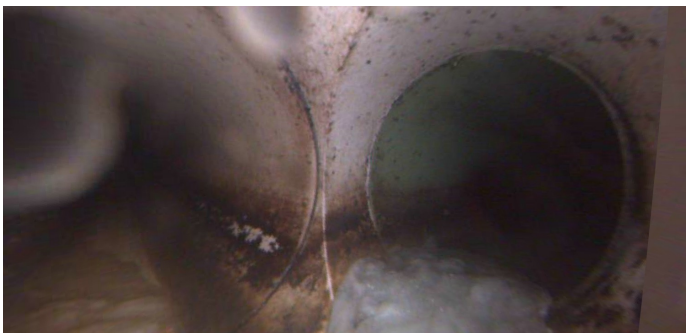
Code: **TFA**
Description: **Tap Factory Active**

Distance (ft): **336.8**
Structural Grade: **0**
O&M Grade: **0**
Clock Start/From: **3**
Clock To:
1st Value: **4.000**
2nd Value:
Value Percent:
Continuous Index:
Within 8" of Joint:
Remarks:

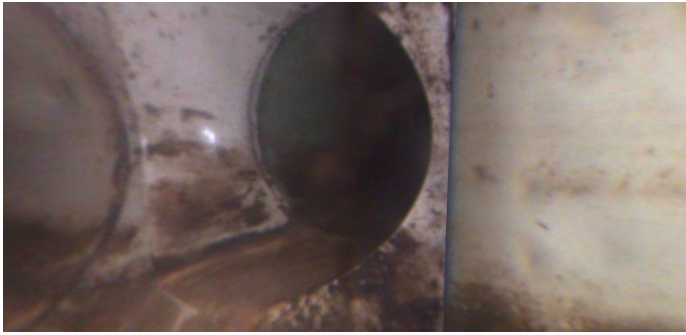
Code: **TFA**
Description: **Tap Factory Active**

Distance (ft): **351.3**
Structural Grade: **0**
O&M Grade: **0**
Clock Start/From: **9**
Clock To:
1st Value: **4.000**
2nd Value:
Value Percent:
Continuous Index:
Within 8" of Joint:
Remarks:

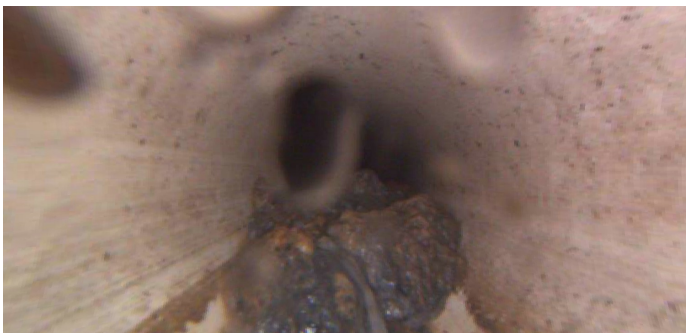
Code: **DSZ**
Description: **Deposits Settled Other**

Distance (ft): **369.0**
Structural Grade: **0**
O&M Grade: **2**
Clock Start/From: **3**
Clock To: **9**
1st Value:
2nd Value:
Value Percent: **10.000**
Continuous Index:
Within 8" of Joint: **NO**
Remarks: **mixed material**

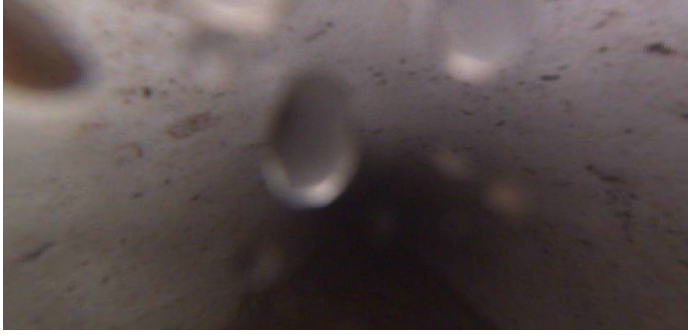
Code:	MSA
Description:	Abandoned Survey
Distance (ft):	371.2
Structural Grade:	0
O&M Grade:	0
Clock Start/From:	
Clock To:	
1st Value:	
2nd Value:	
Value Percent:	
Continuous Index:	
Within 8" of Joint:	NO
Remarks:	DSZ
