Profile/Photo Observation Report

Street:	DIAMOND DR	Flow Control:	Not Controlled
City:	Hobart, IN	Year Renewed:	
Location:	Light Highway	Tape/Media #:	
Purpose:	Routine Assessment	Dia/Height:	8"
Use:	Sanitary	Material:	PVC
Drain Area:	NA	Lining:	
Category:	NA		
Comment:	Flow direction wrong		
Location Details:		Direction of Survey:	Upstream
US MH:	M-308-019	DS MH:	M-308-020
		Total Length Surveyed (ft):	164.4

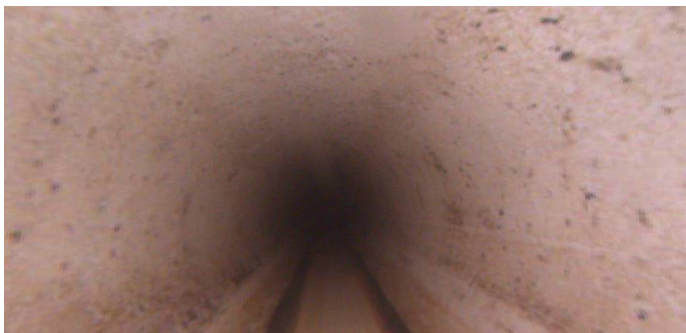
Code: **AMH**
Description: **Manhole**

Distance (ft): **.0**
Structural Grade: **0**
O&M Grade: **0**
Clock Start/From:
Clock To:
1st Value:
2nd Value:
Value Percent:
Continuous Index:
Within 8" of Joint: **NO**
Remarks: **M-308-020**

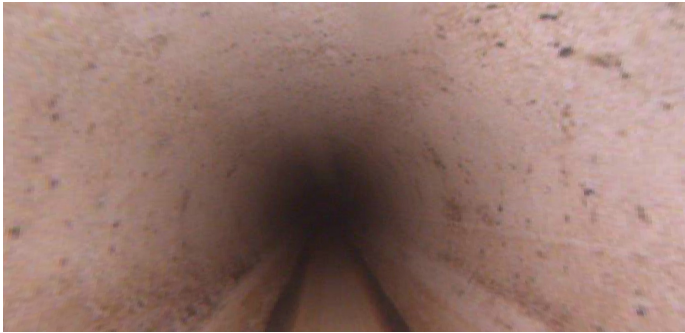
Code:	MWL
Description:	Water Level

Distance (ft):	.0
Structural Grade:	0
O&M Grade:	0
Clock Start/From:	
Clock To:	
1st Value:	
2nd Value:	
Value Percent:	5.000
Continuous Index:	
Within 8" of Joint:	NO
Remarks:

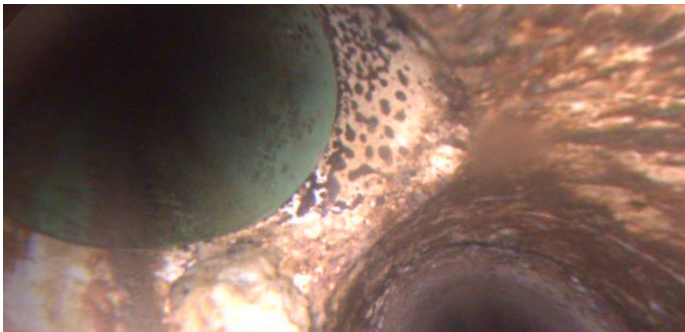
Code:	TF
Description:	Tap Factory

Distance (ft):	47.1
Structural Grade:	0
O&M Grade:	0
Clock Start/From:	10
Clock To:	
1st Value:	4.000
2nd Value:	
Value Percent:	
Continuous Index:	
Within 8" of Joint:	
Remarks:

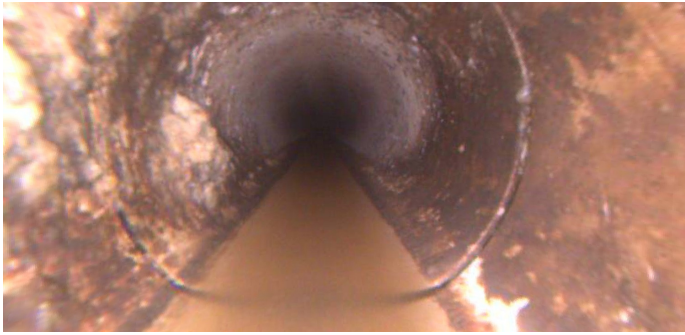
Code: **DAGS**
Description: **Deposits Attached Grease**

Distance (ft): **47.3**
Structural Grade: **0**
O&M Grade: **2**
Clock Start/From: **8**
Clock To: **9**
1st Value:
2nd Value:
Value Percent: **5.000**
Continuous Index:
Within 8" of Joint: **NO**
Remarks:

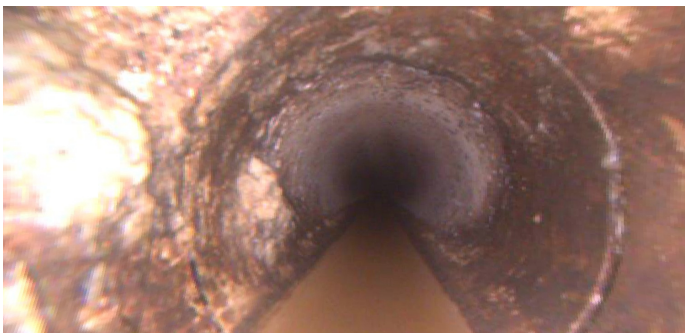
Code: **DAZ**
Description: **Deposits Attached Other**

Distance (ft): **47.3**
Structural Grade: **0**
O&M Grade: **2**
Clock Start/From: **7**
Clock To: **5**
1st Value:
2nd Value:
Value Percent: **5.000**
Continuous Index:
Within 8" of Joint: **YES**
Remarks:

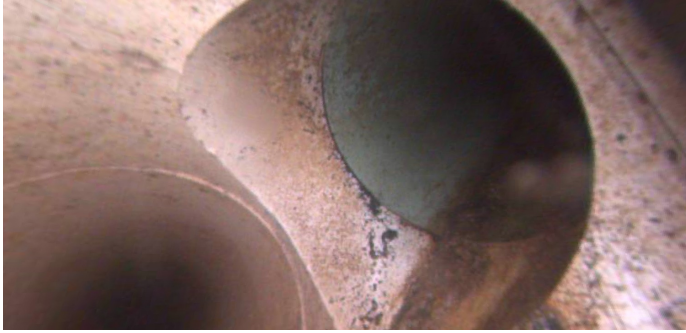
Code: **TF**
Description: **Tap Factory**

Distance (ft): **60.2**
Structural Grade: **0**
O&M Grade: **0**
Clock Start/From: **2**
Clock To:
1st Value: **4.000**
2nd Value:
Value Percent:
Continuous Index:
Within 8" of Joint:
Remarks:

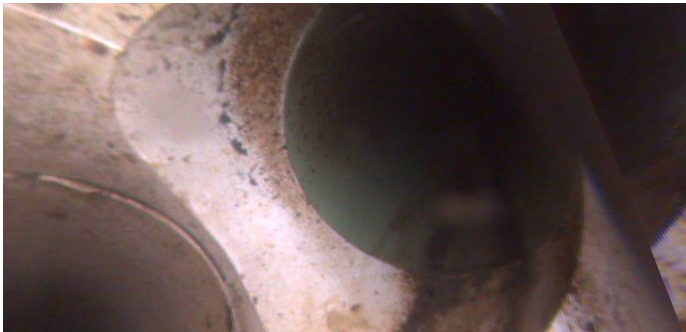
Code: **TF**
Description: **Tap Factory**

Distance (ft): **123.8**
Structural Grade: **0**
O&M Grade: **0**
Clock Start/From: **2**
Clock To:
1st Value: **4.000**
2nd Value:
Value Percent:
Continuous Index:
Within 8" of Joint:
Remarks:

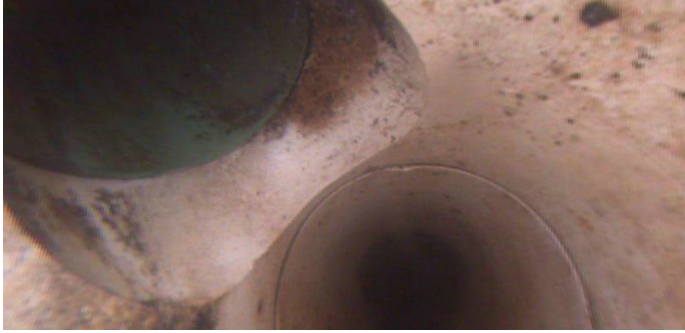
Code: **TF**
Description: **Tap Factory**

Distance (ft): **136.8**
Structural Grade: **0**
O&M Grade: **0**
Clock Start/From: **10**
Clock To:
1st Value: **4.000**
2nd Value:
Value Percent:
Continuous Index:
Within 8" of Joint:
Remarks:

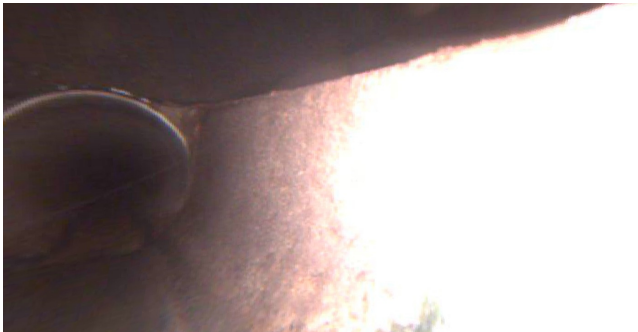
Code: **AMH**
Description: **Manhole**

Distance (ft): **164.4**
Structural Grade: **0**
O&M Grade: **0**
Clock Start/From:
Clock To:
1st Value:
2nd Value:
Value Percent:
Continuous Index:
Within 8" of Joint: **NO**
Remarks: **M-308-019**
