Profile/Photo Observation Report

Street:	DIAMOND DR & COLORADO ST	Flow Control:	Not Controlled
City:	Hobart, IN	Year Renewed:	
Location:	Light Highway	Tape/Media #:	
Purpose:	Routine Assessment	Dia/Height:	8"
Use:	Sanitary	Material:	PVC
Drain Area:	NA	Lining:	
Category:	NA		
Comment:	Rocks in the tracks at 0 ft F_S_P_C . Flow direction wrong		
Location Details:		Direction of Survey:	Upstream
US MH:	M-308-020	DS MH:	M-308-021
		Total Length Surveyed (ft):	4.5

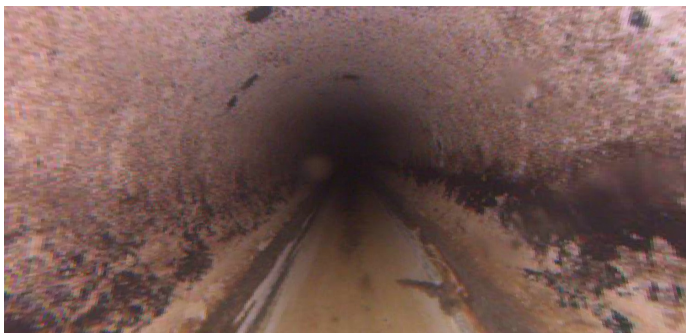
Code: **AMH**
Description: **Manhole**

Distance (ft): **.0**
Structural Grade: **0**
O&M Grade: **0**
Clock Start/From:
Clock To:
1st Value:
2nd Value:
Value Percent:
Continuous Index:
Within 8" of Joint: **NO**
Remarks: **M-308-021**

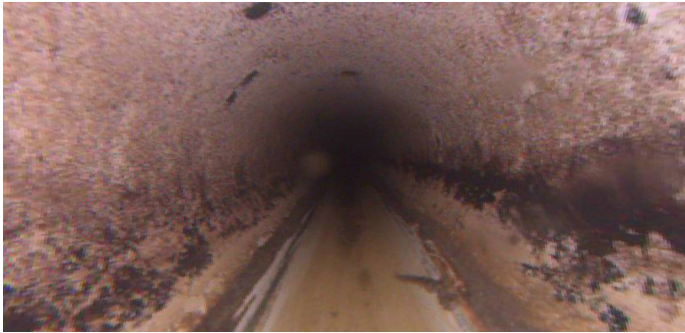
Code:	MWL
Description:	Water Level

Distance (ft):	.0
Structural Grade:	0
O&M Grade:	0
Clock Start/From:	
Clock To:	
1st Value:	
2nd Value:	
Value Percent:	5.000
Continuous Index:	
Within 8" of Joint:	NO
Remarks:

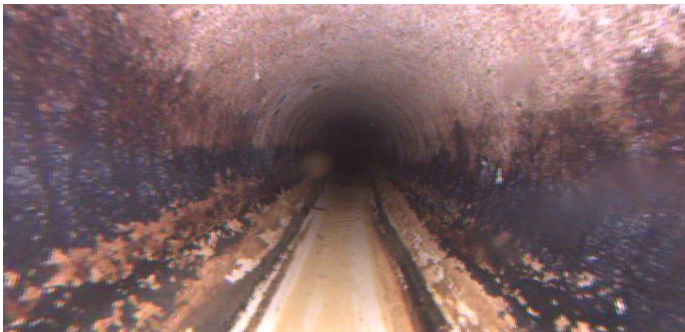
Code:	MSA
Description:	Abandoned Survey

Distance (ft):	4.5
Structural Grade:	0
O&M Grade:	0
Clock Start/From:	
Clock To:	
1st Value:	
2nd Value:	
Value Percent:	
Continuous Index:	
Within 8" of Joint:	NO
Remarks:	camera stopped
