Profile/Photo Observation Report

Street:	FOXCROFT STREET	Flow Control:	Not Controlled
City:	Hobart, IN	Year Renewed:	
Location:	Light Highway	Tape/Media #:	
Purpose:	Routine Assessment	Dia/Height:	8"
Use:	Sanitary	Material:	PVC
Drain Area:	NA	Lining:	
Category:	NA		
Comment:	Rocks in the tracks at 0 ft F_S_P_C . Flow direction wrong		
Location Details:		Direction of Survey:	Upstream
US MH:	M-308-020	DS MH:	M-308-021
		Total Length Surveyed (ft):	4.5

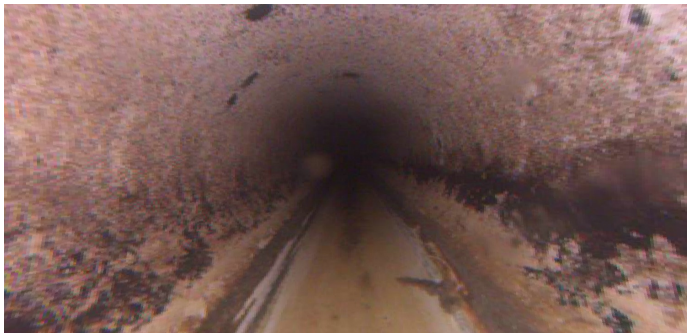
Code: **AMH**
 Description: **Manhole**
 Distance (ft): **.0**
 Structural Grade: **0**
 O&M Grade: **0**
 Clock Start/From:
 Clock To:
 1st Value:
 2nd Value:
 Value Percent:
 Continuous Index:
 Within 8" of Joint: **NO**
 Remarks: **M-308-021**

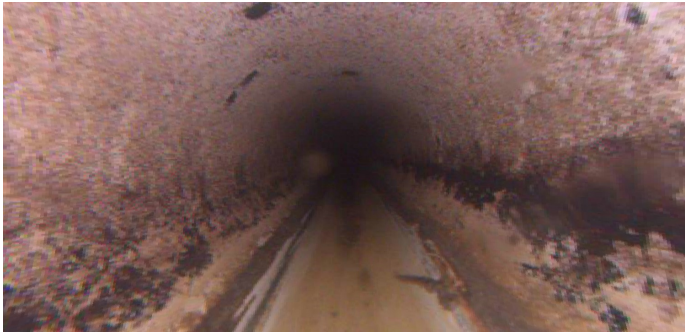
Code:	MWL
Description:	Water Level

Distance (ft):	.0
Structural Grade:	0
O&M Grade:	0
Clock Start/From:	
Clock To:	
1st Value:	
2nd Value:	
Value Percent:	5.000
Continuous Index:	
Within 8" of Joint:	NO
Remarks:

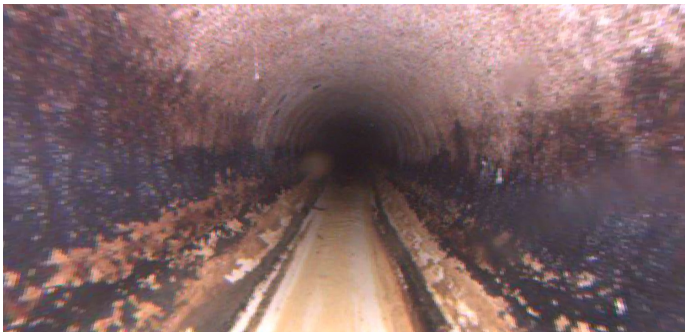
Code:	MSA
Description:	Abandoned Survey

Distance (ft):	4.5
Structural Grade:	0
O&M Grade:	0
Clock Start/From:	
Clock To:	
1st Value:	
2nd Value:	
Value Percent:	
Continuous Index:	
Within 8" of Joint:	NO
Remarks:	camera stopped
