## Profile/Photo Observation Report

Street:	<b>FOXCROFT STREET</b>	Flow Control:	<b>Not Controlled</b>
City:	<b>Hobart, IN</b>	Year Renewed:	
Location:	<b>Light Highway</b>	Tape/Media #:	
Purpose:	<b>Routine Assessment</b>	Dia/Height:	<b>8"</b>
Use:	<b>Sanitary</b>	Material:	<b>PVC</b>
Drain Area:	<b>NA</b>	Lining:	
Category:	<b>NA</b>		
Comment:	<b>P_C at 70 ft nothing visible . Flow direction wrong</b>		
Location Details:		Direction of Survey:	<b>Downstream</b>
US MH:	<b>M-308-020</b>	DS MH:	<b>M-308-021</b>
		Total Length Surveyed (ft):	<b>71.7</b>

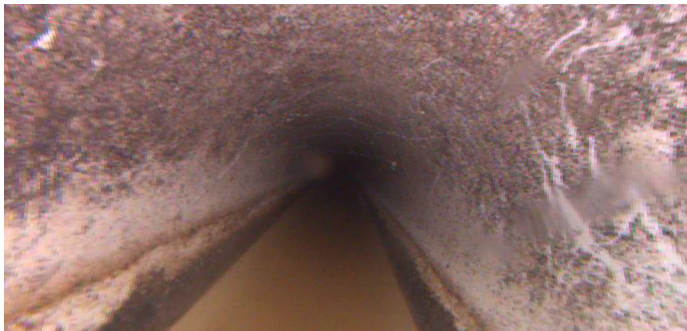
Code: **AMH**  
 Description: **Manhole**

Distance (ft): **.0**  
 Structural Grade: **0**  
 O&M Grade: **0**  
 Clock Start/From:  
 Clock To:  
 1st Value:  
 2nd Value:  
 Value Percent:  
 Continuous Index:  
 Within 8" of Joint: **NO**  
 Remarks: **M-308-020**

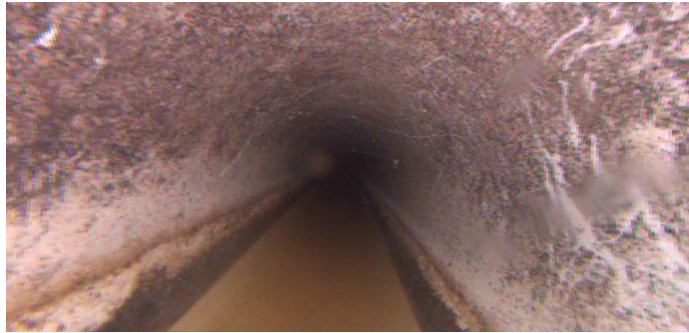
Code: **MWL**  
Description: **Water Level**

Distance (ft): **.0**  
Structural Grade: **0**  
O&M Grade: **0**  
Clock Start/From:  
Clock To:  
1st Value:  
2nd Value:  
Value Percent: **5.000**  
Continuous Index:  
Within 8" of Joint: **NO**  
Remarks:

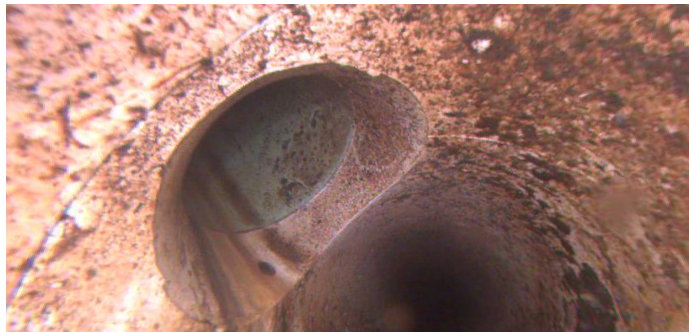
Code: **TF**  
Description: **Tap Factory**

Distance (ft): **25.0**  
Structural Grade: **0**  
O&M Grade: **0**  
Clock Start/From: **10**  
Clock To:  
1st Value: **4.000**  
2nd Value:  
Value Percent:  
Continuous Index:  
Within 8" of Joint:  
Remarks:

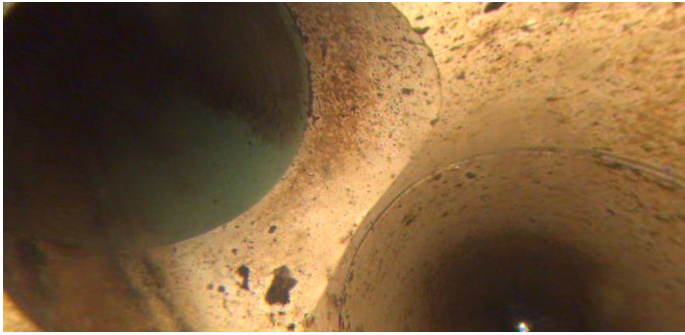
Code: **TF**  
Description: **Tap Factory**

Distance (ft): **39.1**  
Structural Grade: **0**  
O&M Grade: **0**  
Clock Start/From: **2**  
Clock To:  
1st Value: **4.000**  
2nd Value:  
Value Percent:  
Continuous Index:  
Within 8" of Joint:  
Remarks:

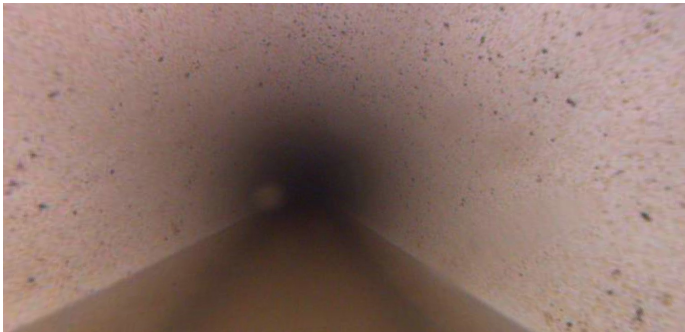
Code: **MWL**  
Description: **Water Level**

Distance (ft): **71.7**  
Structural Grade: **0**  
O&M Grade: **0**  
Clock Start/From:  
Clock To:  
1st Value:  
2nd Value:  
Value Percent: **20.000**  
Continuous Index:  
Within 8" of Joint: **NO**  
Remarks:

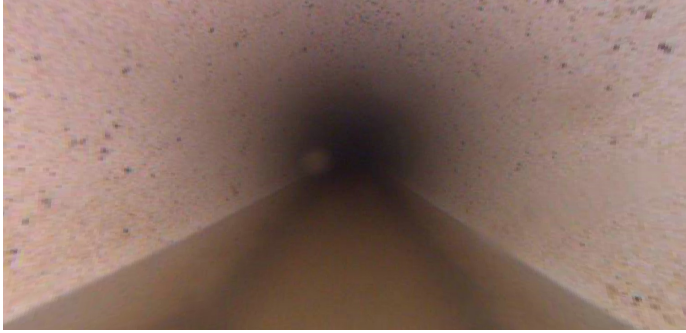
Code:	<b>MSA</b>
Description:	<b>Abandoned Survey</b>
Distance (ft):	<b>71.7</b>
Structural Grade:	<b>0</b>
O&M Grade:	<b>0</b>
Clock Start/From:	
Clock To:	
1st Value:	
2nd Value:	
Value Percent:	
Continuous Index:	
Within 8" of Joint:	<b>NO</b>
Remarks:	<b>Possible debris under water</b>
