Profile/Photo Observation Report

Date:	03/21/2018	Weather:		Coding:	PACP 6.0
Pipe Length (ft):	103.7	Owner:	NA	Pre Clean:	No Pre-Cleaning
P.O.#:		Surveyor:	Selasie Honu	PSR:	P-308-022-021
Customer:		Clean Date:	01/01/1900	Shape:	C

Street:	COLORADO ST	Flow Control:	Not Controlled
City:	Hobart, IN	Year Renewed:	
Location:	Light Highway	Tape/Media #:	
Purpose:	Routine Assessment	Dia/Height:	8"
Use:	Sanitary	Material:	PVC
Drain Area:	NA	Lining:	
Category:	NA		
Comment:	Catch pole in last image . Flow direction wrong		
Location Details:		Direction of Survey:	Upstream
US MH:	M-308-021	DS MH:	M-308-022
		Total Length Surveyed (ft):	98.3

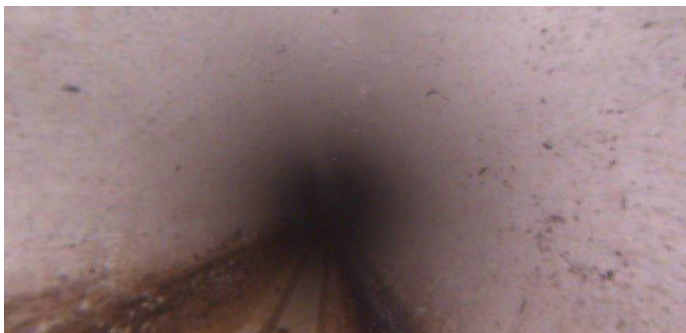
Code: **AMH**
Description: **Manhole**

Distance (ft): **.0**
Structural Grade: **0**
O&M Grade: **0**
Clock Start/From:
Clock To:
1st Value:
2nd Value:
Value Percent:
Continuous Index:
Within 8" of Joint: **NO**
Remarks: **M-308-022**

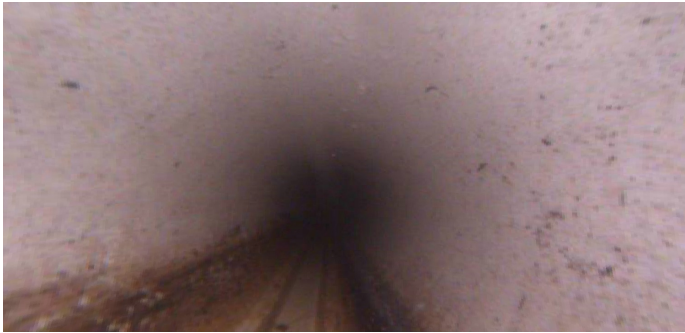
Code:	MWL
Description:	Water Level

Distance (ft):	.0
Structural Grade:	0
O&M Grade:	0
Clock Start/From:	
Clock To:	
1st Value:	
2nd Value:	
Value Percent:	5.000
Continuous Index:	
Within 8" of Joint:	NO
Remarks:

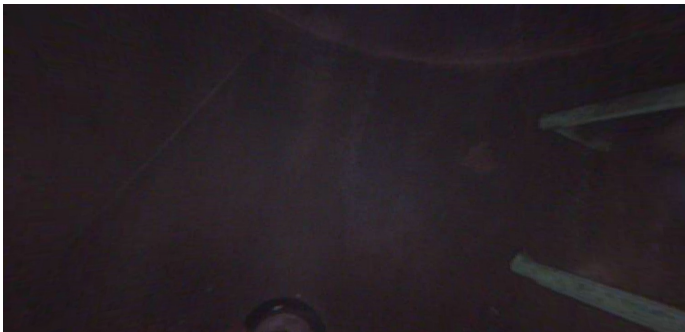
Code:	AMH
Description:	Manhole

Distance (ft):	98.3
Structural Grade:	0
O&M Grade:	0
Clock Start/From:	
Clock To:	
1st Value:	
2nd Value:	
Value Percent:	
Continuous Index:	
Within 8" of Joint:	NO
Remarks:	M-308-021
