Profile/Photo Observation Report

Street:	FOXCROFT STREET	Flow Control:	Not Controlled
City:	Hobart, IN	Year Renewed:	
Location:	Light Highway	Tape/Media #:	
Purpose:	Routine Assessment	Dia/Height:	8"
Use:	Sanitary	Material:	PVC
Drain Area:	NA	Lining:	
Category:	NA		
Comment:	Flow direction wrong

Location Details:		Direction of Survey:	Upstream
US MH:	M-308-021	DS MH:	M-308-026
		Total Length Surveyed (ft):	249.3

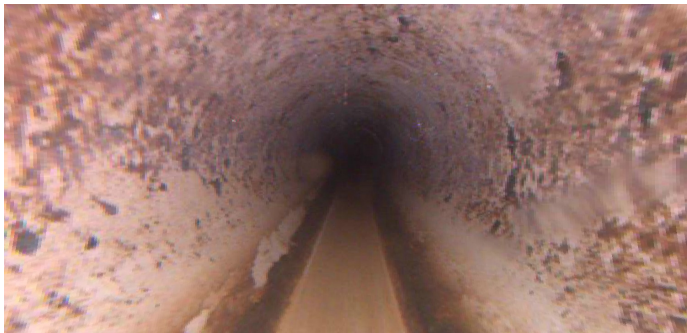
Code: **AMH**
 Description: **Manhole**

Distance (ft): **.0**
 Structural Grade: **0**
 O&M Grade: **0**
 Clock Start/From:
 Clock To:
 1st Value:
 2nd Value:
 Value Percent:
 Continuous Index:
 Within 8" of Joint: **NO**
 Remarks: **M-308-026**

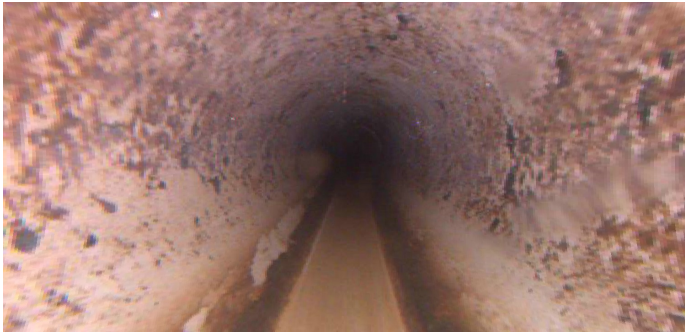
Code:	MWL
Description:	Water Level

Distance (ft):	.0
Structural Grade:	0
O&M Grade:	0
Clock Start/From:	
Clock To:	
1st Value:	
2nd Value:	
Value Percent:	5.000
Continuous Index:	
Within 8" of Joint:	NO
Remarks:

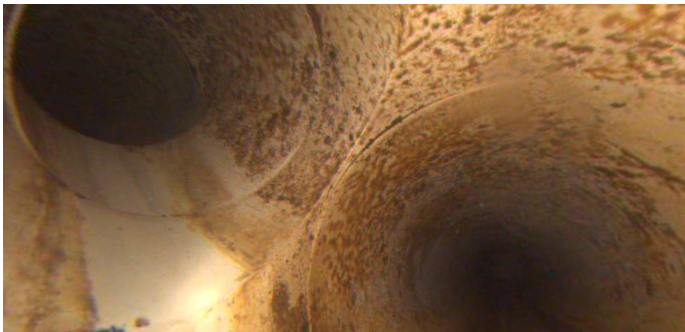
Code:	TF
Description:	Tap Factory

Distance (ft):	5.1
Structural Grade:	0
O&M Grade:	0
Clock Start/From:	2
Clock To:	
1st Value:	4.000
2nd Value:	
Value Percent:	
Continuous Index:	
Within 8" of Joint:	
Remarks:

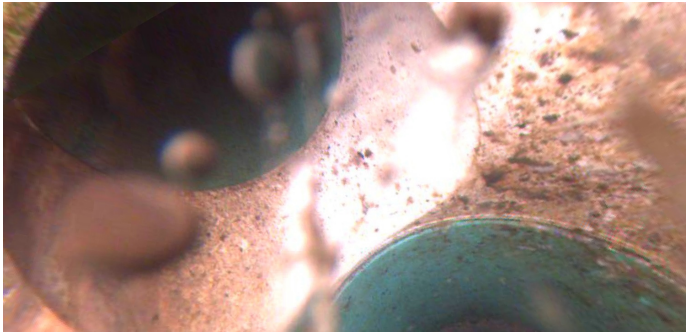
Code: **TF**
Description: **Tap Factory**

Distance (ft): **111.7**
Structural Grade: **0**
O&M Grade: **0**
Clock Start/From: **11**
Clock To:
1st Value: **4.000**
2nd Value:
Value Percent:
Continuous Index:
Within 8" of Joint:
Remarks:

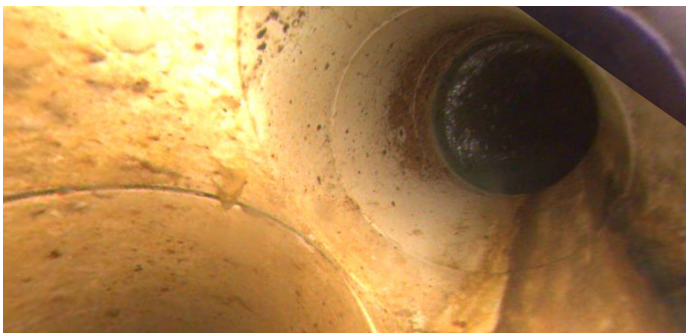
Code: **TF**
Description: **Tap Factory**

Distance (ft): **221.9**
Structural Grade: **0**
O&M Grade: **0**
Clock Start/From: **10**
Clock To:
1st Value: **4.000**
2nd Value:
Value Percent:
Continuous Index:
Within 8" of Joint:
Remarks:

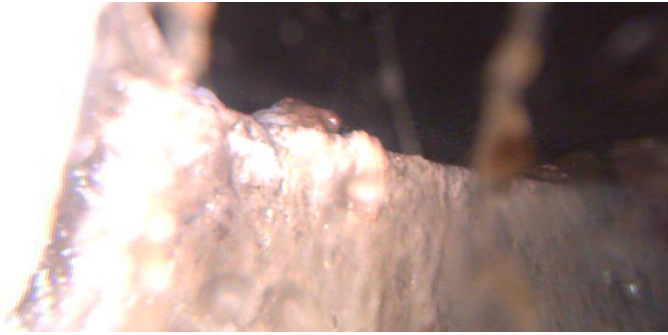
Code: **AMH**
Description: **Manhole**

Distance (ft): **249.3**
Structural Grade: **0**
O&M Grade: **0**
Clock Start/From:
Clock To:
1st Value:
2nd Value:
Value Percent:
Continuous Index:
Within 8" of Joint: **NO**
Remarks: **M-308-021**
