Profile/Photo Observation Report

Street:	COLORADO ST	Flow Control:	Not Controlled
City:	Hobart, IN	Year Renewed:	
Location:	Light Highway	Tape/Media #:	
Purpose:	Routine Assessment	Dia/Height:	8"
Use:	Sanitary	Material:	PVC
Drain Area:	NA	Lining:	
Category:	NA		
Comment:	Flow direction wrong

Location Details:		Direction of Survey:	Downstream
US MH:	M-308-022	DS MH:	M-308-024
		Total Length Surveyed (ft):	169.4

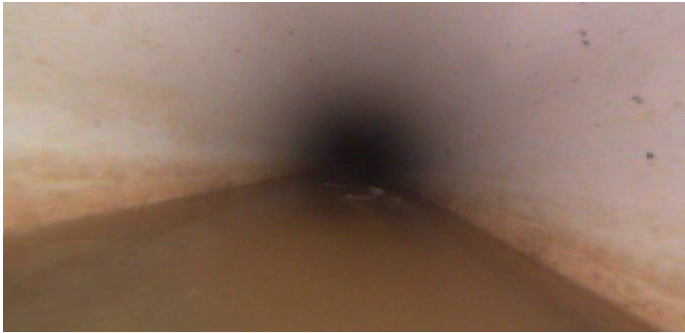
Code:	MWL
Description:	Water Level

Distance (ft):	.0
Structural Grade:	0
O&M Grade:	0
Clock Start/From:	
Clock To:	
1st Value:	
2nd Value:	
Value Percent:	5.000
Continuous Index:	
Within 8" of Joint:	NO
Remarks:

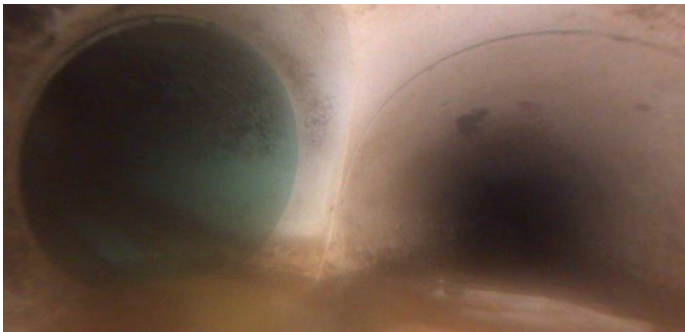
Code:	TFA
Description:	Tap Factory Active

Distance (ft):	25.6
Structural Grade:	0
O&M Grade:	0
Clock Start/From:	9
Clock To:	
1st Value:	4.000
2nd Value:	
Value Percent:	
Continuous Index:	
Within 8" of Joint:	
Remarks:

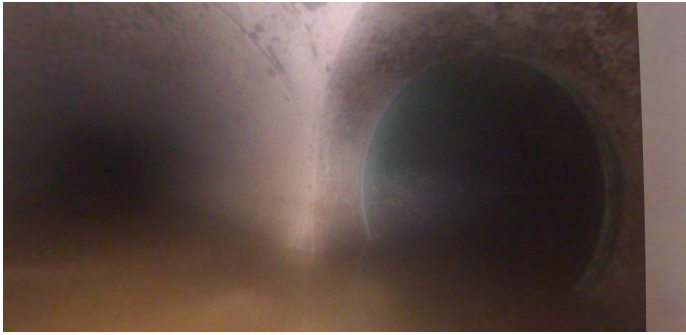
Code: **TFA**
Description: **Tap Factory Active**

Distance (ft): **39.6**
Structural Grade: **0**
O&M Grade: **0**
Clock Start/From: **3**
Clock To:
1st Value: **4.000**
2nd Value:
Value Percent:
Continuous Index:
Within 8" of Joint:
Remarks:

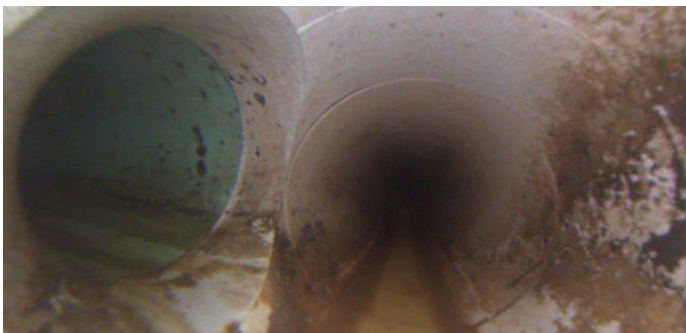
Code: **TF**
Description: **Tap Factory**

Distance (ft): **120.7**
Structural Grade: **0**
O&M Grade: **0**
Clock Start/From: **9**
Clock To:
1st Value: **4.000**
2nd Value:
Value Percent:
Continuous Index:
Within 8" of Joint:
Remarks:

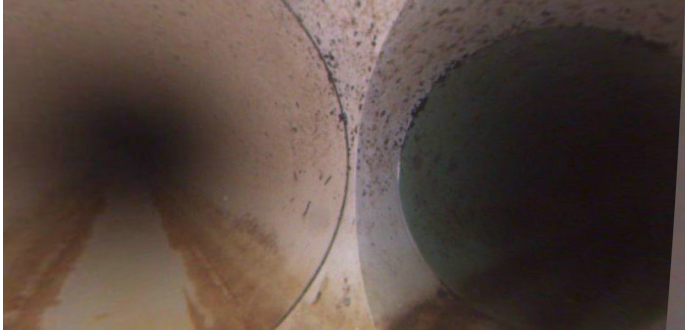
Code: **TF**
Description: **Tap Factory**

Distance (ft): **134.9**
Structural Grade: **0**
O&M Grade: **0**
Clock Start/From: **3**
Clock To:
1st Value: **4.000**
2nd Value:
Value Percent:
Continuous Index:
Within 8" of Joint:
Remarks:

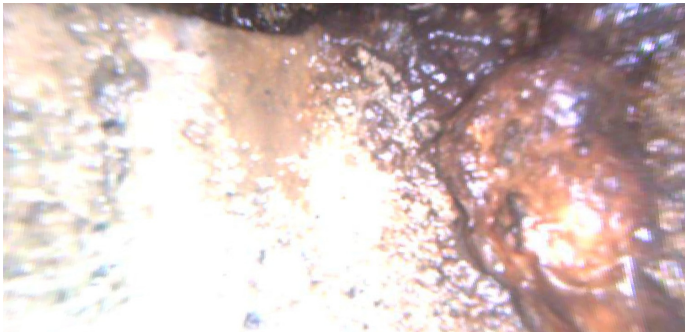
Code: **AMH**
Description: **Manhole**

Distance (ft): **169.4**
Structural Grade: **0**
O&M Grade: **0**
Clock Start/From:
Clock To:
1st Value:
2nd Value:
Value Percent:
Continuous Index:
Within 8" of Joint: **NO**
Remarks: **M-308-024**
