Profile/Photo Observation Report

| Street: | EMERALD DR | Flow Control: | Not Controlled |
| City: | Hobart, IN | Year Renewed: | |

| US MH: | M-308-024 | DS MH: | M-308-018 |

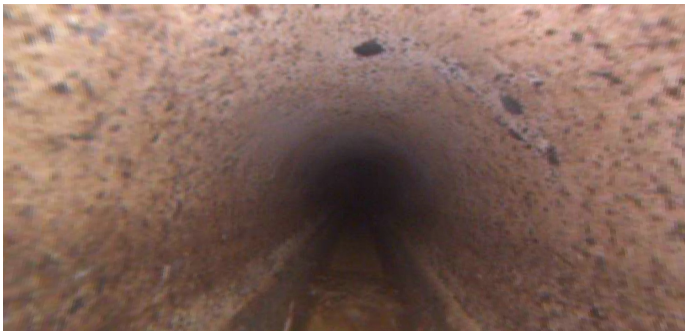
Code: **AMH**
Description: **Manhole**

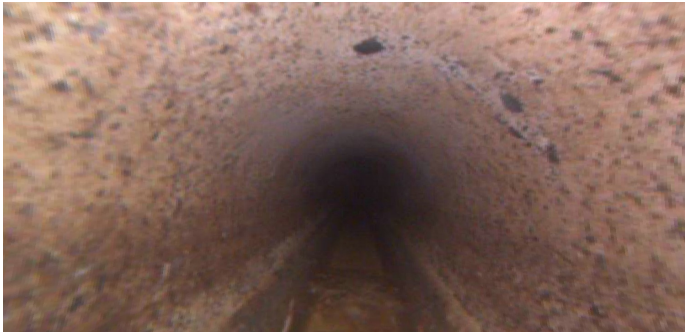
| Code: | MWL |
| Description: | Water Level |

| Distance (ft): | .0 |
| Value Percent: | 5.000 |

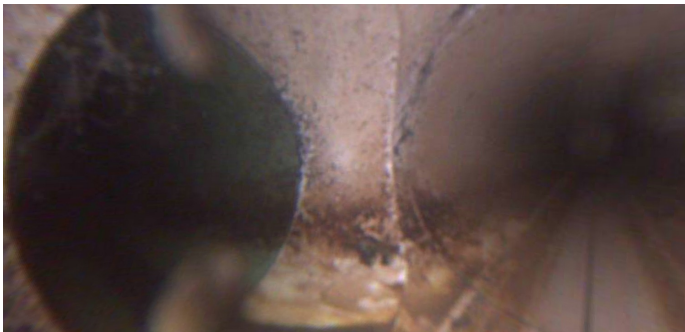
| Code: | TFA |
| Description: | Tap Factory Active |

| Distance (ft): | 79.1 |

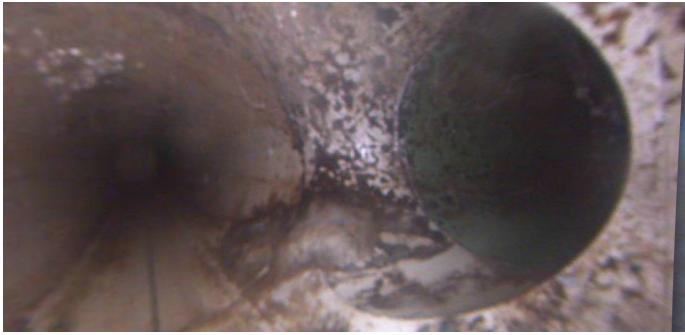
| Position | Code | Observation | Video (sec) | Grade |
|---|---|---|---|---|
| 133.5 | TFD | Tap Factory Defective | 316 | M 2 |

Code: **TFD**
Description: **Tap Factory Defective**

Distance (ft): **133.5**
Structural Grade: **0**
O&M Grade: **2**
Clock Start/From: **9**
Clock To:
1st Value: **4.000**
2nd Value:
Value Percent:
Continuous Index:
Within 8" of Joint:
Remarks: **DAGS**

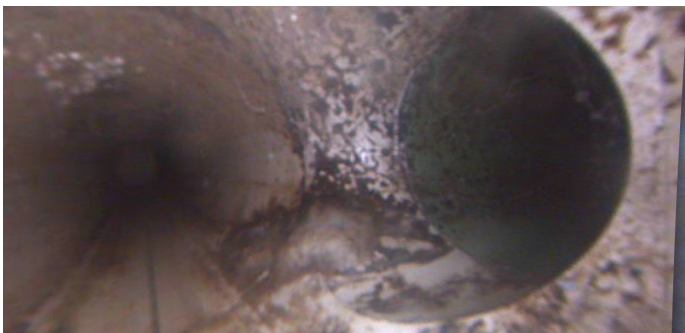
| Position | Code | Observation | Video (sec) | Grade |
|---|---|---|---|---|
| 133.5 | DAGS | Deposits Attached Grease | 328 | M 2 |

Code: **DAGS**
Description: **Deposits Attached Grease**

Distance (ft): **133.5**
Structural Grade: **0**
O&M Grade: **2**
Clock Start/From: **8**
Clock To: **9**
1st Value:
2nd Value:
Value Percent: **5.000**
Continuous Index:
Within 8" of Joint: **NO**
Remarks:

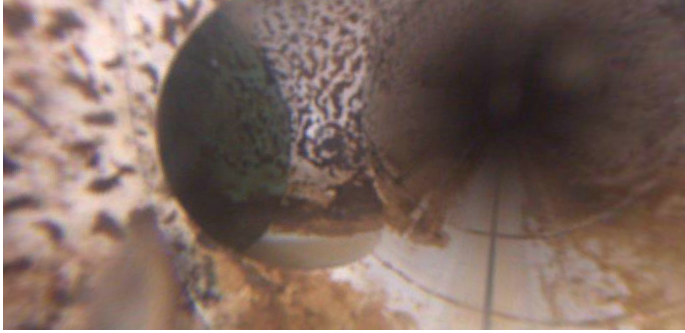
Code: **TFA**
Description: **Tap Factory Active**

Distance (ft): **187.9**
Structural Grade: **0**
O&M Grade: **0**
Clock Start/From: **3**
Clock To:
1st Value: **4.000**
2nd Value:
Value Percent:
Continuous Index:
Within 8" of Joint:
Remarks:

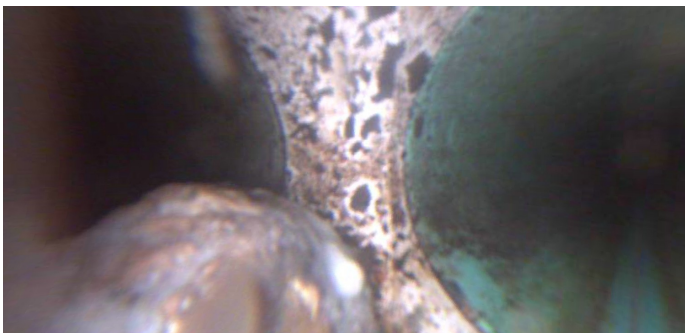
| Position | Code | Observation | Video (sec) | Grade |
|---|---|---|---|---|
| 268.7 | TFD | Tap Factory Defective | 628 | M 2 |

Code: **TFD**
Description: **Tap Factory Defective**

Distance (ft): **268.7**
Structural Grade: **0**
O&M Grade: **2**
Clock Start/From: **3**
Clock To:
1st Value: **4.000**
2nd Value:
Value Percent:
Continuous Index:
Within 8" of Joint:
Remarks: **DAGS**

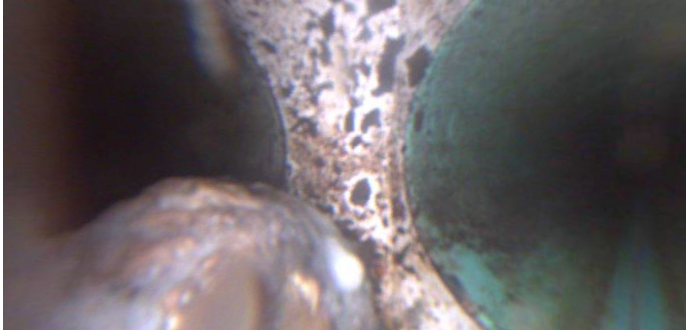
| Position | Code | Observation | Video (sec) | Grade |
|---|---|---|---|---|
| 268.7 | DAGS | Deposits Attached Grease | 639 | M 2 |

Code: **DAGS**
Description: **Deposits Attached Grease**

Distance (ft): **268.7**
Structural Grade: **0**
O&M Grade: **2**
Clock Start/From: **3**
Clock To: **4**
1st Value:
2nd Value:
Value Percent: **5.000**
Continuous Index:
Within 8" of Joint: **NO**
Remarks:

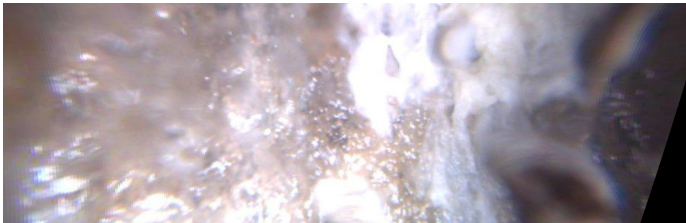
Code: **AMH**
Description: **Manhole**

Distance (ft): **313.7**
Structural Grade: **0**
O&M Grade: **0**
Clock Start/From:
Clock To:
1st Value:
2nd Value:
Value Percent:
Continuous Index:
Within 8" of Joint: **NO**
Remarks: **M-308-024**
