Profile/Photo Observation Report

Date:	03/21/2018	Weather:		Coding:	PACP 6.0
Pipe Length (ft):	302.6	Owner:	NA	Pre Clean:	No Pre-Cleaning
P.O.#:		Surveyor:	Selasie Honu	PSR:	P-308-024-018
Customer:		Clean Date:	01/01/1900	Shape:	C

Street:	FOXCROFT STREET	Flow Control:	Not Controlled
City:	Hobart, IN	Year Renewed:	
Location:	Light Highway	Tape/Media #:	
Purpose:	Routine Assessment	Dia/Height:	8"
Use:	Sanitary	Material:	PVC
Drain Area:	NA	Lining:	
Category:	NA		
Comment:	o

Location Details:		Direction of Survey:	Upstream
US MH:	M-308-024	DS MH:	M-308-018
		Total Length Surveyed (ft):	313.7

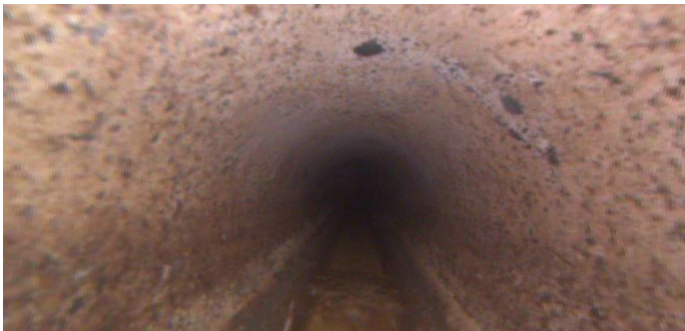
Code: **AMH**
Description: **Manhole**

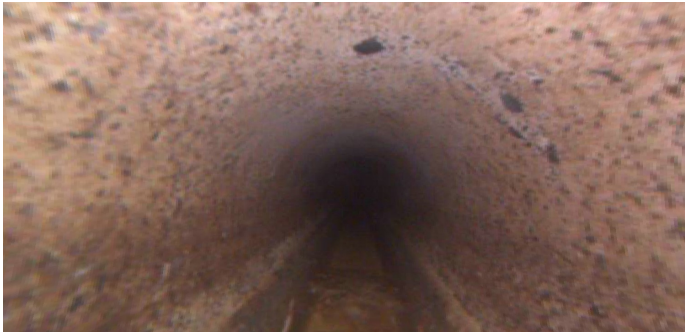
Code: **MWL**
Description: **Water Level**

Distance (ft): **.0**
Structural Grade: **0**
O&M Grade: **0**
Clock Start/From:
Clock To:
1st Value:
2nd Value:
Value Percent: **5.000**
Continuous Index:
Within 8" of Joint: **NO**
Remarks:

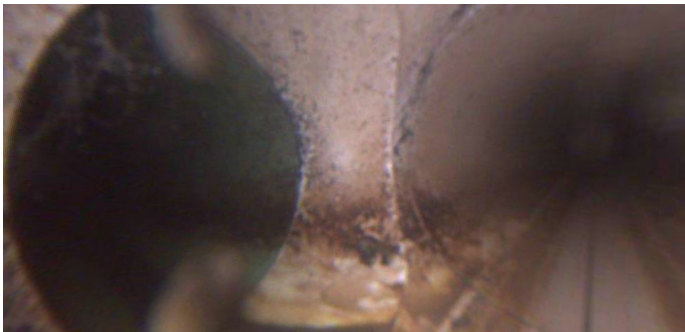
Code: **TFA**
Description: **Tap Factory Active**

Distance (ft): **79.1**
Structural Grade: **0**
O&M Grade: **0**
Clock Start/From: **3**
Clock To:
1st Value: **4.000**
2nd Value:
Value Percent:
Continuous Index:
Within 8" of Joint:
Remarks:

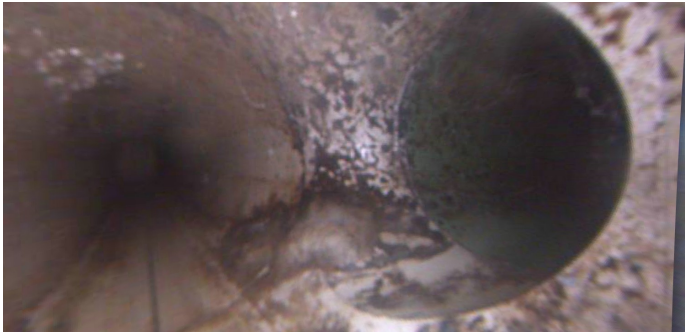
Code: **TFD**
Description: **Tap Factory Defective**

Distance (ft): **133.5**
Structural Grade: **0**
O&M Grade: **2**
Clock Start/From: **9**
Clock To:
1st Value: **4.000**
2nd Value:
Value Percent:
Continuous Index:
Within 8" of Joint:
Remarks: **DAGS**

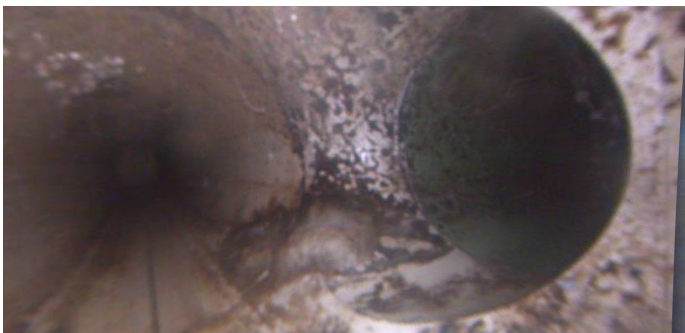
Code: **DAGS**
Description: **Deposits Attached Grease**

Distance (ft): **133.5**
Structural Grade: **0**
O&M Grade: **2**
Clock Start/From: **8**
Clock To: **9**
1st Value:
2nd Value:
Value Percent: **5.000**
Continuous Index:
Within 8" of Joint: **NO**
Remarks:

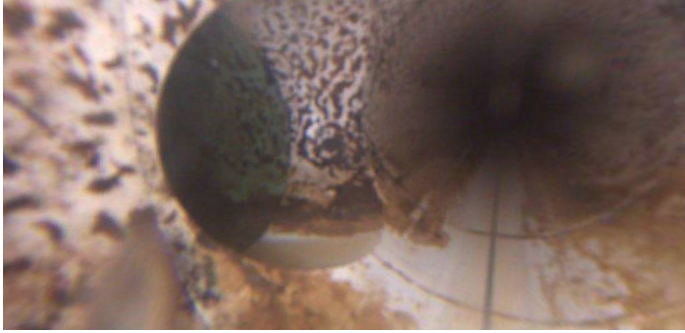
Code: **TFA**
Description: **Tap Factory Active**

Distance (ft): **187.9**
Structural Grade: **0**
O&M Grade: **0**
Clock Start/From: **3**
Clock To:
1st Value: **4.000**
2nd Value:
Value Percent:
Continuous Index:
Within 8" of Joint:
Remarks:

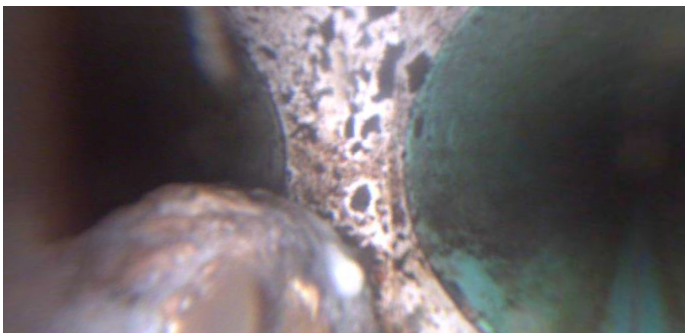
Code: **TFD**
Description: **Tap Factory Defective**

Distance (ft): **268.7**
Structural Grade: **0**
O&M Grade: **2**
Clock Start/From: **3**
Clock To:
1st Value: **4.000**
2nd Value:
Value Percent:
Continuous Index:
Within 8" of Joint:
Remarks: **DAGS**

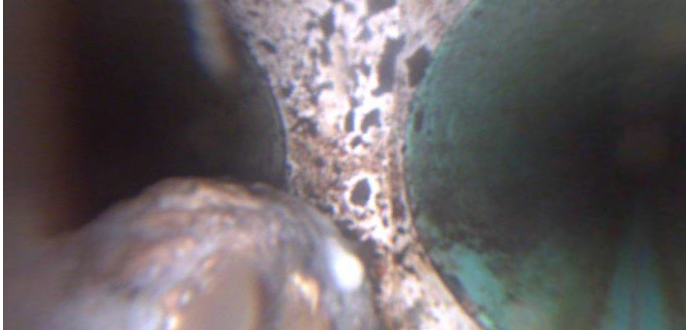
Code: **DAGS**
Description: **Deposits Attached Grease**

Distance (ft): **268.7**
Structural Grade: **0**
O&M Grade: **2**
Clock Start/From: **3**
Clock To: **4**
1st Value:
2nd Value:
Value Percent: **5.000**
Continuous Index:
Within 8" of Joint: **NO**
Remarks:

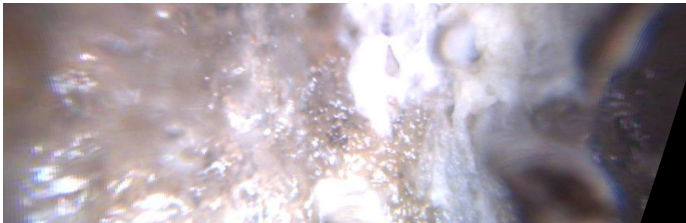
Code: **AMH**
Description: **Manhole**

Distance (ft): **313.7**
Structural Grade: **0**
O&M Grade: **0**
Clock Start/From:
Clock To:
1st Value:
2nd Value:
Value Percent:
Continuous Index:
Within 8" of Joint: **NO**
Remarks: **M-308-024**
