Profile/Photo Observation Report

Date:	03/21/2018	Weather:		Coding:	PACP 6.0
Pipe Length (ft):	302.9	Owner:	NA	Pre Clean:	No Pre-Cleaning
P.O.#:		Surveyor:	Selasie Honu	PSR:	P-308-025-026
Customer:		Clean Date:	01/01/1900	Shape:	C

Street:	COLORADO ST	Flow Control:	Not Controlled
City:	Hobart, IN	Year Renewed:	
Location:	Light Highway	Tape/Media #:	
Purpose:	Routine Assessment	Dia/Height:	8"
Use:	Sanitary	Material:	PVC
Drain Area:	NA	Lining:	
Category:	NA		
Comment:	Flow direction wrong		
Location Details:		Direction of Survey:	Upstream
US MH:	M-308-026	DS MH:	M-308-025
		Total Length Surveyed (ft):	297.2

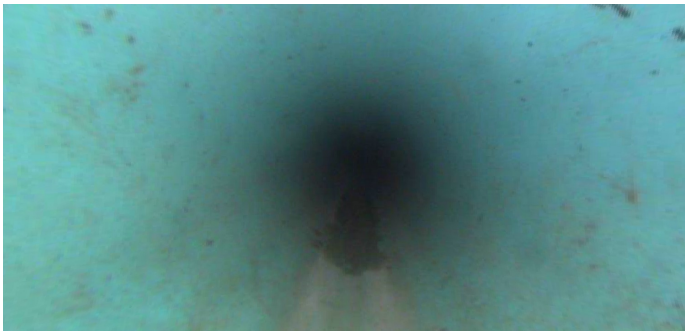
Code: **AMH**
Description: **Manhole**

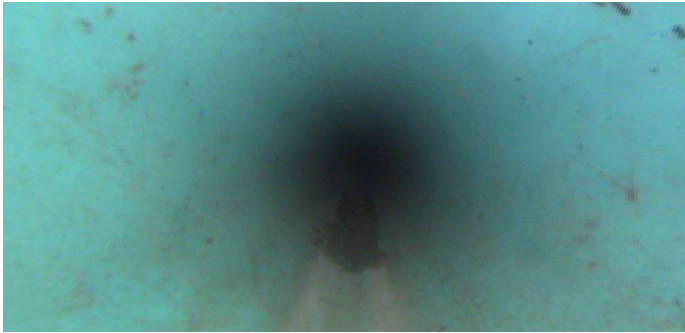
Code:	MWL
Description:	Water Level

Distance (ft):	.0
Structural Grade:	0
O&M Grade:	0
Clock Start/From:	
Clock To:	
1st Value:	
2nd Value:	
Value Percent:	5.000
Continuous Index:	
Within 8" of Joint:	NO
Remarks:

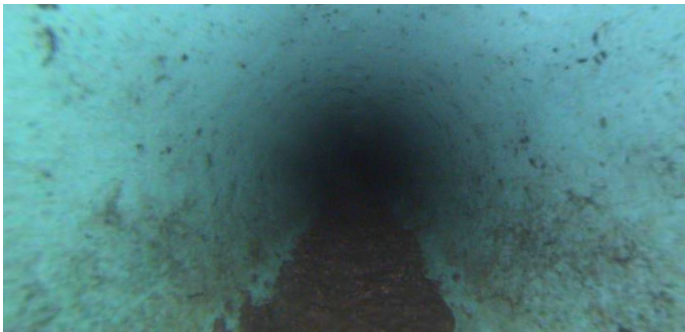
Code:	DSF
Description:	Deposits Settled Fine

Distance (ft):	8.3
Structural Grade:	0
O&M Grade:	2
Clock Start/From:	6
Clock To:	
1st Value:	
2nd Value:	
Value Percent:	5.000
Continuous Index:	S01
Within 8" of Joint:	NO
Remarks:

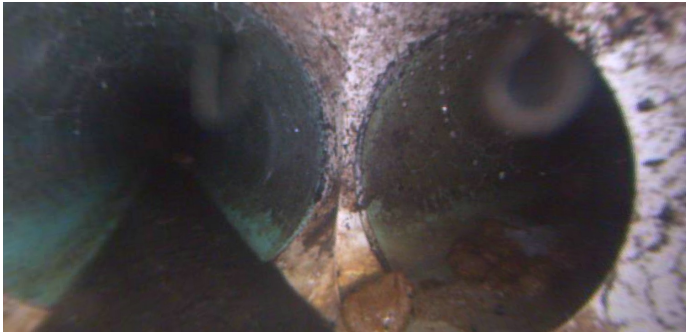
Code: **TF**
Description: **Tap Factory**

Distance (ft): **25.6**
Structural Grade: **0**
O&M Grade: **0**
Clock Start/From: **3**
Clock To:
1st Value: **4.000**
2nd Value:
Value Percent:
Continuous Index:
Within 8" of Joint:
Remarks:

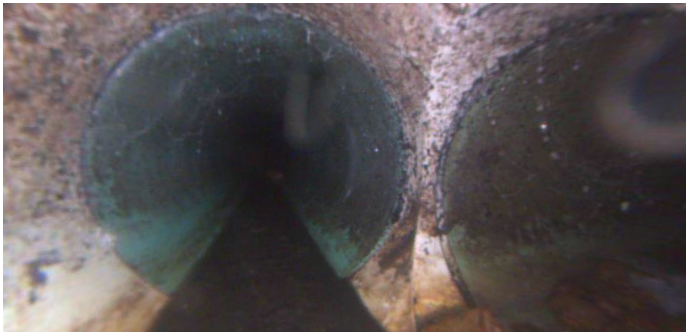
Code: **DSF**
Description: **Deposits Settled Fine**

Distance (ft): **25.6**
Structural Grade: **0**
O&M Grade: **2**
Clock Start/From: **6**
Clock To:
1st Value:
2nd Value:
Value Percent: **5.000**
Continuous Index: **F01**
Within 8" of Joint: **NO**
Remarks:

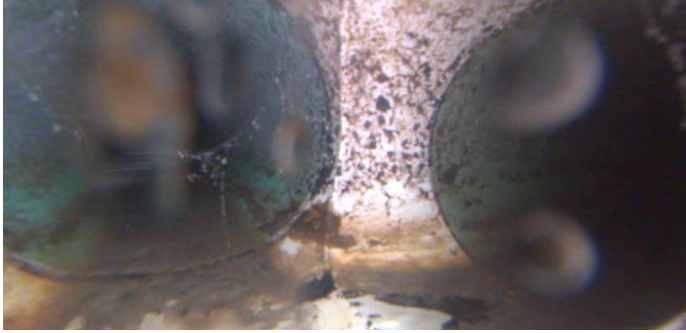
Code: **TFA**
Description: **Tap Factory Active**

Distance (ft): **120.2**
Structural Grade: **0**
O&M Grade: **0**
Clock Start/From: **3**
Clock To:
1st Value: **4.000**
2nd Value:
Value Percent:
Continuous Index:
Within 8" of Joint:
Remarks:

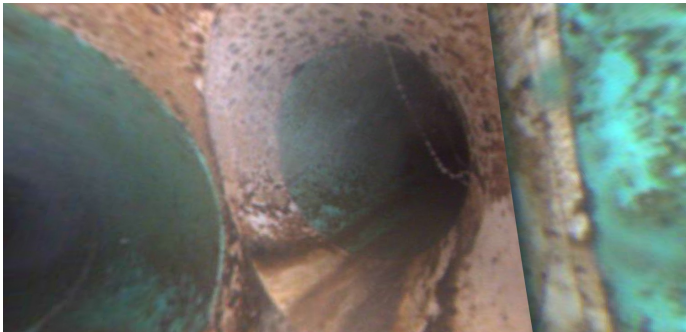
Code: **TF**
Description: **Tap Factory**

Distance (ft): **182.3**
Structural Grade: **0**
O&M Grade: **0**
Clock Start/From: **9**
Clock To:
1st Value: **4.000**
2nd Value:
Value Percent:
Continuous Index:
Within 8" of Joint:
Remarks:

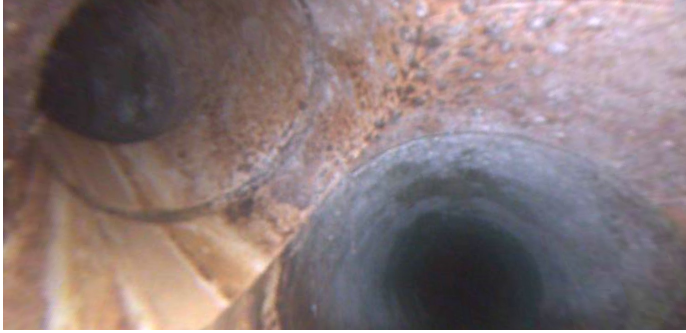
Code: **TF**
Description: **Tap Factory**

Distance (ft): **216.0**
Structural Grade: **0**
O&M Grade: **0**
Clock Start/From: **2**
Clock To:
1st Value: **4.000**
2nd Value:
Value Percent:
Continuous Index:
Within 8" of Joint:
Remarks:

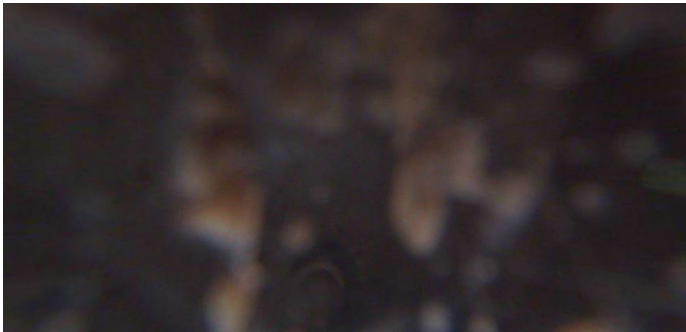
Code: **AMH**
Description: **Manhole**

Distance (ft): **297.2**
Structural Grade: **0**
O&M Grade: **0**
Clock Start/From:
Clock To:
1st Value:
2nd Value:
Value Percent:
Continuous Index:
Within 8" of Joint: **NO**
Remarks: **M-308-026**
