## Profile/Photo Observation Report

Street:	<b>SAPPHIRE CT</b>	Flow Control:	<b>Not Controlled</b>
City:	<b>Hobart, IN</b>	Year Renewed:	
Location:	<b>Light Highway</b>	Tape/Media #:	
Purpose:	<b>Routine Assessment</b>	Dia/Height:	<b>8"</b>
Use:	<b>Sanitary</b>	Material:	<b>PVC</b>
Drain Area:	<b>NA</b>	Lining:	
Category:	<b>NA</b>		
Comment:	<b>MH_F at 317 ft CNL M-308-029 . Flow direction wrong</b>		
Location Details:		Direction of Survey:	<b>Downstream</b>
US MH:	<b>M-308-028</b>	DS MH:	<b>M-308-029</b>
		Total Length Surveyed (ft):	<b>318.6</b>

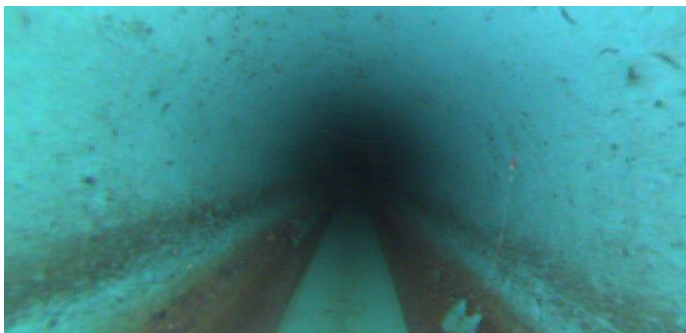
Code: **AMH**  
Description: **Manhole**

Distance (ft): **.0**  
Structural Grade: **0**  
O&M Grade: **0**  
Clock Start/From:  
Clock To:  
1st Value:  
2nd Value:  
Value Percent:  
Continuous Index:  
Within 8" of Joint: **NO**  
Remarks: **M-308-028**

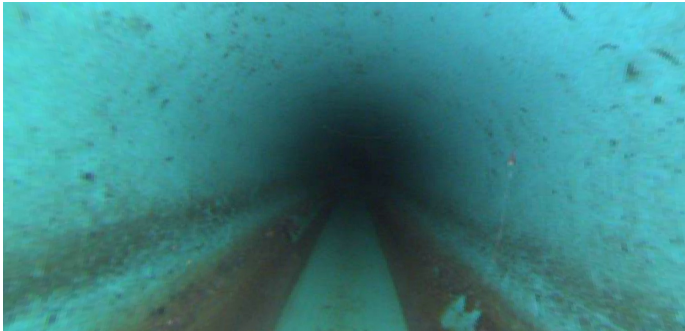
Code:	<b>MWL</b>
Description:	<b>Water Level</b>

Distance (ft):	<b>.0</b>
Structural Grade:	<b>0</b>
O&M Grade:	<b>0</b>
Clock Start/From:	
Clock To:	
1st Value:	
2nd Value:	
Value Percent:	<b>5.000</b>
Continuous Index:	
Within 8" of Joint:	<b>NO</b>
Remarks:

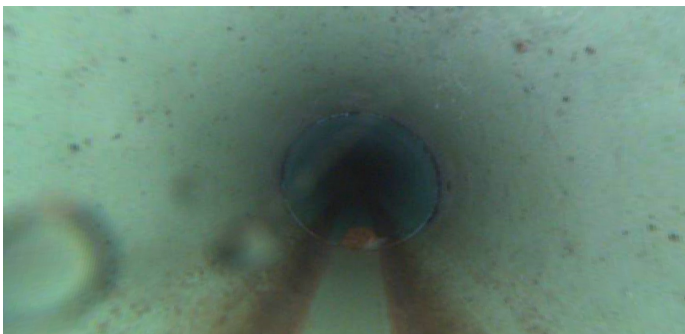
Code:	<b>DSZ</b>
Description:	<b>Deposits Settled Other</b>

Distance (ft):	<b>24.3</b>
Structural Grade:	<b>0</b>
O&M Grade:	<b>2</b>
Clock Start/From:	<b>6</b>
Clock To:	
1st Value:	
2nd Value:	
Value Percent:	<b>5.000</b>
Continuous Index:	
Within 8" of Joint:	<b>YES</b>
Remarks:	<b>mixed material</b>

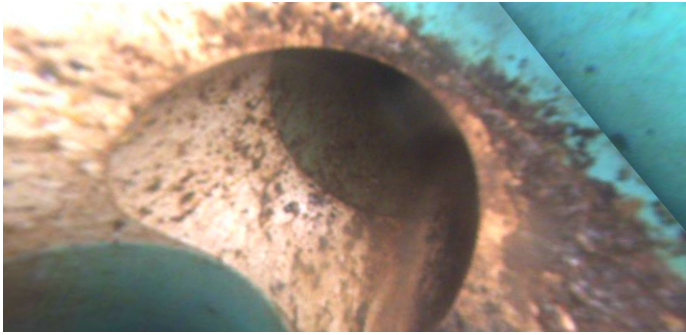
Code: **TF**  
Description: **Tap Factory**

Distance (ft): **79.9**  
Structural Grade: **0**  
O&M Grade: **0**  
Clock Start/From: **10**  
Clock To:  
1st Value: **4.000**  
2nd Value:  
Value Percent:  
Continuous Index:  
Within 8" of Joint:  
Remarks:

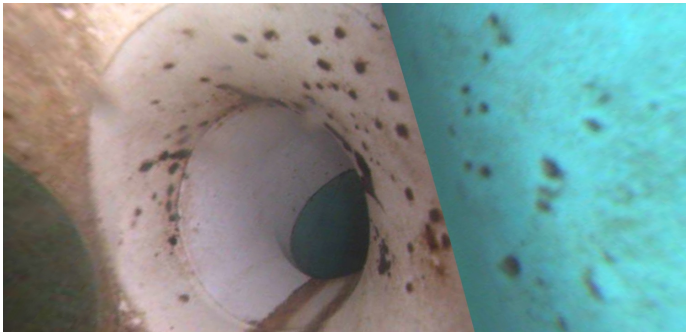
Code: **TF**  
Description: **Tap Factory**

Distance (ft): **156.9**  
Structural Grade: **0**  
O&M Grade: **0**  
Clock Start/From: **2**  
Clock To:  
1st Value: **4.000**  
2nd Value:  
Value Percent:  
Continuous Index:  
Within 8" of Joint:  
Remarks:

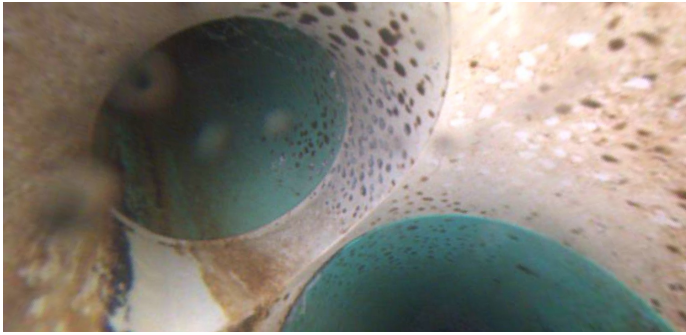
Code: **TF**  
Description: **Tap Factory**

Distance (ft): **158.8**  
Structural Grade: **0**  
O&M Grade: **0**  
Clock Start/From: **11**  
Clock To:  
1st Value: **4.000**  
2nd Value:  
Value Percent:  
Continuous Index:  
Within 8" of Joint:  
Remarks:

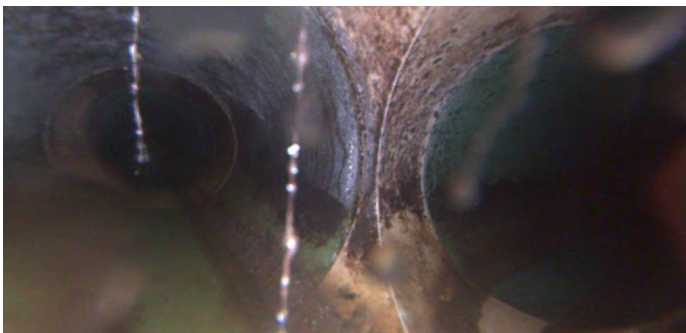
Code: **TFA**  
Description: **Tap Factory Active**

Distance (ft): **264.5**  
Structural Grade: **0**  
O&M Grade: **0**  
Clock Start/From: **3**  
Clock To:  
1st Value: **4.000**  
2nd Value:  
Value Percent:  
Continuous Index:  
Within 8" of Joint:  
Remarks:

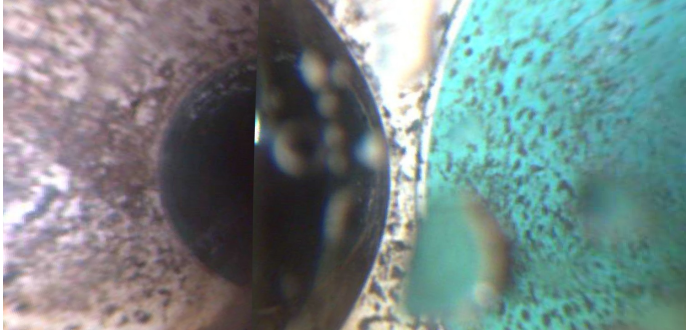
Code: **TFA**  
Description: **Tap Factory Active**

Distance (ft): **266.6**  
Structural Grade: **0**  
O&M Grade: **0**  
Clock Start/From: **9**  
Clock To:  
1st Value: **4.000**  
2nd Value:  
Value Percent:  
Continuous Index:  
Within 8" of Joint:  
Remarks:
