Profile/Photo Observation Report

Date:	03/21/2018	Weather:		Coding:	PACP 6.0
Pipe Length (ft):	478.0	Owner:	NA	Pre Clean:	No Pre-Cleaning
P.O.#:		Surveyor:	Selasie Honu	PSR:	P-308-029-028
Customer:		Clean Date:	01/01/1900	Shape:	C

Street:	FOXCROFT STREET	Flow Control:	Not Controlled
City:	Hobart, IN	Year Renewed:	
Location:	Light Highway	Tape/Media #:	
Purpose:	Routine Assessment	Dia/Height:	8"
Use:	Sanitary	Material:	PVC
Drain Area:	NA	Lining:	
Category:	NA		
Comment:	MH_F at 317 ft CNL M-308-029 . Flow direction wrong		
Location Details:		Direction of Survey:	Downstream
US MH:	M-308-028	DS MH:	M-308-029
		Total Length Surveyed (ft):	318.6

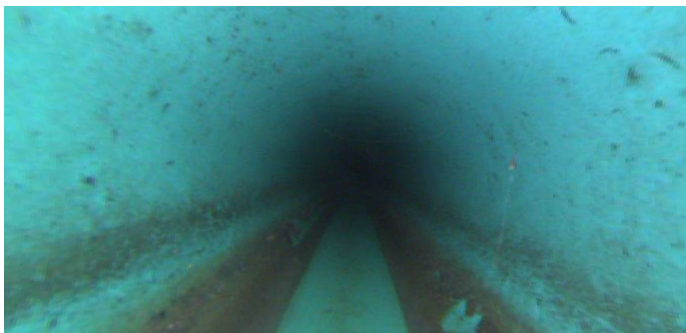
Code: **AMH**
Description: **Manhole**

Distance (ft): **.0**
Structural Grade: **0**
O&M Grade: **0**
Clock Start/From:
Clock To:
1st Value:
2nd Value:
Value Percent:
Continuous Index:
Within 8" of Joint: **NO**
Remarks: **M-308-028**

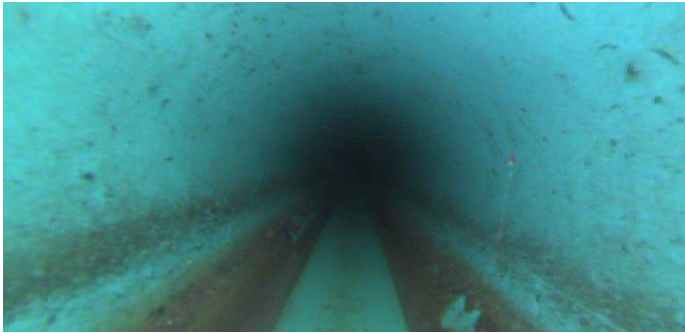
Code:	MWL
Description:	Water Level

Distance (ft):	.0
Structural Grade:	0
O&M Grade:	0
Clock Start/From:	
Clock To:	
1st Value:	
2nd Value:	
Value Percent:	5.000
Continuous Index:	
Within 8" of Joint:	NO
Remarks:

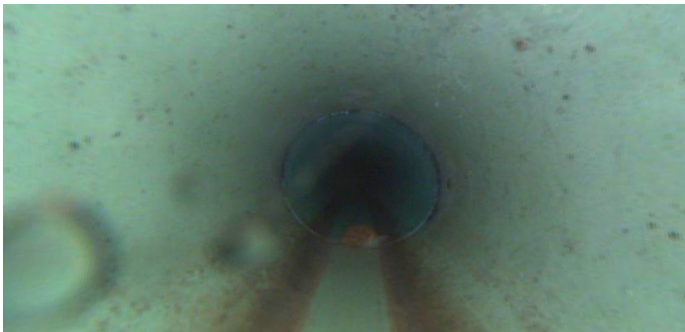
Code:	DSZ
Description:	Deposits Settled Other

Distance (ft):	24.3
Structural Grade:	0
O&M Grade:	2
Clock Start/From:	6
Clock To:	
1st Value:	
2nd Value:	
Value Percent:	5.000
Continuous Index:	
Within 8" of Joint:	YES
Remarks:	mixed material

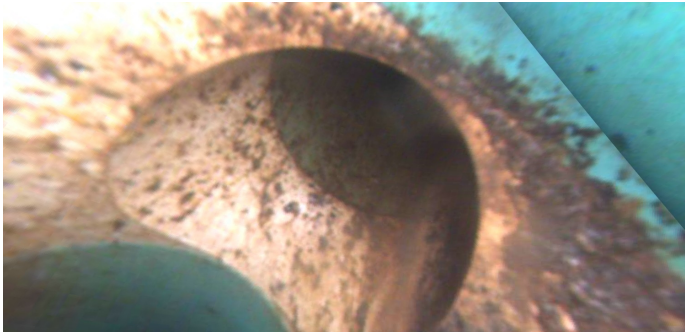
Code: **TF**
Description: **Tap Factory**

Distance (ft): **79.9**
Structural Grade: **0**
O&M Grade: **0**
Clock Start/From: **10**
Clock To:
1st Value: **4.000**
2nd Value:
Value Percent:
Continuous Index:
Within 8" of Joint:
Remarks:

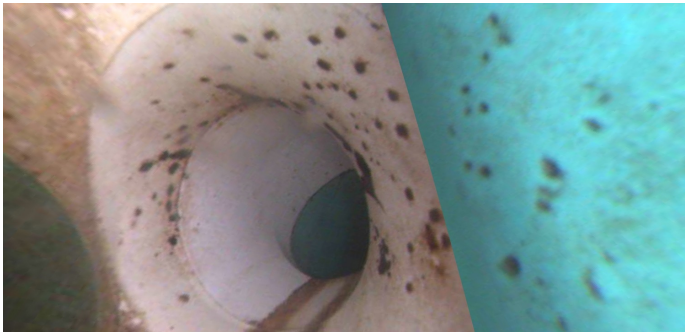
Code: **TF**
Description: **Tap Factory**

Distance (ft): **156.9**
Structural Grade: **0**
O&M Grade: **0**
Clock Start/From: **2**
Clock To:
1st Value: **4.000**
2nd Value:
Value Percent:
Continuous Index:
Within 8" of Joint:
Remarks:

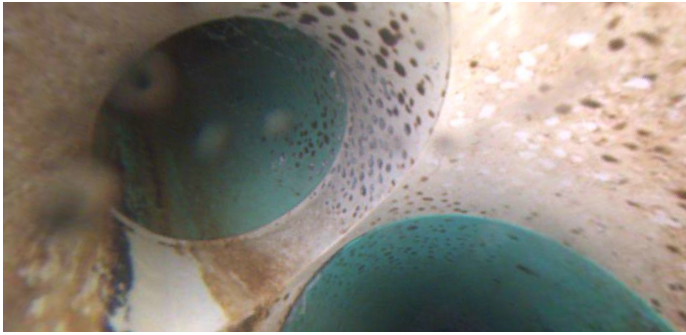
Code: **TF**
Description: **Tap Factory**

Distance (ft): **158.8**
Structural Grade: **0**
O&M Grade: **0**
Clock Start/From: **11**
Clock To:
1st Value: **4.000**
2nd Value:
Value Percent:
Continuous Index:
Within 8" of Joint:
Remarks:

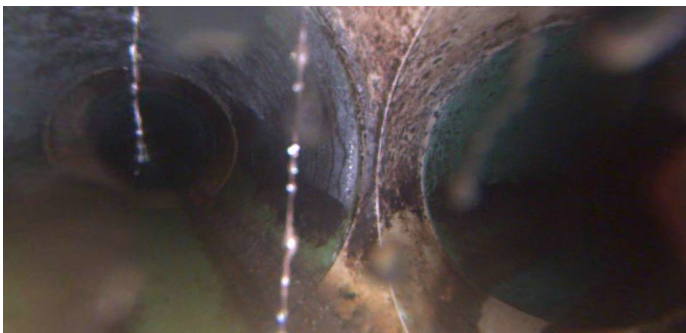
Code: **TFA**
Description: **Tap Factory Active**

Distance (ft): **264.5**
Structural Grade: **0**
O&M Grade: **0**
Clock Start/From: **3**
Clock To:
1st Value: **4.000**
2nd Value:
Value Percent:
Continuous Index:
Within 8" of Joint:
Remarks:

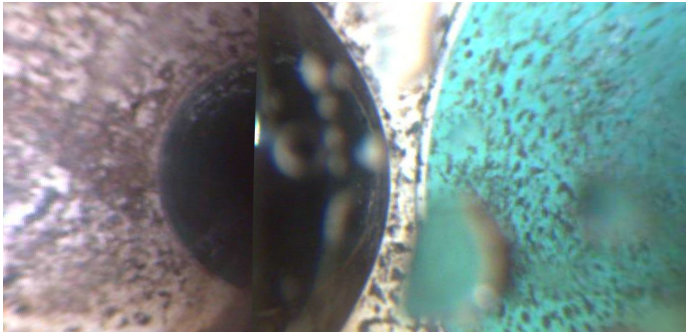
Code: **TFA**
Description: **Tap Factory Active**

Distance (ft): **266.6**
Structural Grade: **0**
O&M Grade: **0**
Clock Start/From: **9**
Clock To:
1st Value: **4.000**
2nd Value:
Value Percent:
Continuous Index:
Within 8" of Joint:
Remarks:
