Profile/Ph	oto Observatio	n Report			RedZon
Date:	03/23/2018	Weather:		Coding:	PACP 6.0
Pipe Length (ft): 6.7	Owner:	NA	Pre Clean:	No Pre-Cleaning
P.O.#:		Surveyor:	Jen Costello	PSR:	P-308-035-031
Customer:		Clean Date:	01/01/1900	Shape:	С
Street:	OFF W 61ST AVE		Flow Control:	Not Controlle	d
City:	Hobart, IN		Year Renewed:		
Location:	Light Highway		Tape/Media #:		
Purpose:	Routine Assessme	ent	Dia/Height:	8"	
Use:	Sanitary		Material:	PVC	
Drain Area:	NA		Lining:		
Category:	NA				
Comment:	F_S_P_C at 0 ft bu	uild up around the pi	ipe		
Location Detail	ls:		Direction of Survey:	Downstream	
US MH:	M-308-031	DS MH: M	-308-035	Total Length Surveyed (ft	:): .8
0&M Index:	3.00	O&M Quick:	3100	O&M Rating:	3.00
tructural Index:	0.00	Structural Quick	<: 0000	Structural Rating	0.00
Verall Index:	3.00	Overall Quick:	3100	Overall Rating:	3.00

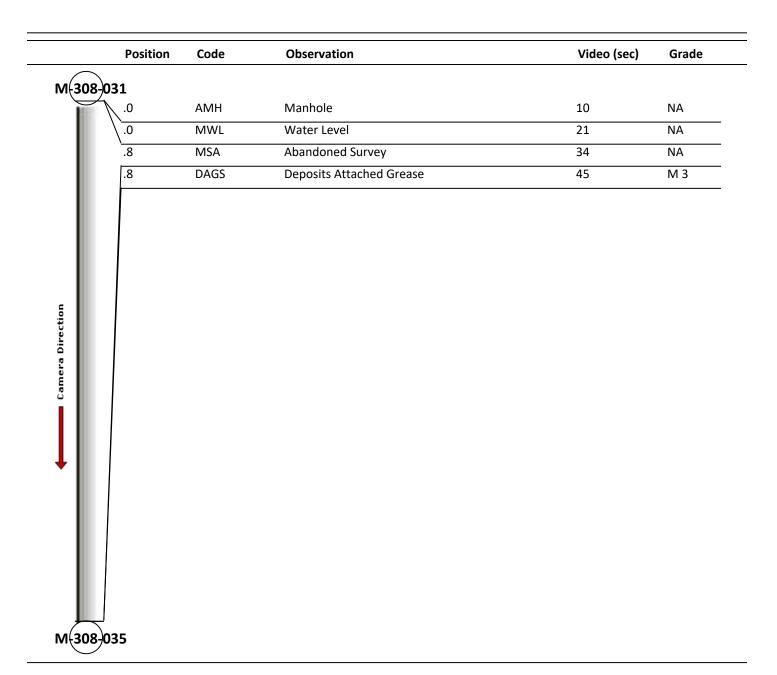
Code:DAGSDescription:Deposits Attached Grease

Distance (ft):	.8
Structural Grade:	0
O&M Grade:	3
Clock Start/From:	7
Clock To:	5
1st Value:	
2nd Value:	
Value Percent:	20.000
Continuous Index:	
Within 8" of Joint:	NO
Remarks:
