## Profile/Photo Observation Report

| Street: | <b>FOXCROFT STREET</b> | Flow Control: | <b>Not Controlled</b> |
| US MH: | <b>M-308-031</b> | DS MH: | <b>M-308-035</b> |

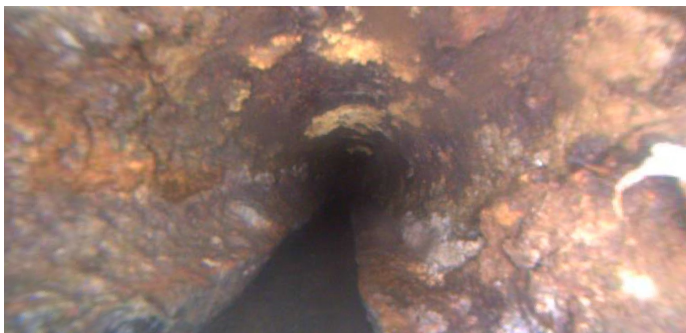
Code: **AMH**  
Description: **Manhole**

Distance (ft): **.0**  
Structural Grade: **0**  
O&M Grade: **0**  
Clock Start/From:  
Clock To:  
1st Value:  
2nd Value:  
Value Percent:  
Continuous Index:  
Within 8" of Joint: **NO**  
Remarks: **M-308-031**

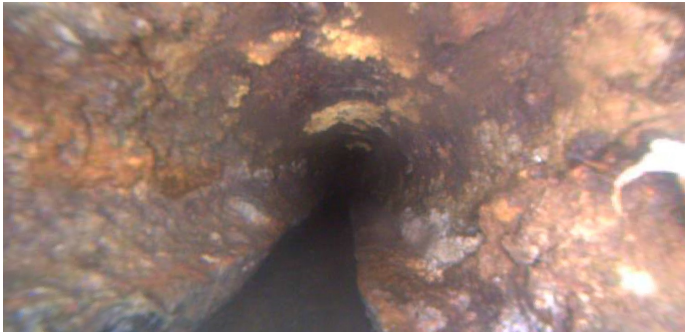
| Code: | <b>MWL</b> |
| Description: | <b>Water Level</b> |

| Value Percent: | <b>5.000</b> |

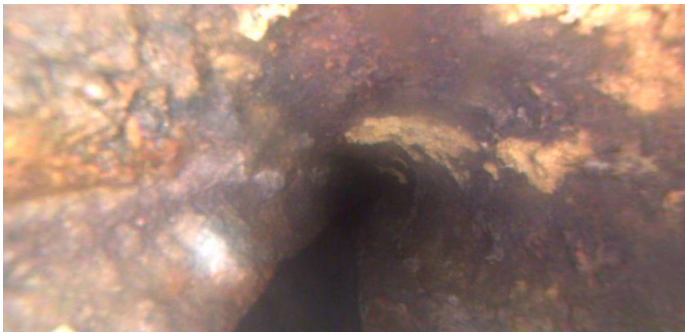
| Code: | <b>MSA</b> |
| Description: | <b>Abandoned Survey</b> |

| Remarks: | <b>OVERTURNED</b> |

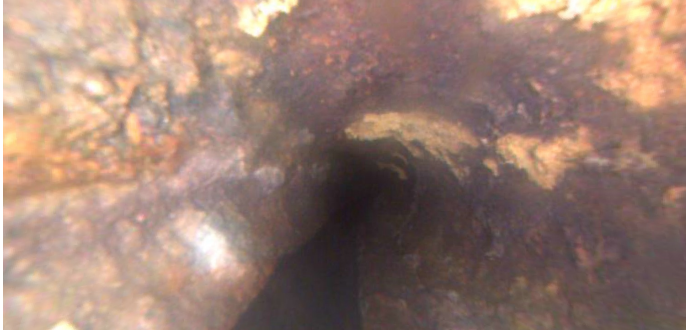
| Code: | <b>DAGS</b> |
| Description: | <b>Deposits Attached Grease</b> |
| O&M Grade: | <b>3</b> |
| Clock Start/From: | <b>7</b> |
| Clock To: | <b>5</b> |
| Value Percent: | <b>20.000</b> |
