Profile/Photo Observation Report

Street:	GILL ST	Flow Control:	Not Controlled
City:	Hobart, IN	Year Renewed:	
Location:	Other	Tape/Media #:	
Purpose:	Not Known	Dia/Height:	10"
Use:	Sanitary	Material:	VCP
Drain Area:	NA	Lining:	
Category:	NA		
Comment:

Location Details:		Direction of Survey:	Downstream
US MH:	M-403-002	DS MH:	M-403-001
		Total Length Surveyed (ft):	23.8

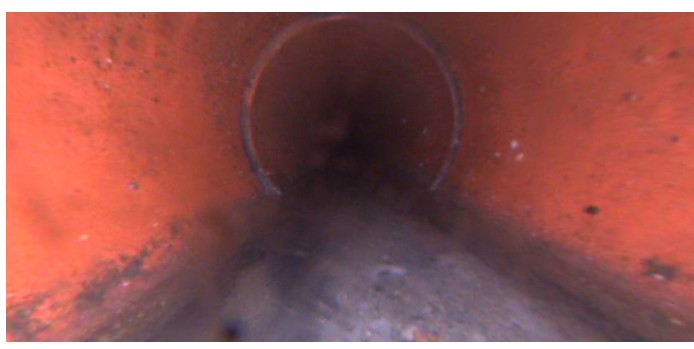
Code: **AMH**
Description: **Manhole**

Distance (ft): **.0**
Structural Grade: **0**
O&M Grade: **0**
Clock Start/From:
Clock To:
1st Value:
2nd Value:
Value Percent:
Continuous Index:
Within 8" of Joint: **NO**
Remarks: **M-403-002**

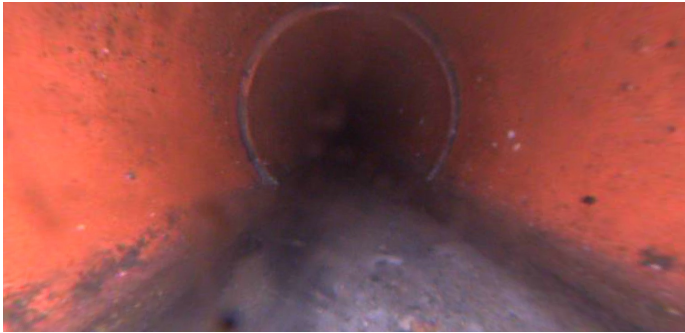
Code:	MWL
Description:	Water Level

Distance (ft):	.0
Structural Grade:	0
O&M Grade:	0
Clock Start/From:	
Clock To:	
1st Value:	
2nd Value:	
Value Percent:	10.000
Continuous Index:	
Within 8" of Joint:	NO
Remarks:

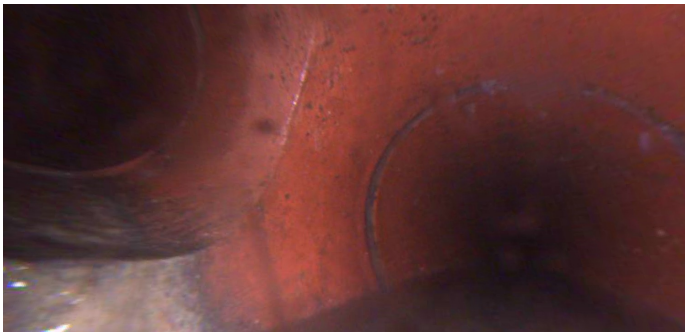
Code:	TF
Description:	Tap Factory

Distance (ft):	23.5
Structural Grade:	0
O&M Grade:	0
Clock Start/From:	9
Clock To:	
1st Value:	4.000
2nd Value:	
Value Percent:	
Continuous Index:	
Within 8" of Joint:	
Remarks:

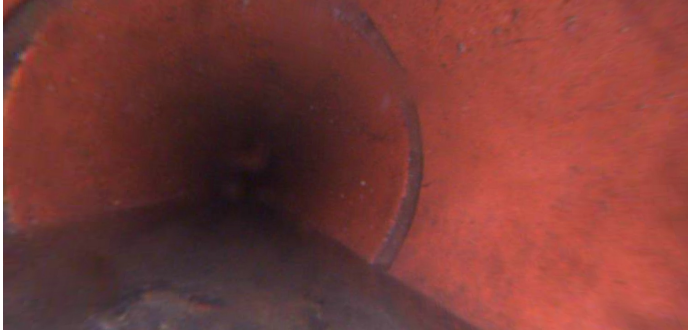
Code:	MSA
Description:	Abandoned Survey
Distance (ft):	23.8
Structural Grade:	0
O&M Grade:	0
Clock Start/From:	
Clock To:	
1st Value:	
2nd Value:	
Value Percent:	
Continuous Index:	
Within 8" of Joint:	NO
Remarks:	DEBRIS UNDER WATER
