## Profile/Photo Observation Report

Date:	<b>03/29/2018</b>	Weather:		Coding:	<b>PACP 6.0</b>
Pipe Length (ft):	<b>244.3</b>	Owner:	<b>NA</b>	Pre Clean:	<b>Not Known</b>
P.O.#:		Surveyor:	<b>Jen Costello</b>	PSR:	<b>P-403-002-003</b>
Customer:		Clean Date:	<b>01/01/1900</b>	Shape:	<b>C</b>

Street:	<b>GILL ST</b>	Flow Control:	<b>Not Controlled</b>
City:	<b>Hobart, IN</b>	Year Renewed:	
Location:	<b>Other</b>	Tape/Media #:	
Purpose:	<b>Not Known</b>	Dia/Height:	<b>10"</b>
Use:	<b>Sanitary</b>	Material:	<b>VCP</b>
Drain Area:	<b>NA</b>	Lining:	
Category:	<b>NA</b>		
Comment:

Location Details:		Direction of Survey:	<b>Upstream</b>
US MH:	<b>M-403-003</b>	DS MH:	<b>M-403-002</b>
		Total Length Surveyed (ft):	<b>238.1</b>

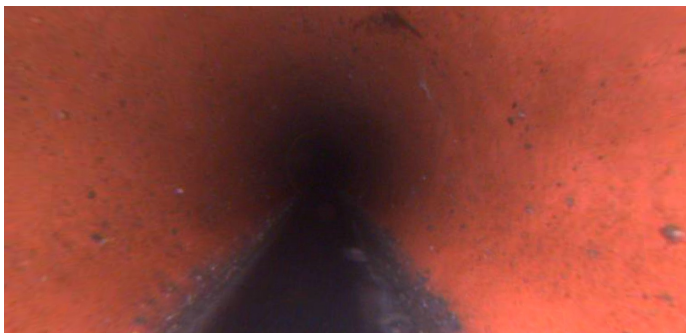
Code: **AMH**  
Description: **Manhole**

Distance (ft): **.0**  
Structural Grade: **0**  
O&M Grade: **0**  
Clock Start/From:  
Clock To:  
1st Value:  
2nd Value:  
Value Percent:  
Continuous Index:  
Within 8" of Joint: **NO**  
Remarks: **M-403-002**

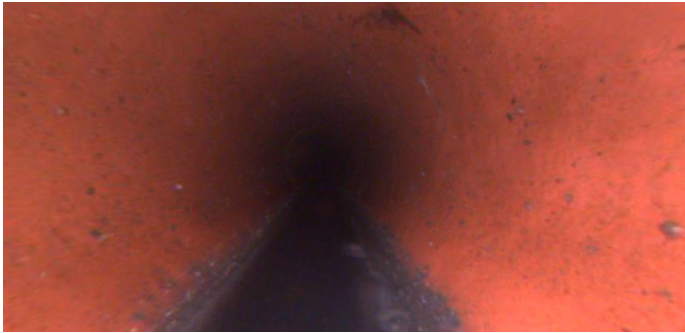
Code:	<b>MWL</b>
Description:	<b>Water Level</b>

Distance (ft):	<b>.0</b>
Structural Grade:	<b>0</b>
O&M Grade:	<b>0</b>
Clock Start/From:	
Clock To:	
1st Value:	
2nd Value:	
Value Percent:	<b>5.000</b>
Continuous Index:	
Within 8" of Joint:	<b>NO</b>
Remarks:

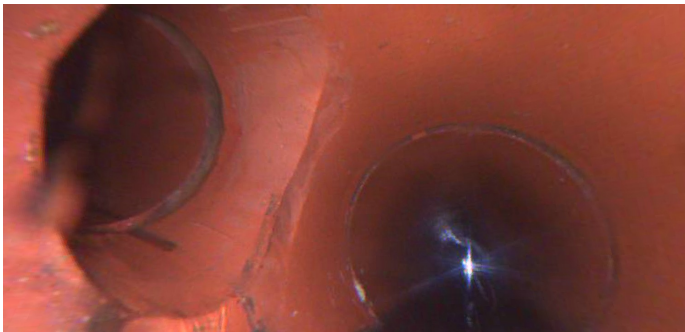
Code:	<b>TF</b>
Description:	<b>Tap Factory</b>

Distance (ft):	<b>40.7</b>
Structural Grade:	<b>0</b>
O&M Grade:	<b>0</b>
Clock Start/From:	<b>2</b>
Clock To:	
1st Value:	<b>4.000</b>
2nd Value:	
Value Percent:	
Continuous Index:	
Within 8" of Joint:	
Remarks:

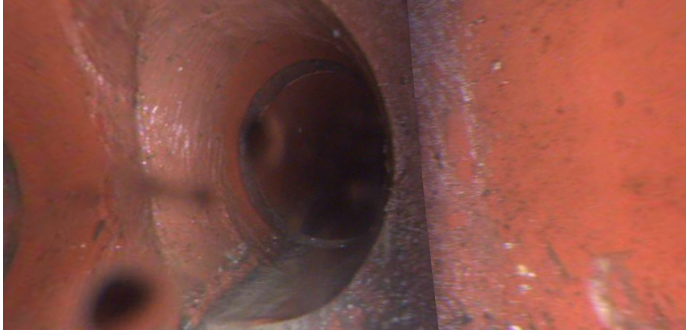
Code: **TF**  
Description: **Tap Factory**

Distance (ft): **72.9**  
Structural Grade: **0**  
O&M Grade: **0**  
Clock Start/From: **9**  
Clock To:  
1st Value: **4.000**  
2nd Value:  
Value Percent:  
Continuous Index:  
Within 8" of Joint:  
Remarks:

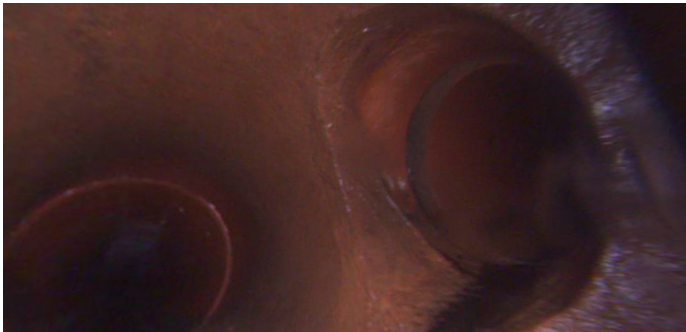
Code: **TFA**  
Description: **Tap Factory Active**

Distance (ft): **104.7**  
Structural Grade: **0**  
O&M Grade: **0**  
Clock Start/From: **2**  
Clock To:  
1st Value: **4.000**  
2nd Value:  
Value Percent:  
Continuous Index:  
Within 8" of Joint:  
Remarks:

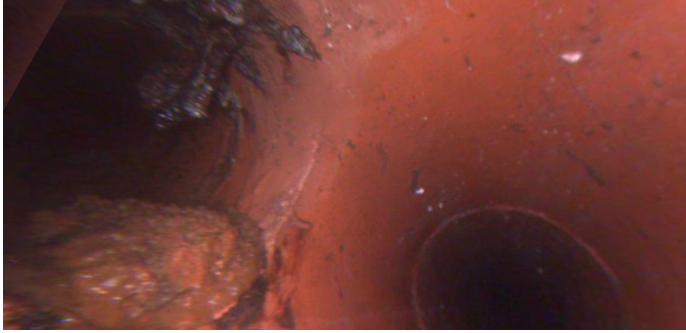
Code: **TF**  
Description: **Tap Factory**

Distance (ft): **132.2**  
Structural Grade: **0**  
O&M Grade: **0**  
Clock Start/From: **10**  
Clock To:  
1st Value: **4.000**  
2nd Value:  
Value Percent:  
Continuous Index:  
Within 8" of Joint:  
Remarks:

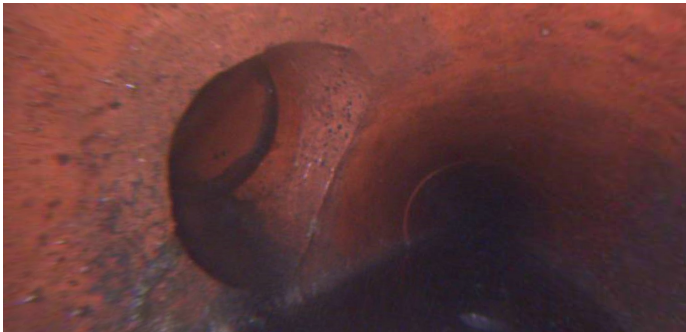
Code: **TF**  
Description: **Tap Factory**

Distance (ft): **225.7**  
Structural Grade: **0**  
O&M Grade: **0**  
Clock Start/From: **9**  
Clock To:  
1st Value: **4.000**  
2nd Value:  
Value Percent:  
Continuous Index:  
Within 8" of Joint:  
Remarks:

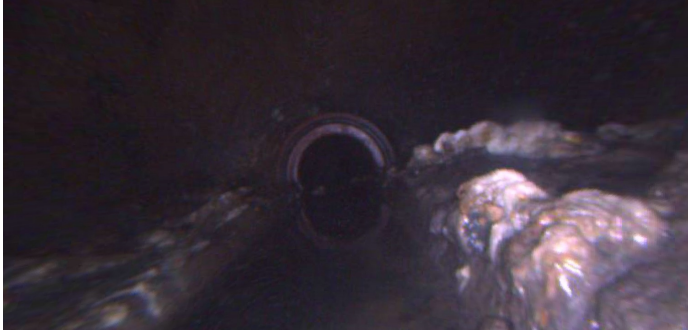
Code: **AMH**  
Description: **Manhole**

Distance (ft): **238.1**  
Structural Grade: **0**  
O&M Grade: **0**  
Clock Start/From:  
Clock To:  
1st Value:  
2nd Value:  
Value Percent:  
Continuous Index:  
Within 8" of Joint: **NO**  
Remarks: **M-403-003**
