## Profile/Photo Observation Report

Street:	<b>Roche St.</b>	Flow Control:	<b>Not Controlled</b>
City:	<b>Hobart, IN</b>	Year Renewed:	
Location:	<b>Light Highway</b>	Tape/Media #:	
Purpose:	<b>Routine Assessment</b>	Dia/Height:	<b>10"</b>
Use:	<b>Sanitary</b>	Material:	<b>VCP</b>
Drain Area:	<b>NA</b>	Lining:	
Category:	<b>NA</b>		
Comment:

Location Details:		Direction of Survey:	<b>Upstream</b>
US MH:	<b>M-403-004</b>	DS MH:	<b>M-403-003</b>
		Total Length Surveyed (ft):	<b>253.7</b>

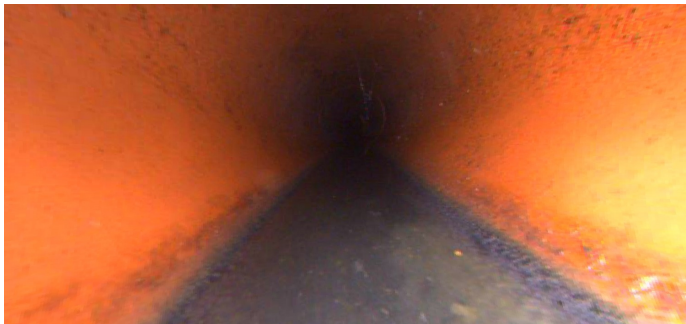
Code:	AMH
Description:	Manhole

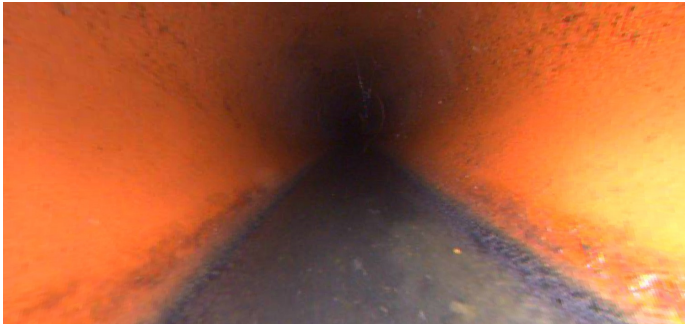
Code:	<b>MWL</b>
Description:	<b>Water Level</b>

Distance (ft):	<b>.0</b>
Structural Grade:	<b>0</b>
O&M Grade:	<b>0</b>
Clock Start/From:	
Clock To:	
1st Value:	
2nd Value:	
Value Percent:	<b>10.000</b>
Continuous Index:	
Within 8" of Joint:	<b>NO</b>
Remarks:

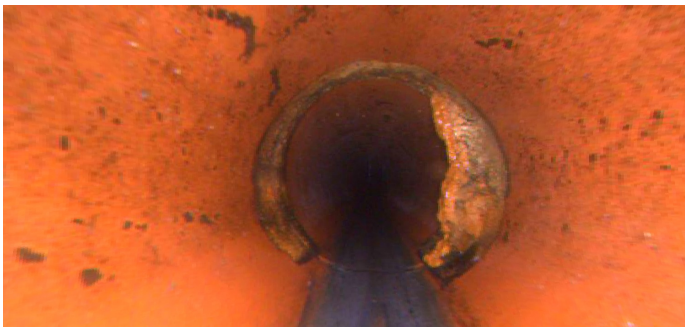
Code:	<b>DAE</b>
Description:	<b>Deposits Attached Encrustation</b>

Distance (ft):	<b>8.9</b>
Structural Grade:	<b>0</b>
O&M Grade:	<b>2</b>
Clock Start/From:	<b>7</b>
Clock To:	<b>5</b>
1st Value:	
2nd Value:	
Value Percent:	<b>10.000</b>
Continuous Index:	
Within 8" of Joint:	<b>YES</b>
Remarks:

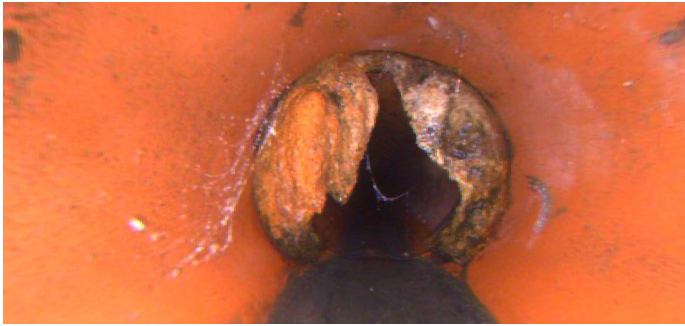
Code: **DAE**  
Description: **Deposits Attached Encrustation**

Distance (ft): **28.5**  
Structural Grade: **0**  
O&M Grade: **5**  
Clock Start/From: **7**  
Clock To: **5**  
1st Value:  
2nd Value:  
Value Percent: **40.000**  
Continuous Index:  
Within 8" of Joint: **YES**  
Remarks:

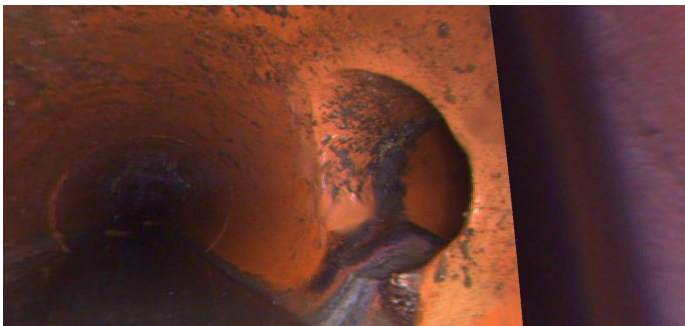
Code: **TF**  
Description: **Tap Factory**

Distance (ft): **39.9**  
Structural Grade: **0**  
O&M Grade: **0**  
Clock Start/From: **3**  
Clock To:  
1st Value: **4.000**  
2nd Value:  
Value Percent:  
Continuous Index:  
Within 8" of Joint:  
Remarks:

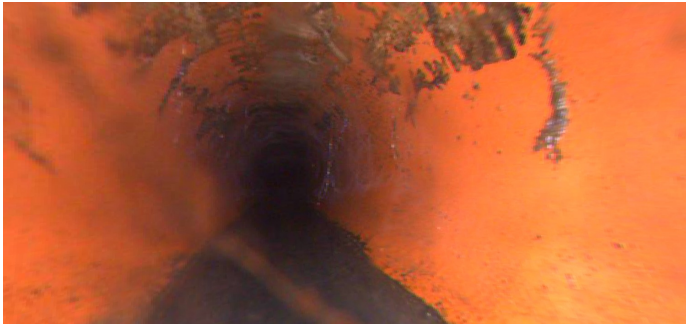
Code: **DAZ**  
Description: **Deposits Attached Other**

Distance (ft): **72.9**  
Structural Grade: **0**  
O&M Grade: **2**  
Clock Start/From: **11**  
Clock To: **2**  
1st Value:  
2nd Value:  
Value Percent: **5.000**  
Continuous Index: **S01**  
Within 8" of Joint: **YES**  
Remarks: **WANDER**

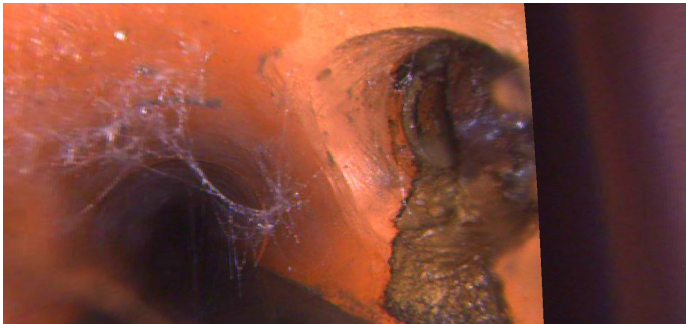
Code: **TFD**  
Description: **Tap Factory Defective**

Distance (ft): **112.8**  
Structural Grade: **0**  
O&M Grade: **2**  
Clock Start/From: **2**  
Clock To:  
1st Value: **4.000**  
2nd Value:  
Value Percent:  
Continuous Index:  
Within 8" of Joint:  
Remarks: **ENCrustATIONS IN TAP**

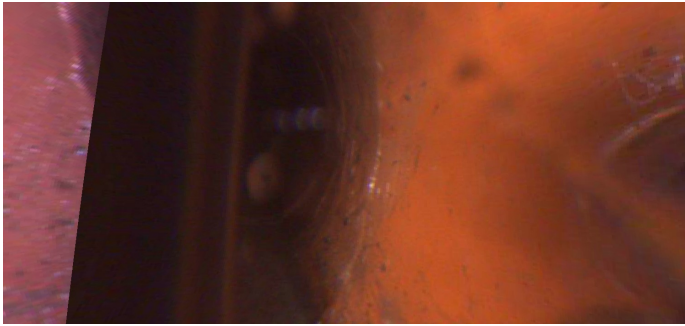
Code: **TF**  
Description: **Tap Factory**

Distance (ft): **120.0**  
Structural Grade: **0**  
O&M Grade: **0**  
Clock Start/From: **10**  
Clock To:  
1st Value: **4.000**  
2nd Value:  
Value Percent:  
Continuous Index:  
Within 8" of Joint:  
Remarks:

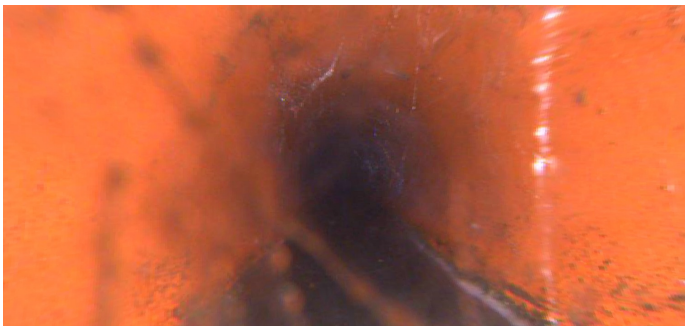
Code: **MGO**  
Description: **General Observation**

Distance (ft): **184.8**  
Structural Grade: **0**  
O&M Grade: **0**  
Clock Start/From:  
Clock To:  
1st Value:  
2nd Value:  
Value Percent:  
Continuous Index:  
Within 8" of Joint: **NO**  
Remarks: **SPIDER WEBS AND WATER DROPLETS ON LENS**

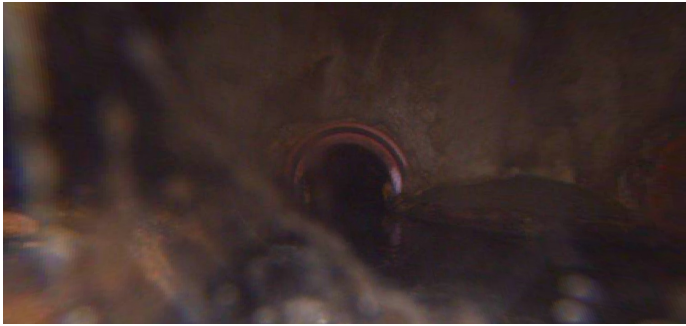
Code: **AMH**  
Description: **Manhole**

Distance (ft): **253.7**  
Structural Grade: **0**  
O&M Grade: **0**  
Clock Start/From:  
Clock To:  
1st Value:  
2nd Value:  
Value Percent:  
Continuous Index:  
Within 8" of Joint: **NO**  
Remarks: **M-403-004**

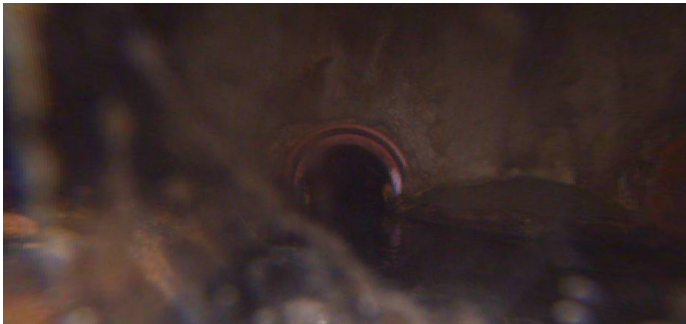
Code: **DAZ**  
Description: **Deposits Attached Other**

Distance (ft): **253.7**  
Structural Grade: **0**  
O&M Grade: **2**  
Clock Start/From: **11**  
Clock To: **2**  
1st Value:  
2nd Value:  
Value Percent: **5.000**  
Continuous Index: **F01**  
Within 8" of Joint: **YES**  
Remarks: **WANDER**
