Profile/Photo Observation Report

Street:	GILL ST	Flow Control:	Not Controlled
City:	Hobart, IN	Year Renewed:	
Location:	Light Highway	Tape/Media #:	
Purpose:	Routine Assessment	Dia/Height:	12"
Use:	Sanitary	Material:	VCP
Drain Area:	NA	Lining:	
Category:	NA		
Comment:

Location Details:		Direction of Survey:	Downstream
US MH:	M-403-004	DS MH:	M-403-005
		Total Length Surveyed (ft):	46.2

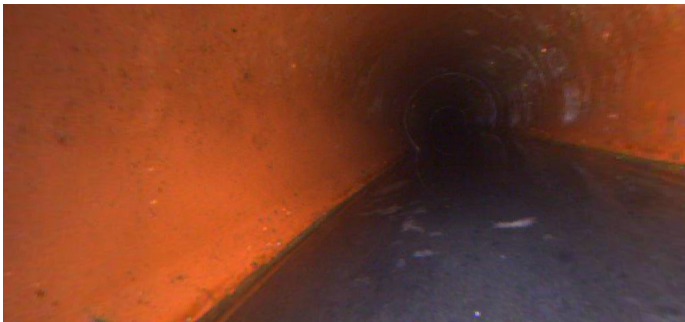
Code: **AMH**
Description: **Manhole**

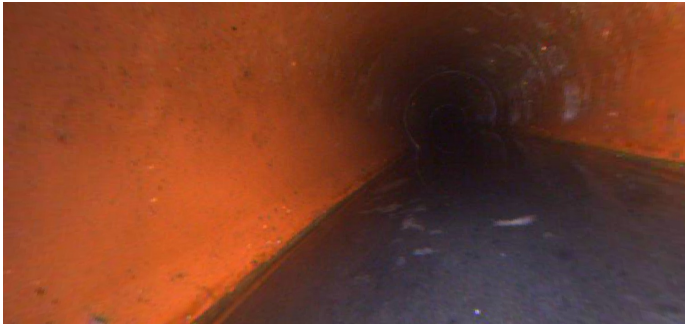
Code:	MWL
Description:	Water Level

Distance (ft):	.0
Structural Grade:	0
O&M Grade:	0
Clock Start/From:	
Clock To:	
1st Value:	
2nd Value:	
Value Percent:	5.000
Continuous Index:	
Within 8" of Joint:	NO
Remarks:

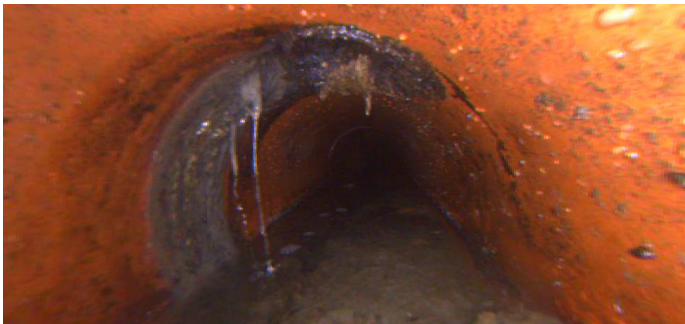
Code:	DAE
Description:	Deposits Attached Encrustation

Distance (ft):	16.4
Structural Grade:	0
O&M Grade:	3
Clock Start/From:	8
Clock To:	1
1st Value:	
2nd Value:	
Value Percent:	15.000
Continuous Index:	
Within 8" of Joint:	NO
Remarks:

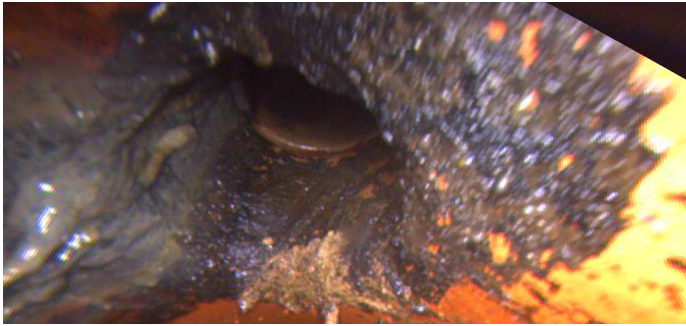
Code: **TF**
Description: **Tap Factory**

Distance (ft): **16.9**
Structural Grade: **0**
O&M Grade: **0**
Clock Start/From: **12**
Clock To:
1st Value: **4.000**
2nd Value:
Value Percent:
Continuous Index:
Within 8" of Joint:
Remarks:

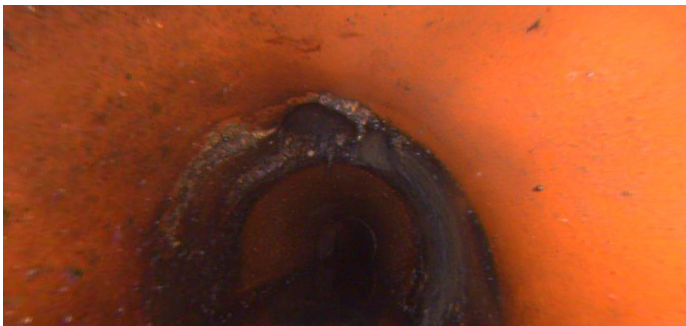
Code: **DAE**
Description: **Deposits Attached Encrustation**

Distance (ft): **30.0**
Structural Grade: **0**
O&M Grade: **3**
Clock Start/From: **8**
Clock To: **4**
1st Value:
2nd Value:
Value Percent: **20.000**
Continuous Index:
Within 8" of Joint: **NO**
Remarks:

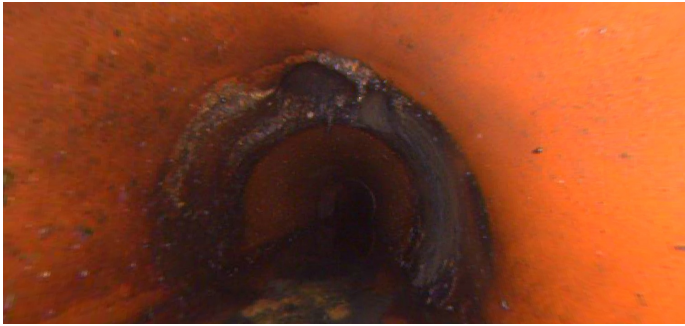
Code: **TF**
Description: **Tap Factory**

Distance (ft): **30.0**
Structural Grade: **0**
O&M Grade: **0**
Clock Start/From: **12**
Clock To:
1st Value: **4.000**
2nd Value:
Value Percent:
Continuous Index:
Within 8" of Joint:
Remarks:

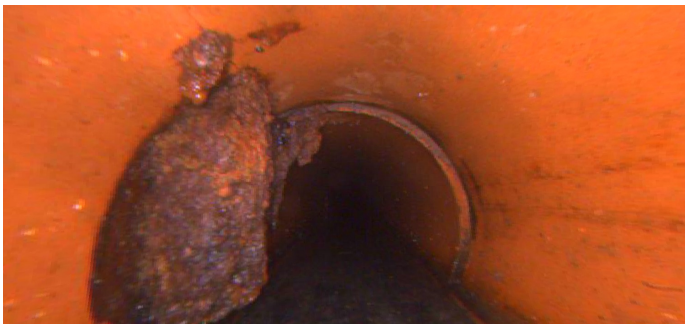
Code: **DAE**
Description: **Deposits Attached Encrustation**

Distance (ft): **34.0**
Structural Grade: **0**
O&M Grade: **4**
Clock Start/From: **8**
Clock To: **4**
1st Value:
2nd Value:
Value Percent: **30.000**
Continuous Index:
Within 8" of Joint: **YES**
Remarks:

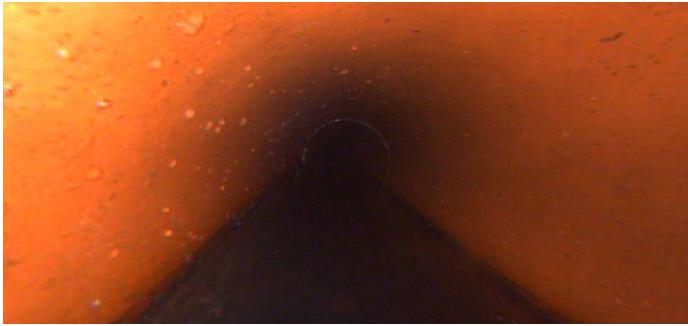
Code:	MSA
Description:	Abandoned Survey
Distance (ft):	46.2
Structural Grade:	0
O&M Grade:	0
Clock Start/From:	
Clock To:	
1st Value:	
2nd Value:	
Value Percent:	
Continuous Index:	
Within 8" of Joint:	NO
Remarks:	camera stopped
