Profile/Photo Observation Report

Street:	Dill St.	Flow Control:	Not Controlled
City:	Hobart, IN	Year Renewed:	
Location:	Light Highway	Tape/Media #:	
Purpose:	Routine Assessment	Dia/Height:	12"
Use:	Sanitary	Material:	VCP
Drain Area:	NA	Lining:	
Category:	NA		
Comment:

Location Details:		Direction of Survey:	Downstream
US MH:	M-403-004	DS MH:	M-403-005
		Total Length Surveyed (ft):	46.2

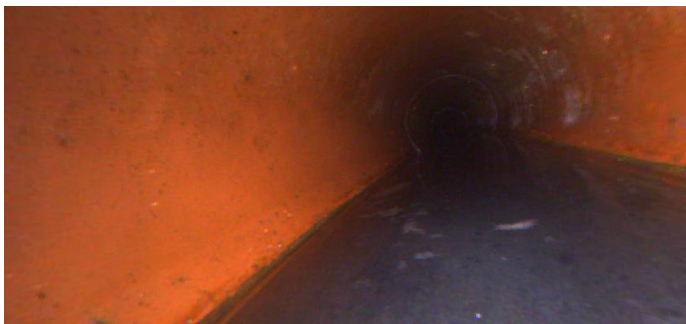
Code: **AMH**
Description: **Manhole**

Distance (ft): **.0**
Structural Grade: **0**
O&M Grade: **0**
Clock Start/From:
Clock To:
1st Value:
2nd Value:
Value Percent:
Continuous Index:
Within 8" of Joint: **NO**
Remarks: **M-403-004**

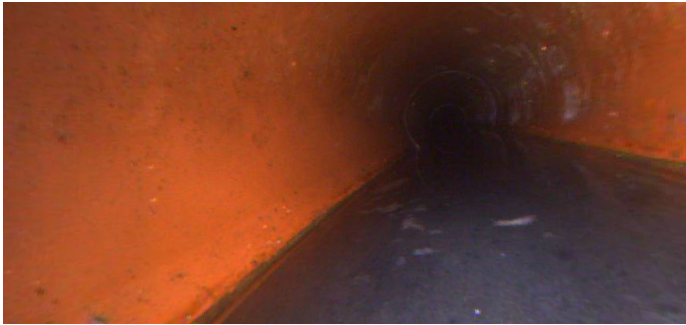
Code:	MWL
Description:	Water Level

Distance (ft):	.0
Structural Grade:	0
O&M Grade:	0
Clock Start/From:	
Clock To:	
1st Value:	
2nd Value:	
Value Percent:	5.000
Continuous Index:	
Within 8" of Joint:	NO
Remarks:

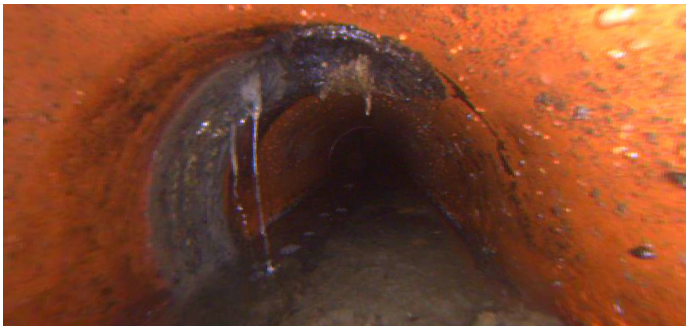
Code:	DAE
Description:	Deposits Attached Encrustation

Distance (ft):	16.4
Structural Grade:	0
O&M Grade:	3
Clock Start/From:	8
Clock To:	1
1st Value:	
2nd Value:	
Value Percent:	15.000
Continuous Index:	
Within 8" of Joint:	NO
Remarks:

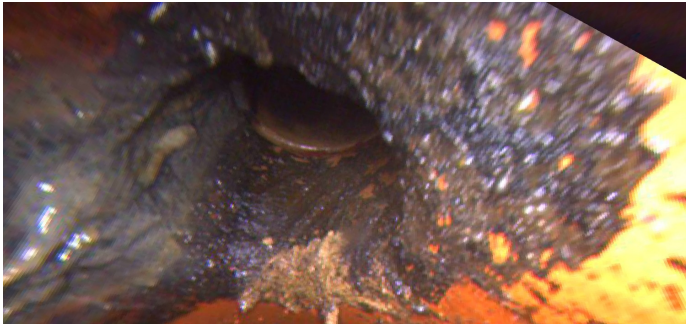
Code: **TF**
Description: **Tap Factory**

Distance (ft): **16.9**
Structural Grade: **0**
O&M Grade: **0**
Clock Start/From: **12**
Clock To:
1st Value: **4.000**
2nd Value:
Value Percent:
Continuous Index:
Within 8" of Joint:
Remarks:

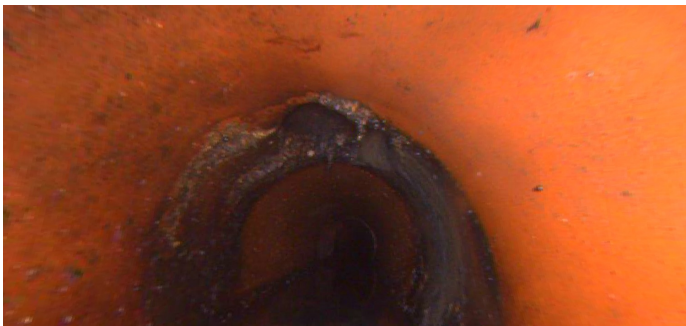
Code: **DAE**
Description: **Deposits Attached Encrustation**

Distance (ft): **30.0**
Structural Grade: **0**
O&M Grade: **3**
Clock Start/From: **8**
Clock To: **4**
1st Value:
2nd Value:
Value Percent: **20.000**
Continuous Index:
Within 8" of Joint: **NO**
Remarks:

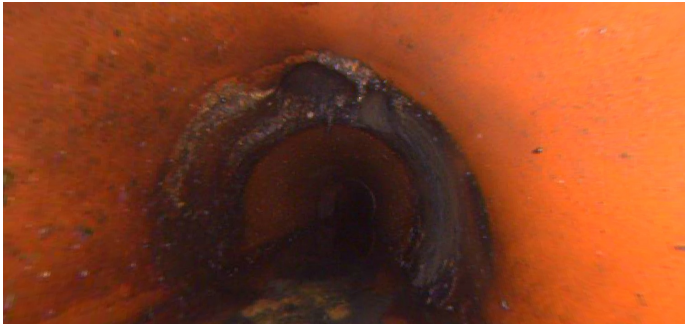
Code: **TF**
Description: **Tap Factory**

Distance (ft): **30.0**
Structural Grade: **0**
O&M Grade: **0**
Clock Start/From: **12**
Clock To:
1st Value: **4.000**
2nd Value:
Value Percent:
Continuous Index:
Within 8" of Joint:
Remarks:

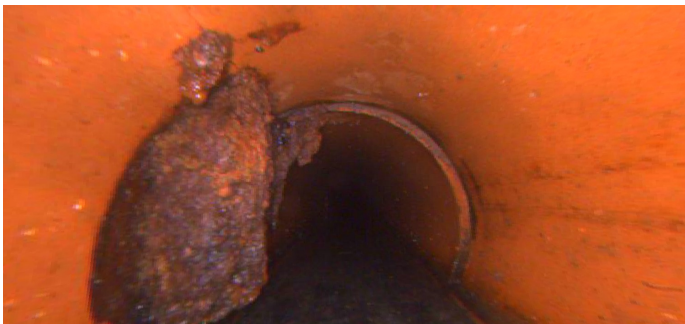
Code: **DAE**
Description: **Deposits Attached Encrustation**

Distance (ft): **34.0**
Structural Grade: **0**
O&M Grade: **4**
Clock Start/From: **8**
Clock To: **4**
1st Value:
2nd Value:
Value Percent: **30.000**
Continuous Index:
Within 8" of Joint: **YES**
Remarks:

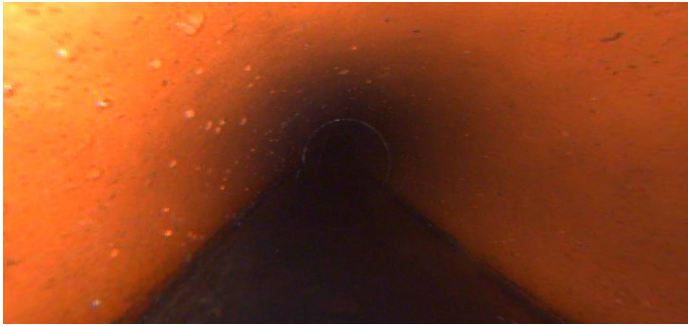
Code:	MSA
Description:	Abandoned Survey
Distance (ft):	46.2
Structural Grade:	0
O&M Grade:	0
Clock Start/From:	
Clock To:	
1st Value:	
2nd Value:	
Value Percent:	
Continuous Index:	
Within 8" of Joint:	NO
Remarks:	camera stopped
