Profile/Photo Observation Report

Street:	GILL ST	Flow Control:	Not Controlled
City:	Hobart, IN	Year Renewed:	
Location:	Light Highway	Tape/Media #:	
Purpose:	Routine Assessment	Dia/Height:	12"
Use:	Sanitary	Material:	VCP
Drain Area:	NA	Lining:	
Category:	NA		
Comment:

Location Details:		Direction of Survey:	Upstream
US MH:	M-403-004	DS MH:	M-403-005
		Total Length Surveyed (ft):	120.8

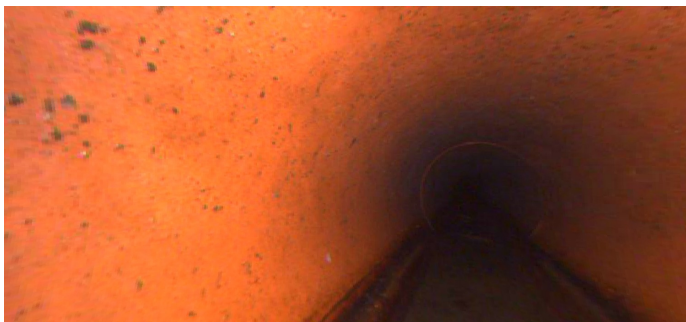
Code: **AMH**
Description: **Manhole**

Distance (ft): **.0**
Structural Grade: **0**
O&M Grade: **0**
Clock Start/From:
Clock To:
1st Value:
2nd Value:
Value Percent:
Continuous Index:
Within 8" of Joint: **NO**
Remarks: **M-403-005**

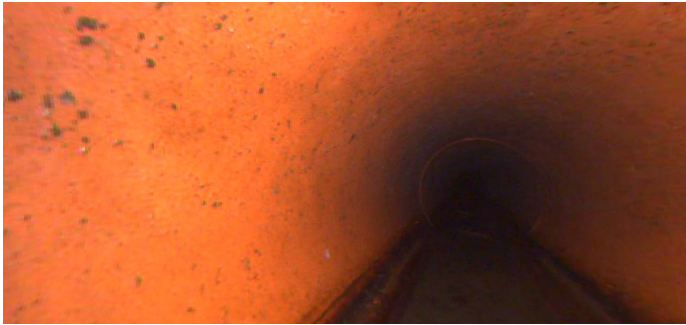
Code:	MWL
Description:	Water Level

Distance (ft):	.0
Structural Grade:	0
O&M Grade:	0
Clock Start/From:	
Clock To:	
1st Value:	
2nd Value:	
Value Percent:	5.000
Continuous Index:	
Within 8" of Joint:	NO
Remarks:

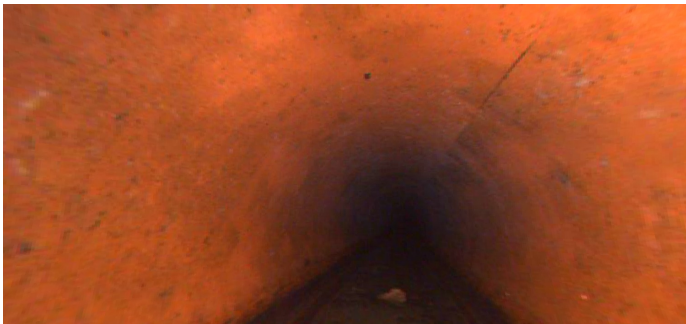
Code:	FL
Description:	Fracture Longitudinal

Distance (ft):	9.5
Structural Grade:	3
O&M Grade:	0
Clock Start/From:	1
Clock To:	
1st Value:	
2nd Value:	
Value Percent:	
Continuous Index:	
Within 8" of Joint:	
Remarks:

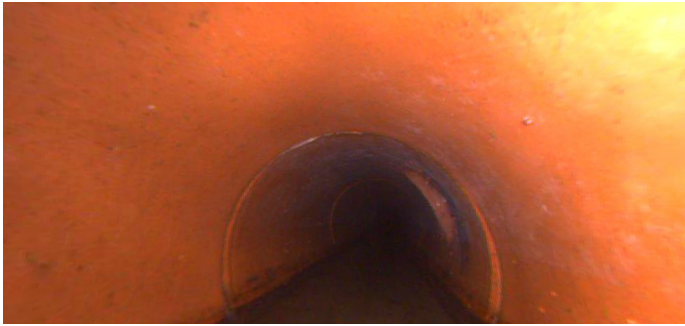
Code: **TF**
Description: **Tap Factory**

Distance (ft): **73.3**
Structural Grade: **0**
O&M Grade: **0**
Clock Start/From: **2**
Clock To:
1st Value: **4.000**
2nd Value:
Value Percent:
Continuous Index:
Within 8" of Joint:
Remarks:

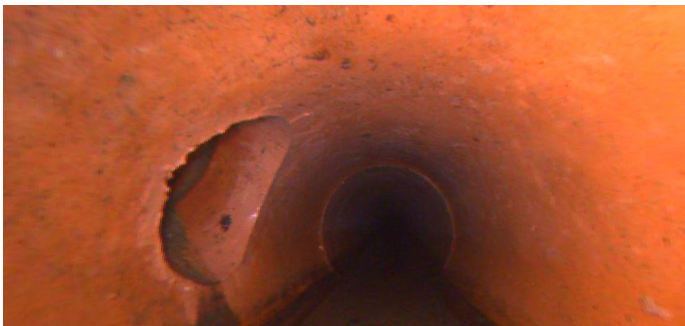
Code: **TF**
Description: **Tap Factory**

Distance (ft): **81.3**
Structural Grade: **0**
O&M Grade: **0**
Clock Start/From: **9**
Clock To:
1st Value: **4.000**
2nd Value:
Value Percent:
Continuous Index:
Within 8" of Joint:
Remarks:

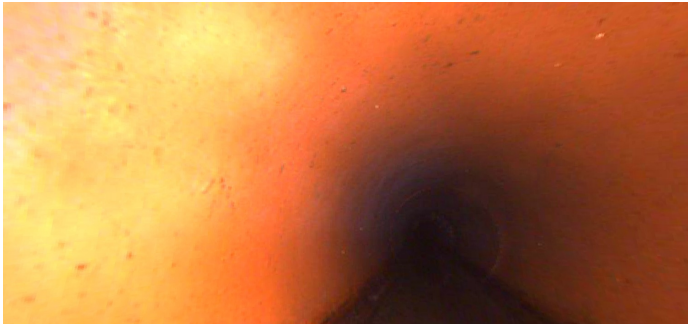
Code:	MSA
Description:	Abandoned Survey
Distance (ft):	120.8
Structural Grade:	0
O&M Grade:	0
Clock Start/From:	
Clock To:	
1st Value:	
2nd Value:	
Value Percent:	
Continuous Index:	
Within 8" of Joint:	NO
Remarks:	camera stopped
