Profile/Photo Observation Report

Street:	Dill St.	Flow Control:	Not Controlled
City:	Hobart, IN	Year Renewed:	
Location:	Light Highway	Tape/Media #:	
Purpose:	Routine Assessment	Dia/Height:	12"
Use:	Sanitary	Material:	VCP
Drain Area:	NA	Lining:	
Category:	NA		
Comment:

Location Details:		Direction of Survey:	Upstream
US MH:	M-403-004	DS MH:	M-403-005
		Total Length Surveyed (ft):	120.8

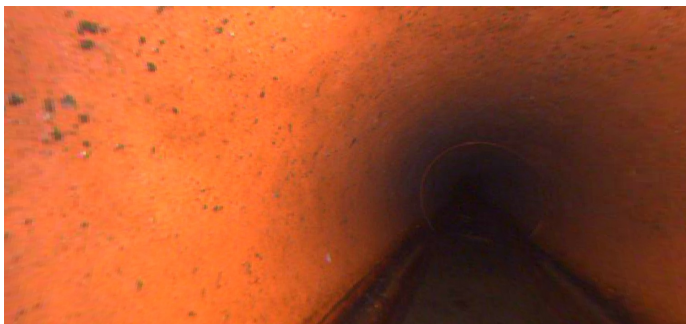
Code: **AMH**
Description: **Manhole**

Distance (ft): **.0**
Structural Grade: **0**
O&M Grade: **0**
Clock Start/From:
Clock To:
1st Value:
2nd Value:
Value Percent:
Continuous Index:
Within 8" of Joint: **NO**
Remarks: **M-403-005**

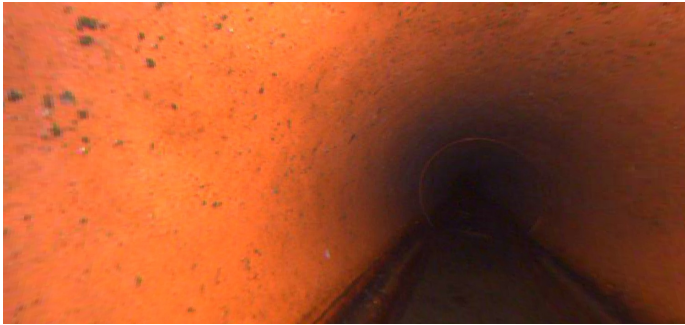
Code:	MWL
Description:	Water Level

Distance (ft):	.0
Structural Grade:	0
O&M Grade:	0
Clock Start/From:	
Clock To:	
1st Value:	
2nd Value:	
Value Percent:	5.000
Continuous Index:	
Within 8" of Joint:	NO
Remarks:

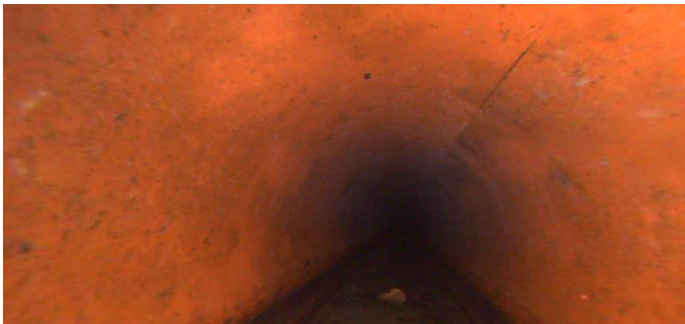
Code:	FL
Description:	Fracture Longitudinal

Distance (ft):	9.5
Structural Grade:	3
O&M Grade:	0
Clock Start/From:	1
Clock To:	
1st Value:	
2nd Value:	
Value Percent:	
Continuous Index:	
Within 8" of Joint:	
Remarks:

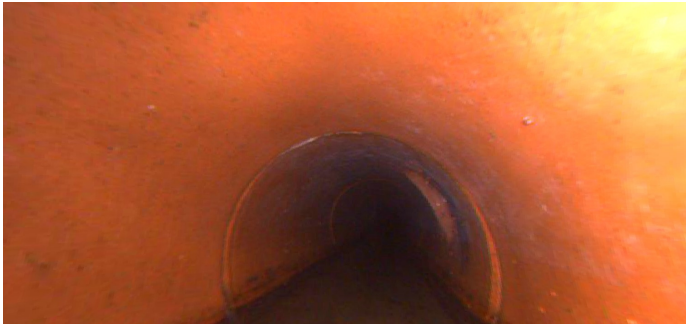
Code: **TF**
Description: **Tap Factory**

Distance (ft): **73.3**
Structural Grade: **0**
O&M Grade: **0**
Clock Start/From: **2**
Clock To:
1st Value: **4.000**
2nd Value:
Value Percent:
Continuous Index:
Within 8" of Joint:
Remarks:

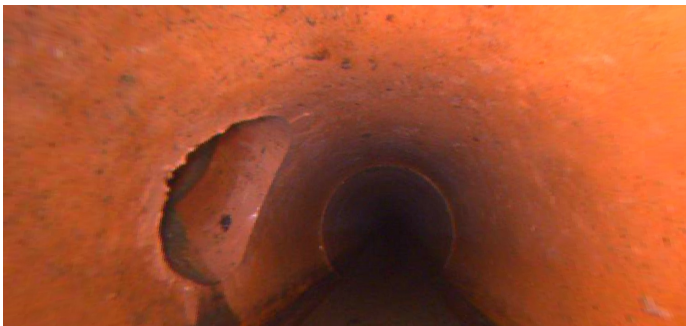
Code: **TF**
Description: **Tap Factory**

Distance (ft): **81.3**
Structural Grade: **0**
O&M Grade: **0**
Clock Start/From: **9**
Clock To:
1st Value: **4.000**
2nd Value:
Value Percent:
Continuous Index:
Within 8" of Joint:
Remarks:

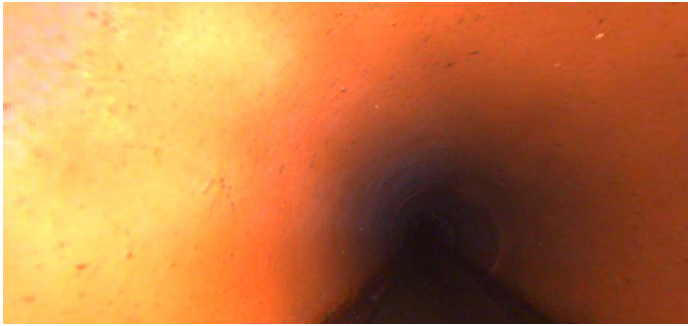
Code:	MSA
Description:	Abandoned Survey
Distance (ft):	120.8
Structural Grade:	0
O&M Grade:	0
Clock Start/From:	
Clock To:	
1st Value:	
2nd Value:	
Value Percent:	
Continuous Index:	
Within 8" of Joint:	NO
Remarks:	camera stopped
