## Profile/Photo Observation Report

Street:	<b>KREFFT ST</b>	Flow Control:	<b>Not Controlled</b>
City:	<b>Hobart, IN</b>	Year Renewed:	
Location:	<b>Light Highway</b>	Tape/Media #:	
Purpose:	<b>Routine Assessment</b>	Dia/Height:	<b>12"</b>
Use:	<b>Sanitary</b>	Material:	<b>VCP</b>
Drain Area:	<b>NA</b>	Lining:	
Category:	<b>NA</b>		
Comment:

Location Details:		Direction of Survey:	<b>Downstream</b>
US MH:	<b>M-403-005</b>	DS MH:	<b>M-403-006</b>
		Total Length Surveyed (ft):	<b>72.2</b>

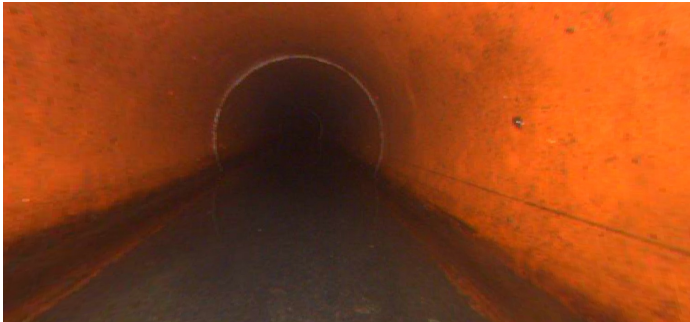
Code: AMH

Description: Manhole

Distance (ft): .0

Remarks: M-403-005

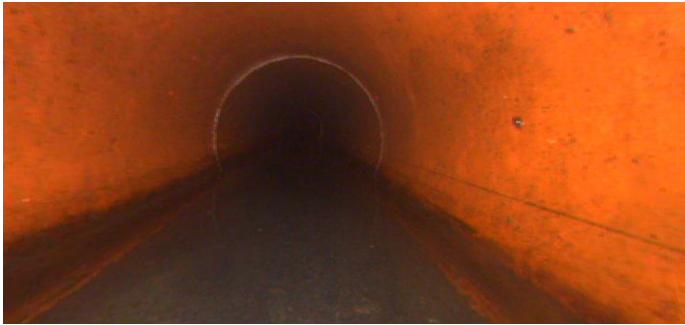
Code:	<b>MWL</b>
Description:	<b>Water Level</b>

Distance (ft):	<b>.0</b>
Structural Grade:	<b>0</b>
O&M Grade:	<b>0</b>
Clock Start/From:	
Clock To:	
1st Value:	
2nd Value:	
Value Percent:	<b>5.000</b>
Continuous Index:	
Within 8" of Joint:	<b>NO</b>
Remarks:

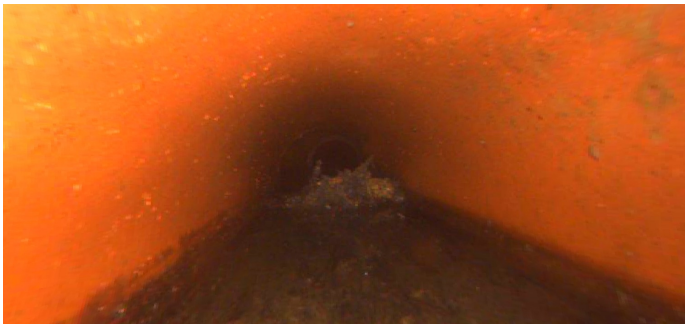
Code:	<b>DSZ</b>
Description:	<b>Deposits Settled Other</b>

Distance (ft):	<b>69.9</b>
Structural Grade:	<b>0</b>
O&M Grade:	<b>3</b>
Clock Start/From:	<b>3</b>
Clock To:	<b>7</b>
1st Value:	
2nd Value:	
Value Percent:	<b>20.000</b>
Continuous Index:	
Within 8" of Joint:	<b>NO</b>
Remarks:	<b>mixed material</b>

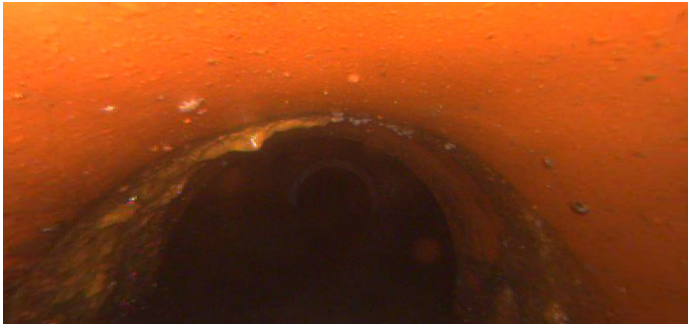
Code:	<b>MSA</b>
Description:	<b>Abandoned Survey</b>
Distance (ft):	<b>72.2</b>
Structural Grade:	<b>0</b>
O&M Grade:	<b>0</b>
Clock Start/From:	
Clock To:	
1st Value:	
2nd Value:	
Value Percent:	
Continuous Index:	
Within 8" of Joint:	<b>NO</b>
Remarks:	<b>mixed material blocking camera passage</b>
