Profile/Photo Observation Report

| Street: | Dill St. | Flow Control: | Not Controlled |
| City: | Hobart, IN | Year Renewed: | |

| US MH: | M-403-005 | DS MH: | M-403-006 |

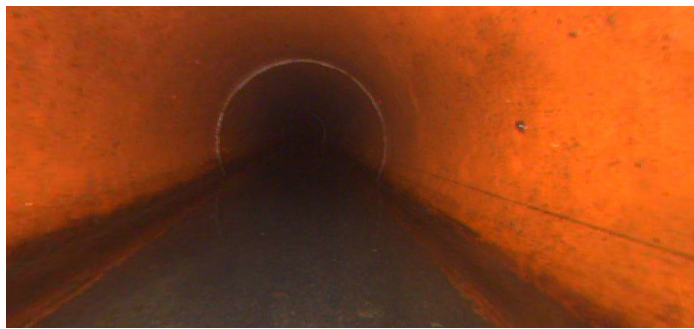
Code: **AMH**
Description: **Manhole**

Distance (ft): **.0**
Structural Grade: **0**
O&M Grade: **0**
Clock Start/From:
Clock To:
1st Value:
2nd Value:
Value Percent:
Continuous Index:
Within 8" of Joint: **NO**
Remarks: **M-403-005**

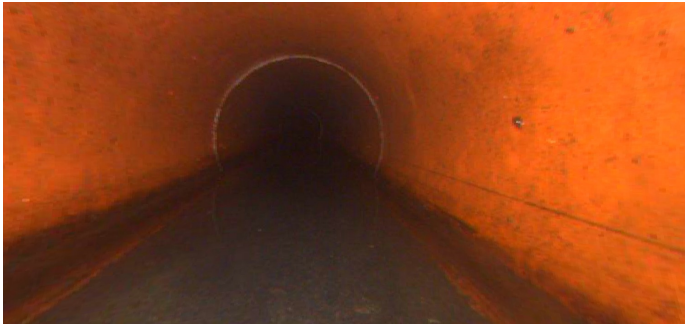
| Code: | MWL |
| Description: | Water Level |

| Value Percent: | 5.000 |

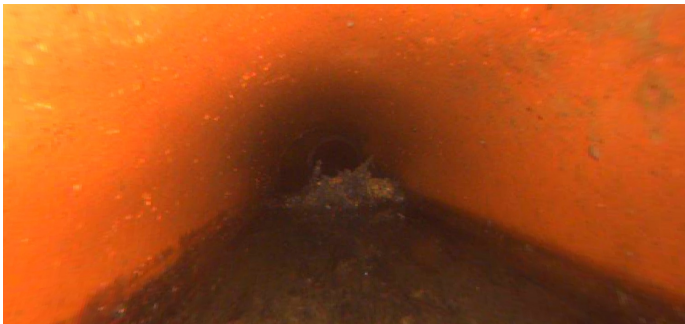
| | Position | Code | Observation | Video (sec) | Grade |
|--|---|---|---|---|---|
| | 69.9 | DSZ | Deposits Settled Other | 172 | M 3 |

| Code: | DSZ |
| Description: | Deposits Settled Other |

| Distance (ft): | 69.9 |
| O&M Grade: | 3 |
| Clock Start/From: | 3 |
| Clock To: | 7 |
| Value Percent: | 20.000 |
| Remarks: | mixed material |

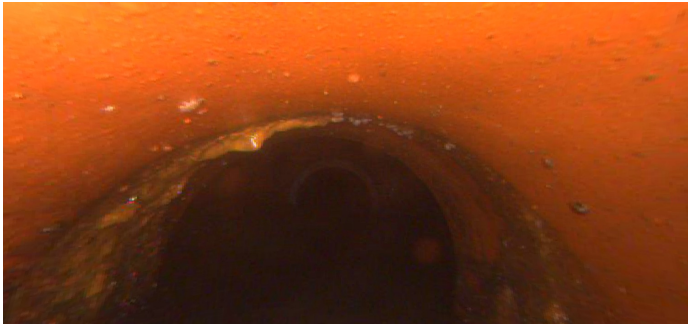
| | Position | Code | Observation | Video (sec) | Grade |
|--|---|---|---|---|---|
| | 72.2 | MSA | Abandoned Survey | 188 | NA |

| Code: | MSA |
| Description: | Abandoned Survey |
| Distance (ft): | 72.2 |
| Remarks: | mixed material blocking camera passage |
