Profile/Photo Observation Report

Date:	04/09/2018	Weather:		Coding:	PACP 6.0
Pipe Length (ft):	112.1	Owner:	NA	Pre Clean:	Not Known
P.O.#:		Surveyor:	Mark Ruby	PSR:	P-403-009-024
Customer:		Clean Date:	01/01/1900	Shape:	C

Street:	W 40th ave	Flow Control:	Not Controlled
City:	Hobart, IN	Year Renewed:	
Location:	Other	Tape/Media #:	
Purpose:	Not Known	Dia/Height:	10"
Use:	Sanitary	Material:	PVC
Drain Area:	NA	Lining:	
Category:	NA		
Comment:

Location Details:		Direction of Survey:	Upstream
US MH:	M-403-009	DS MH:	M-404-024
		Total Length Surveyed (ft):	64.3

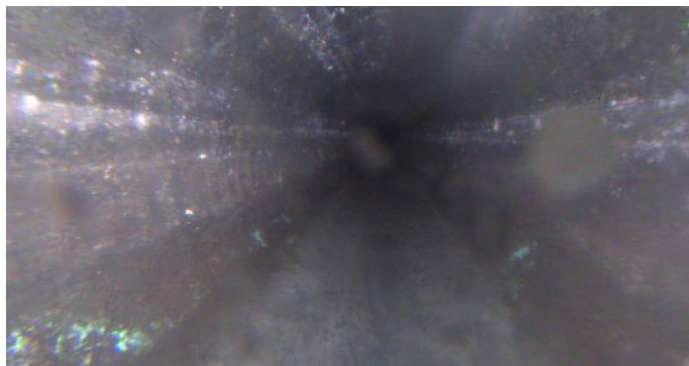
Code: **AMH**
 Description: **Manhole**

Distance (ft): **.0**
 Structural Grade: **0**
 O&M Grade: **0**
 Clock Start/From:
 Clock To:
 1st Value:
 2nd Value:
 Value Percent:
 Continuous Index:
 Within 8" of Joint: **NO**
 Remarks: **M-404-024**

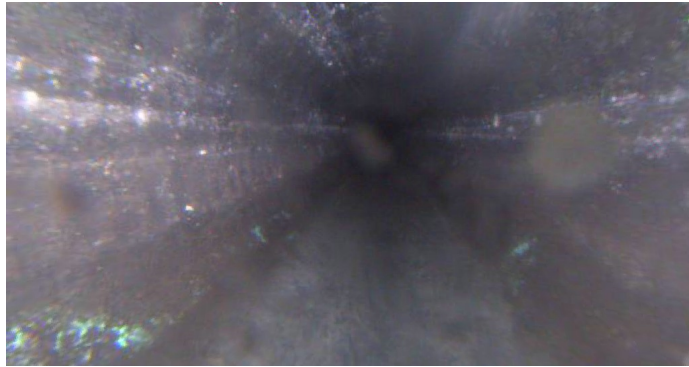
Code: **MWL**
Description: **Water Level**

Distance (ft): **.0**
Structural Grade: **0**
O&M Grade: **0**
Clock Start/From:
Clock To:
1st Value:
2nd Value:
Value Percent: **10.000**
Continuous Index:
Within 8" of Joint: **NO**
Remarks:

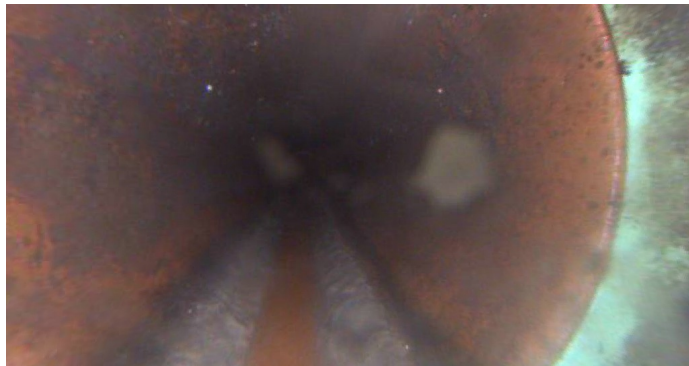
Code: **MMC**
Description: **Material Change**

Distance (ft): **24.2**
Structural Grade: **0**
O&M Grade: **0**
Clock Start/From:
Clock To:
1st Value:
2nd Value:
Value Percent:
Continuous Index:
Within 8" of Joint: **NO**
Remarks: **VCP**

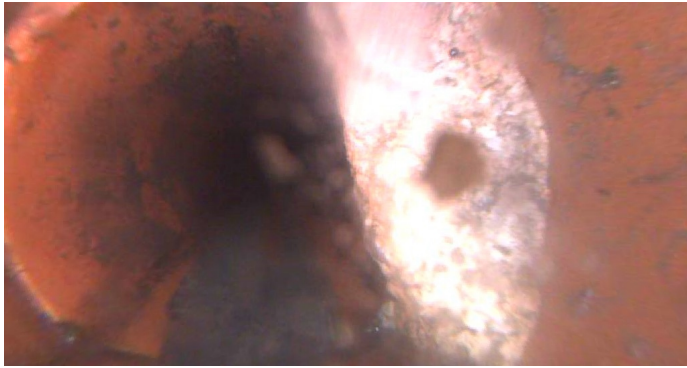
Code: **DAGS**
Description: **Deposits Attached Grease**

Distance (ft): **38.7**
Structural Grade: **0**
O&M Grade: **3**
Clock Start/From: **1**
Clock To: **5**
1st Value:
2nd Value:
Value Percent: **20.000**
Continuous Index:
Within 8" of Joint: **YES**
Remarks:

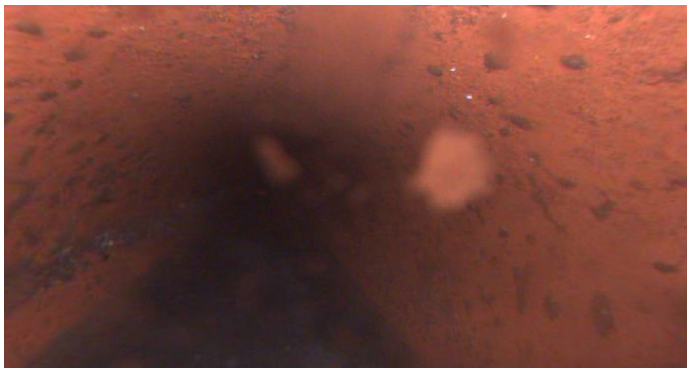
Code: **MSA**
Description: **Abandoned Survey**

Distance (ft): **64.3**
Structural Grade: **0**
O&M Grade: **0**
Clock Start/From:
Clock To:
1st Value:
2nd Value:
Value Percent:
Continuous Index:
Within 8" of Joint: **NO**
Remarks: **Debris under water**
