## Profile/Photo Observation Report

Date:	<b>11/08/2021</b>	Weather:		Coding:	<b>PACP 7.0</b>
Pipe Length (ft):	<b>175.0</b>	Owner:	<b>City of Hobart</b>	Pre Clean:	<b>Heavy Cleaning</b>
P.O.#:	<b>YES502259</b>	Surveyor:	<b>Steven Bucklin</b>	PSR:	<b>P-505-070-001</b>
Customer:	<b>City of Hobart, IN (Red</b>	Clean Date:	<b>11/08/2021</b>	Shape:	<b>C</b>

Street:	<b>South Wilson Street</b>	Flow Control:	<b>Not Controlled</b>
City:	<b>City of Hobart</b>	Year Renewed:	
Location:	<b>Local rural streets with light traffic, t</b>	Tape/Media #:	
Purpose:	<b>Routine Assessment</b>	Dia/Height:	<b>10"</b>
Use:	<b>Sanitary Sewage Pipe</b>	Material:	<b>VCP</b>
Drain Area:		Lining:	<b>None</b>
Category:	<b>NA</b>		
Comment:			
Location Details:		Direction of Survey:	<b>Downstream</b>
US MH:	<b>M-404-001</b>	DS MH:	<b>M-505-070</b>
		Total Length Surveyed (ft):	<b>175.0</b>

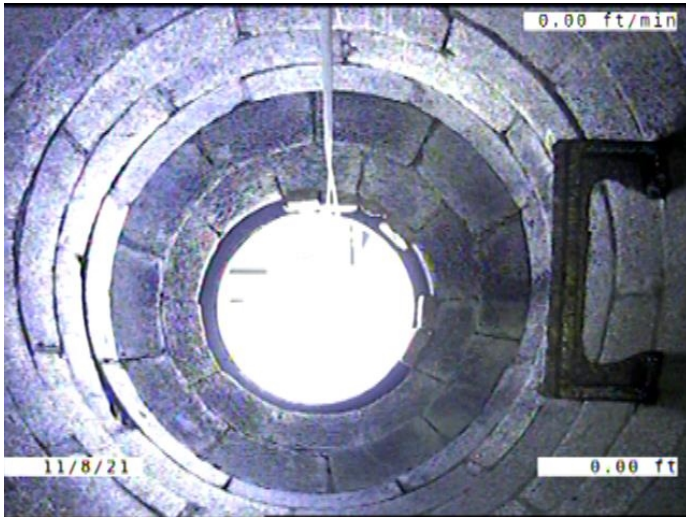
Code: **AMH**  
Description: **Manhole**

Distance (ft): **.0**  
Structural Grade: **0**  
O&M Grade: **0**  
Clock Start/From:  
Clock To:  
1st Value:  
2nd Value:  
Value Percent:  
Continuous Index:  
Within 8" of Joint: **NO**  
Remarks: **M-404-001**

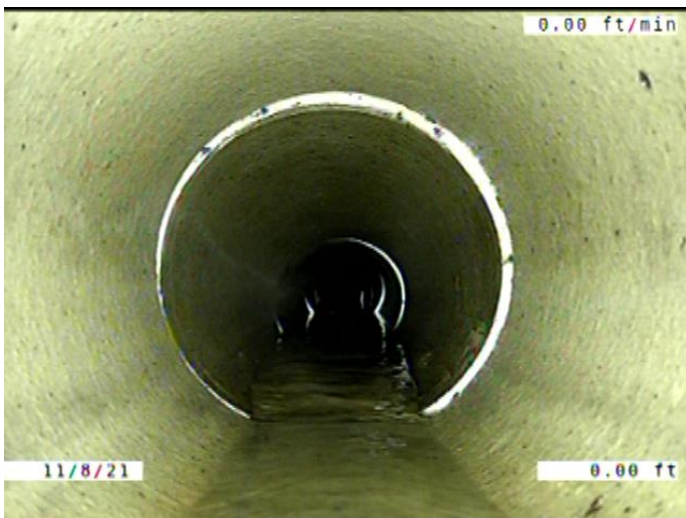
Code: **MWL**  
Description: **Miscellaneous Water Level**

Distance (ft): **.0**  
Structural Grade: **0**  
O&M Grade: **0**  
Clock Start/From:  
Clock To:  
1st Value:  
2nd Value:  
Value Percent: **10.000**  
Continuous Index:  
Within 8" of Joint: **NO**  
Remarks:

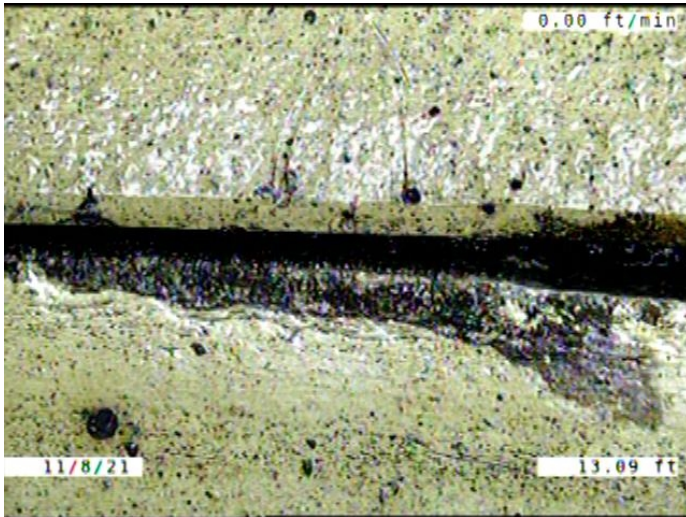
Code: **ISJ**  
Description: **Infiltration Stain Joint**

Distance (ft): **13.1**  
Structural Grade: **0**  
O&M Grade: **1**  
Clock Start/From: **2**  
Clock To: **3**  
1st Value:  
2nd Value:  
Value Percent:  
Continuous Index:  
Within 8" of Joint: **YES**  
Remarks:

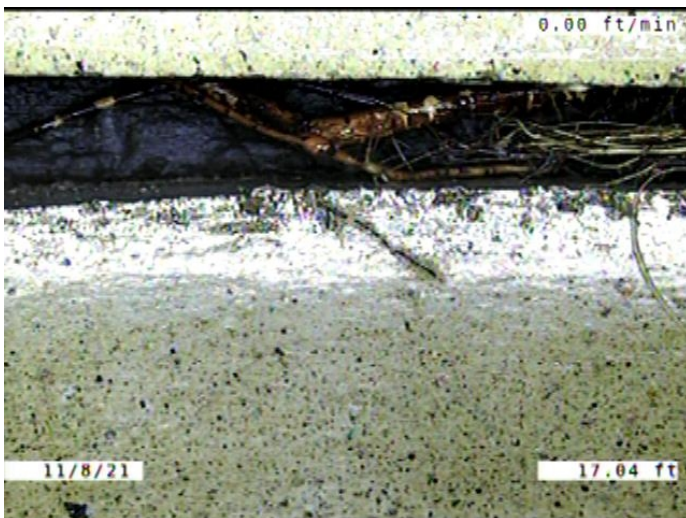
Code: **RFJ**  
Description: **Roots Fine Joint**

Distance (ft): **17.0**  
Structural Grade: **0**  
O&M Grade: **1**  
Clock Start/From: **11**  
Clock To: **2**  
1st Value:  
2nd Value:  
Value Percent:  
Continuous Index:  
Within 8" of Joint: **YES**  
Remarks:

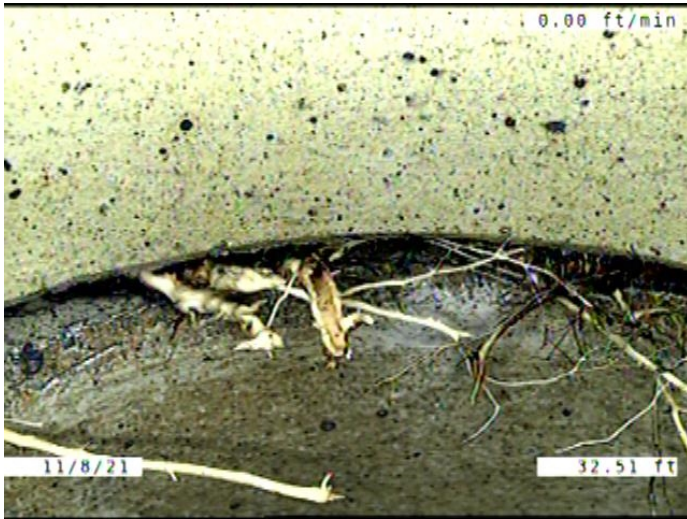
Code: **RFJ**  
Description: **Roots Fine Joint**

Distance (ft): **32.5**  
Structural Grade: **0**  
O&M Grade: **1**  
Clock Start/From: **10**  
Clock To: **1**  
1st Value:  
2nd Value:  
Value Percent:  
Continuous Index:  
Within 8" of Joint: **YES**  
Remarks:

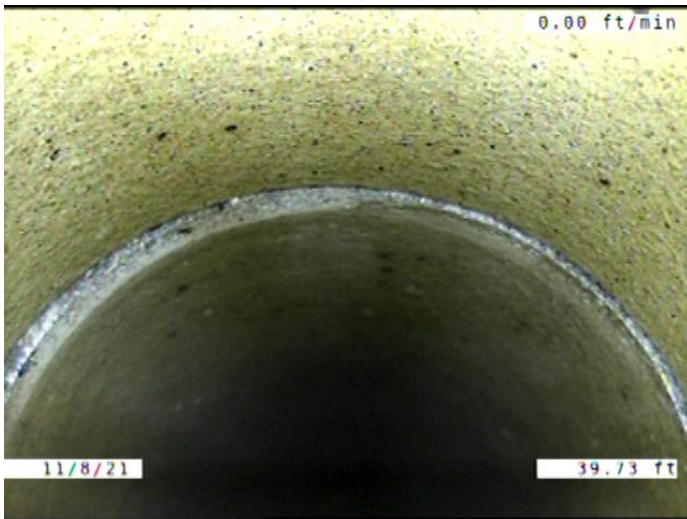
Code: **MWLS**  
Description: **Miscellaneous Water Level Sag**

Distance (ft): **39.7**  
Structural Grade: **3**  
O&M Grade: **0**  
Clock Start/From:  
Clock To:  
1st Value:  
2nd Value:  
Value Percent: **35.000**  
Continuous Index: **S01**  
Within 8" of Joint: **NO**  
Remarks:

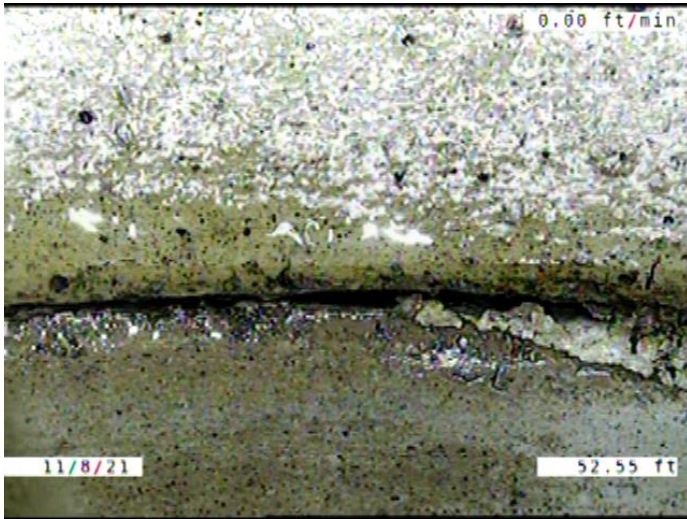
Code: **IDJ**  
 Description: **Infiltration Dripper Joint**

Distance (ft): **52.6**  
 Structural Grade: **0**  
 O&M Grade: **3**  
 Clock Start/From: **11**  
 Clock To: **12**  
 1st Value:  
 2nd Value:  
 Value Percent:  
 Continuous Index:  
 Within 8" of Joint: **YES**  
 Remarks:

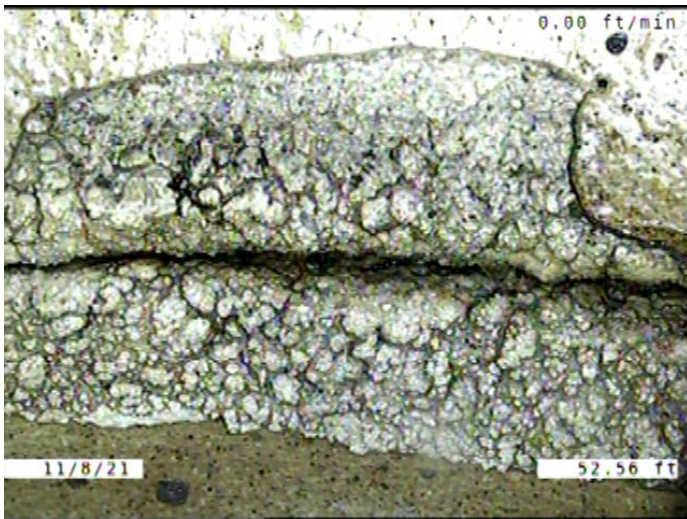
Code: **DAE**  
 Description: **Deposits Attached Encrustation**

Distance (ft): **52.6**  
 Structural Grade: **0**  
 O&M Grade: **2**  
 Clock Start/From: **10**  
 Clock To: **2**  
 1st Value:  
 2nd Value:  
 Value Percent: **5.000**  
 Continuous Index:  
 Within 8" of Joint: **YES**  
 Remarks:

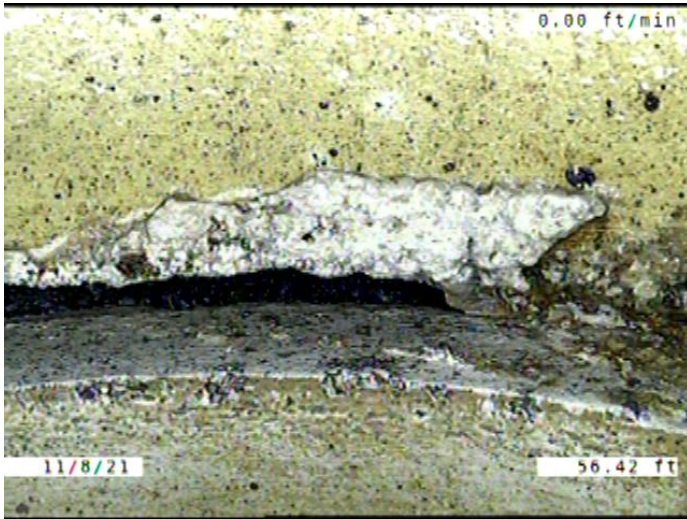
Code: **DAE**  
Description: **Deposits Attached Encrustation**

Distance (ft): **56.4**  
Structural Grade: **0**  
O&M Grade: **2**  
Clock Start/From: **12**  
Clock To: **3**  
1st Value:  
2nd Value:  
Value Percent: **5.000**  
Continuous Index:  
Within 8" of Joint: **YES**  
Remarks:

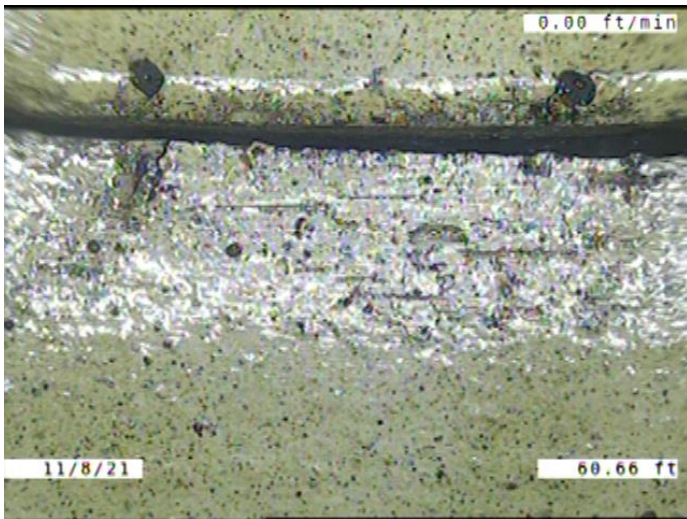
Code: **MCU**  
Description: **Miscellaneous Camera Underwater**

Distance (ft): **60.7**  
Structural Grade: **0**  
O&M Grade: **4**  
Clock Start/From:  
Clock To:  
1st Value:  
2nd Value:  
Value Percent:  
Continuous Index:  
Within 8" of Joint: **NO**  
Remarks: **Out at 61.7**

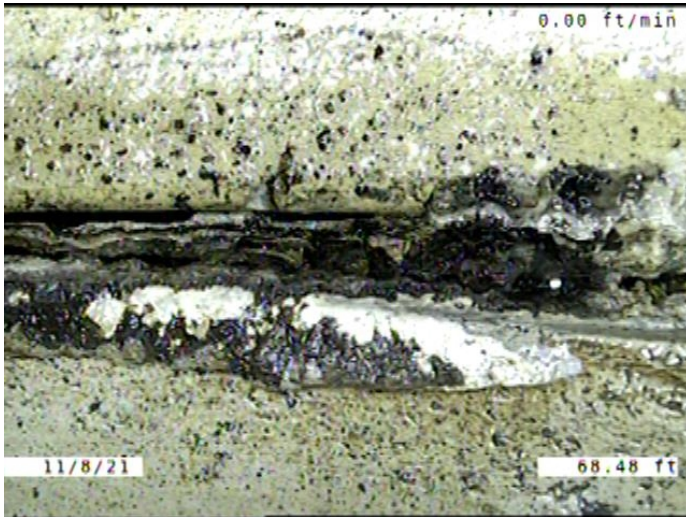
Code: **DAE**  
Description: **Deposits Attached Encrustation**

Distance (ft): **68.5**  
Structural Grade: **0**  
O&M Grade: **2**  
Clock Start/From: **9**  
Clock To: **3**  
1st Value:  
2nd Value:  
Value Percent: **5.000**  
Continuous Index:  
Within 8" of Joint: **YES**  
Remarks:

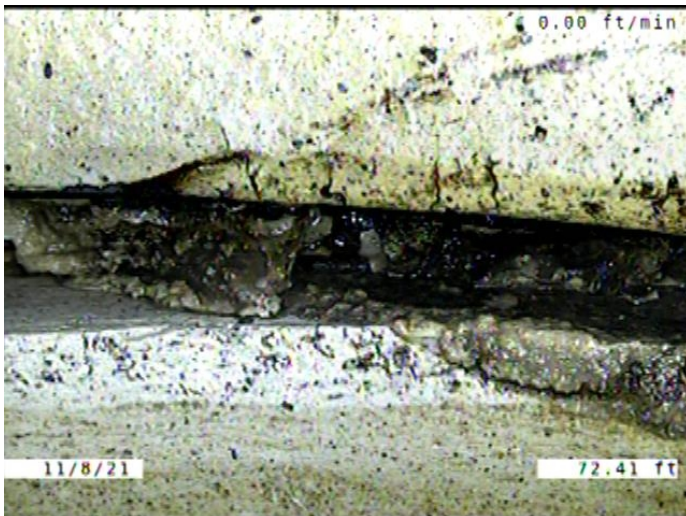
Code: **DAE**  
Description: **Deposits Attached Encrustation**

Distance (ft): **72.4**  
Structural Grade: **0**  
O&M Grade: **2**  
Clock Start/From: **2**  
Clock To: **3**  
1st Value:  
2nd Value:  
Value Percent: **5.000**  
Continuous Index:  
Within 8" of Joint: **YES**  
Remarks:

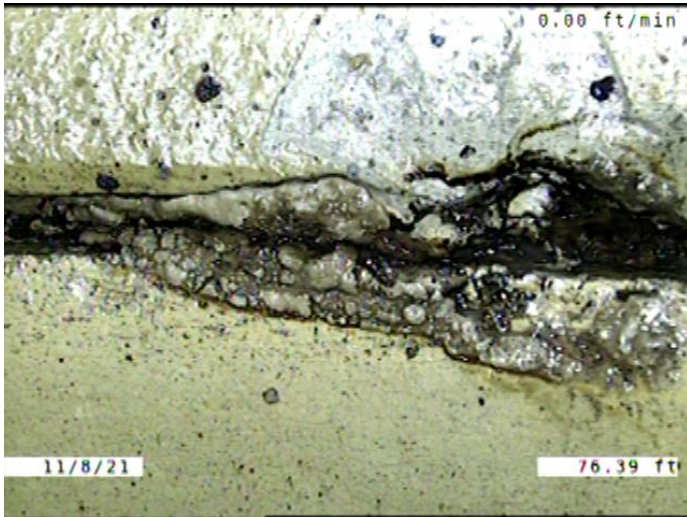
Code: **DAE**  
Description: **Deposits Attached Encrustation**

Distance (ft): **76.4**  
Structural Grade: **0**  
O&M Grade: **2**  
Clock Start/From: **2**  
Clock To: **3**  
1st Value:  
2nd Value:  
Value Percent: **5.000**  
Continuous Index:  
Within 8" of Joint: **YES**  
Remarks:

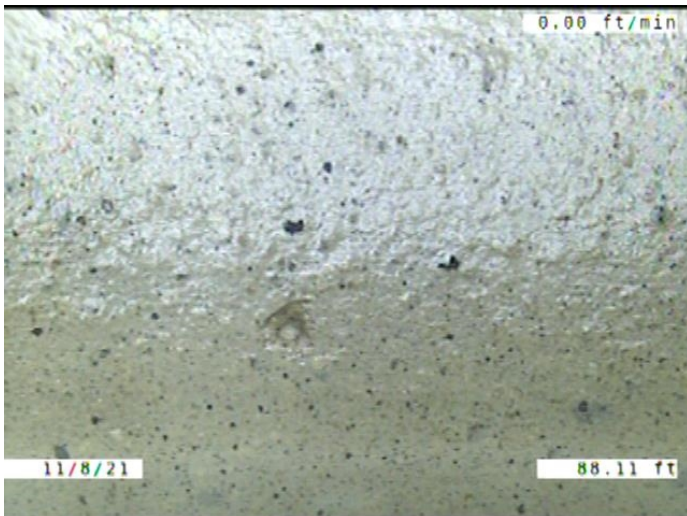
Code: **MCU**  
Description: **Miscellaneous Camera Underwater**

Distance (ft): **88.1**  
Structural Grade: **0**  
O&M Grade: **4**  
Clock Start/From:  
Clock To:  
1st Value:  
2nd Value:  
Value Percent:  
Continuous Index:  
Within 8" of Joint: **NO**  
Remarks: **Out at 89.4**

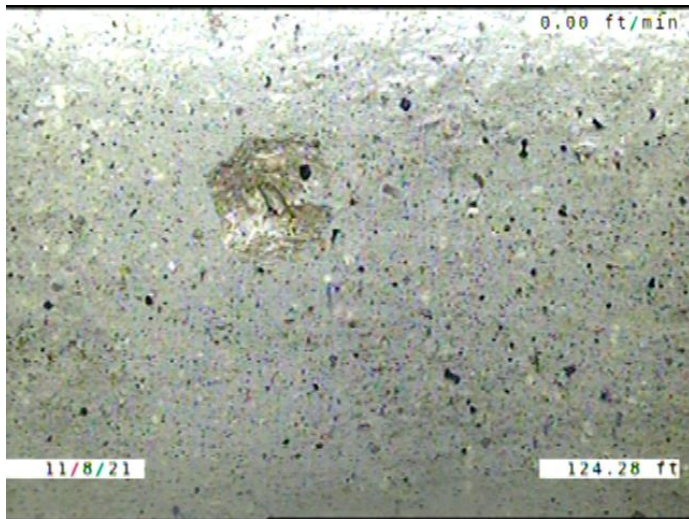
Code: **SSS**  
Description: **Surface Damage Surface Spalling**

Distance (ft): **124.3**  
Structural Grade: **2**  
O&M Grade: **0**  
Clock Start/From: **11**  
Clock To:  
1st Value:  
2nd Value:  
Value Percent:  
Continuous Index:  
Within 8" of Joint: **NO**  
Remarks:

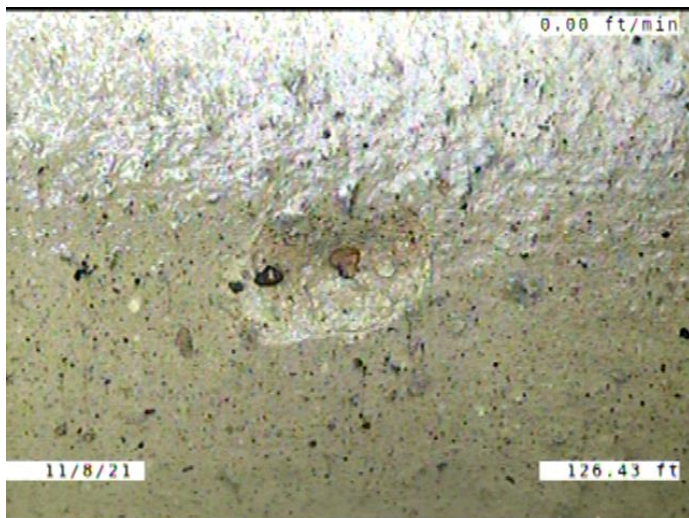
Code: **SSS**  
Description: **Surface Damage Surface Spalling**

Distance (ft): **126.4**  
Structural Grade: **2**  
O&M Grade: **0**  
Clock Start/From: **10**  
Clock To:  
1st Value:  
2nd Value:  
Value Percent:  
Continuous Index:  
Within 8" of Joint: **NO**  
Remarks:

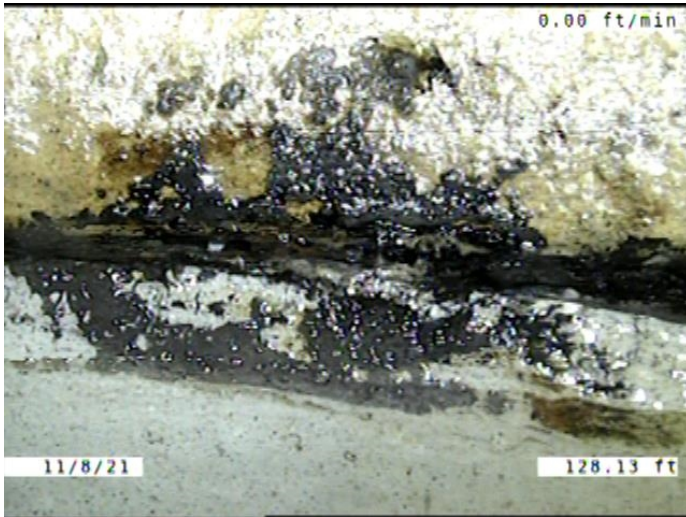
Code: **DAE**  
Description: **Deposits Attached Encrustation**

Distance (ft): **128.1**  
Structural Grade: **0**  
O&M Grade: **2**  
Clock Start/From: **10**  
Clock To: **2**  
1st Value:  
2nd Value:  
Value Percent: **5.000**  
Continuous Index:  
Within 8" of Joint: **YES**  
Remarks:

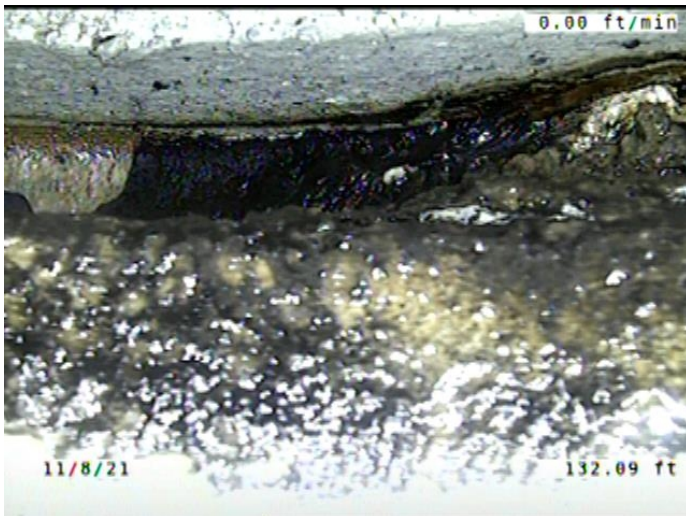
Code: **DAE**  
Description: **Deposits Attached Encrustation**

Distance (ft): **132.1**  
Structural Grade: **0**  
O&M Grade: **2**  
Clock Start/From: **8**  
Clock To: **4**  
1st Value:  
2nd Value:  
Value Percent: **5.000**  
Continuous Index:  
Within 8" of Joint: **YES**  
Remarks:

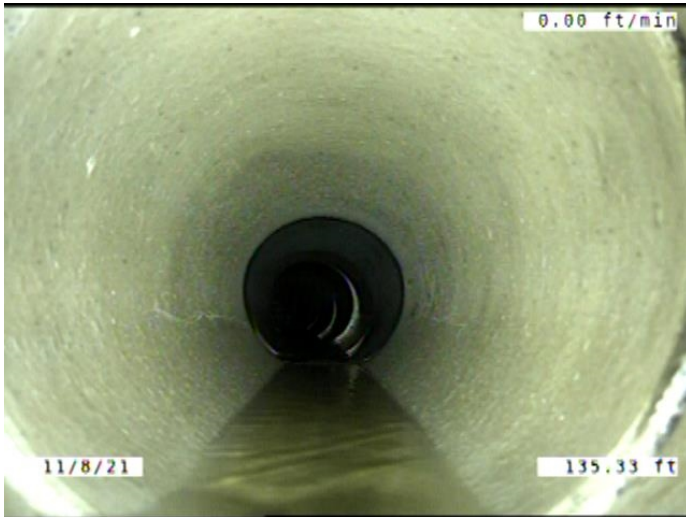
Code: **MWLS**  
 Description: **Miscellaneous Water Level Sag**

Distance (ft): **135.3**  
 Structural Grade: **3**  
 O&M Grade: **0**  
 Clock Start/From:  
 Clock To:  
 1st Value:  
 2nd Value:  
 Value Percent: **35.000**  
 Continuous Index: **F01**  
 Within 8" of Joint: **NO**  
 Remarks:

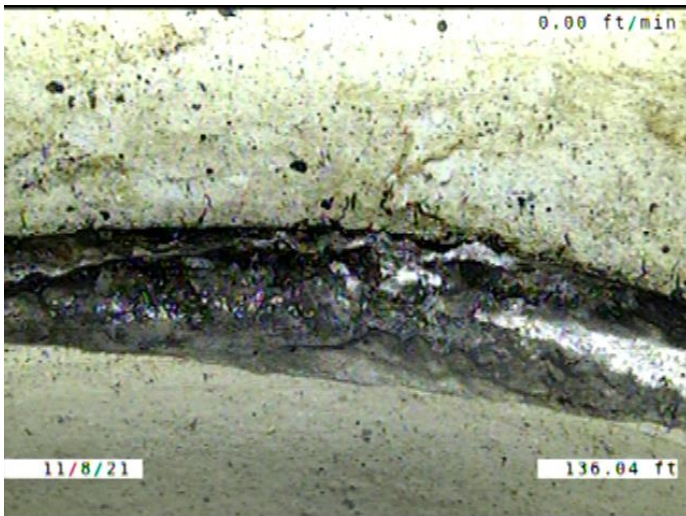
Code: **DAE**  
 Description: **Deposits Attached Encrustation**

Distance (ft): **136.0**  
 Structural Grade: **0**  
 O&M Grade: **2**  
 Clock Start/From: **8**  
 Clock To: **4**  
 1st Value:  
 2nd Value:  
 Value Percent: **5.000**  
 Continuous Index:  
 Within 8" of Joint: **YES**  
 Remarks:

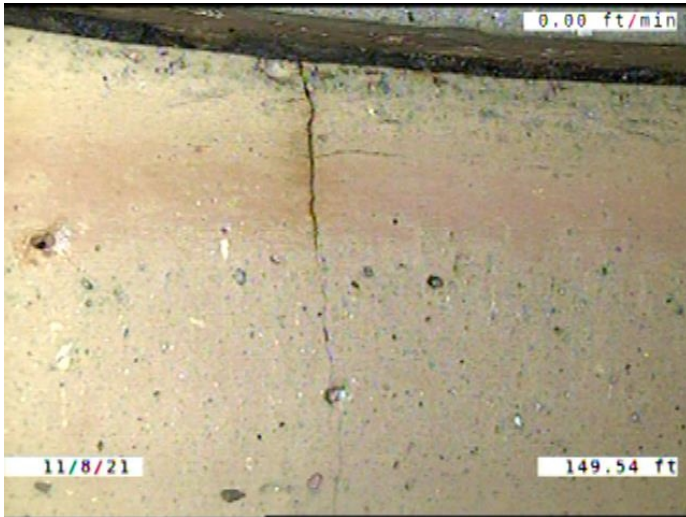
Code: **CL**  
Description: **Crack Longitudinal**

Distance (ft): **149.5**  
Structural Grade: **2**  
O&M Grade: **0**  
Clock Start/From: **10**  
Clock To:  
1st Value:  
2nd Value:  
Value Percent:  
Continuous Index:  
Within 8" of Joint: **YES**  
Remarks:

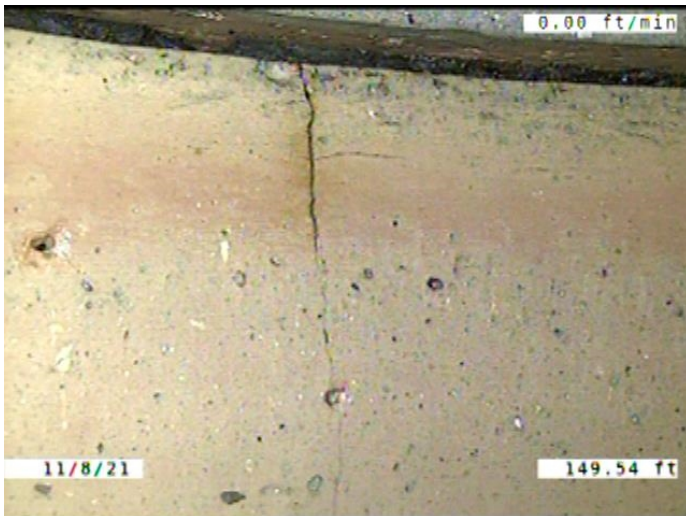
Code: **ISB**  
Description: **Infiltration Stain Barrel**

Distance (ft): **149.5**  
Structural Grade: **0**  
O&M Grade: **1**  
Clock Start/From: **10**  
Clock To:  
1st Value:  
2nd Value:  
Value Percent:  
Continuous Index:  
Within 8" of Joint: **YES**  
Remarks:

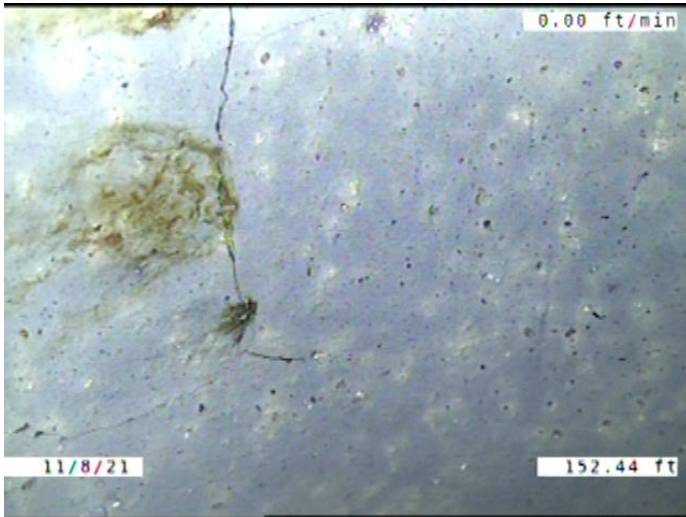
Code: **CM**  
Description: **Crack Multiple**

Distance (ft): **152.4**  
Structural Grade: **3**  
O&M Grade: **0**  
Clock Start/From: **12**  
Clock To: **12**  
1st Value:  
2nd Value:  
Value Percent:  
Continuous Index:  
Within 8" of Joint: **YES**  
Remarks:

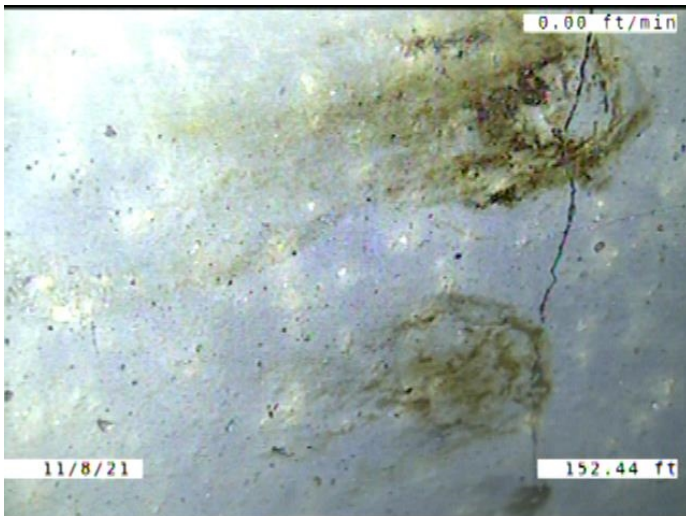
Code: **ISB**  
Description: **Infiltration Stain Barrel**

Distance (ft): **152.4**  
Structural Grade: **0**  
O&M Grade: **1**  
Clock Start/From: **8**  
Clock To: **10**  
1st Value:  
2nd Value:  
Value Percent:  
Continuous Index:  
Within 8" of Joint: **YES**  
Remarks:

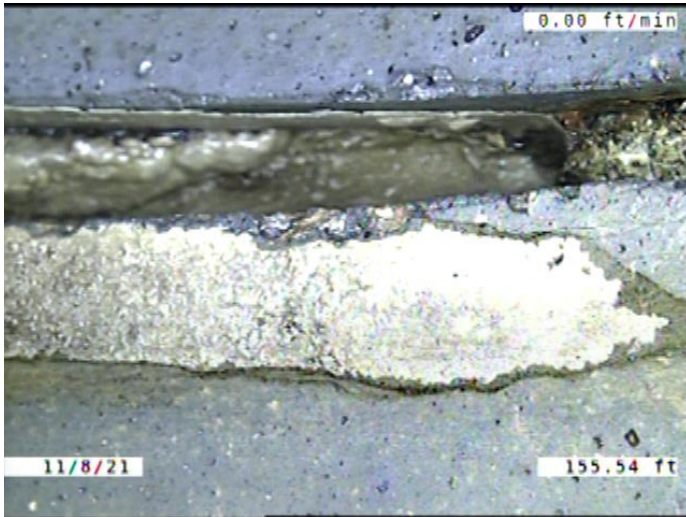
Code: **DAE**  
 Description: **Deposits Attached Encrustation**

Distance (ft): **155.5**  
 Structural Grade: **0**  
 O&M Grade: **2**  
 Clock Start/From: **8**  
 Clock To: **4**  
 1st Value:  
 2nd Value:  
 Value Percent: **5.000**  
 Continuous Index:  
 Within 8" of Joint: **YES**  
 Remarks:

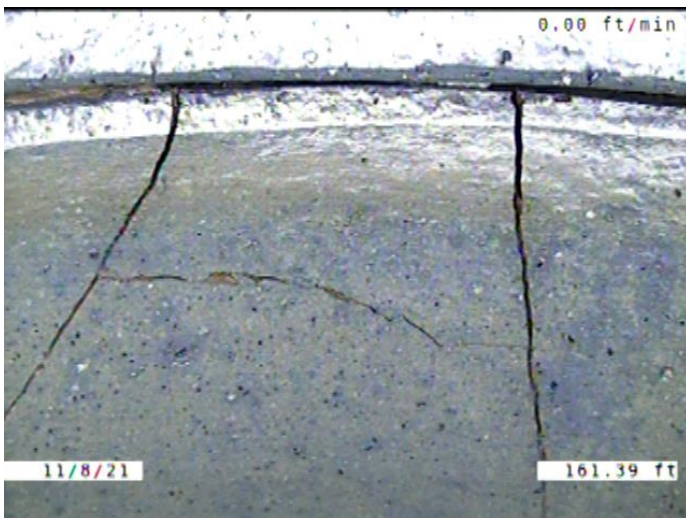
Code: **FM**  
 Description: **Fracture Multiple**

Distance (ft): **161.4**  
 Structural Grade: **4**  
 O&M Grade: **0**  
 Clock Start/From: **10**  
 Clock To: **4**  
 1st Value:  
 2nd Value:  
 Value Percent:  
 Continuous Index:  
 Within 8" of Joint: **YES**  
 Remarks:

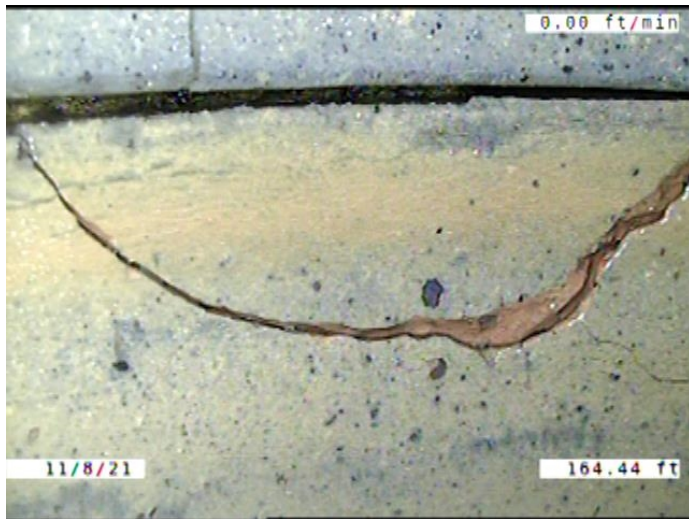
Code: **B**  
Description: **Broken**

Distance (ft): **164.4**  
Structural Grade: **4**  
O&M Grade: **0**  
Clock Start/From: **10**  
Clock To: **1**  
1st Value:  
2nd Value:  
Value Percent:  
Continuous Index:  
Within 8" of Joint: **YES**  
Remarks:

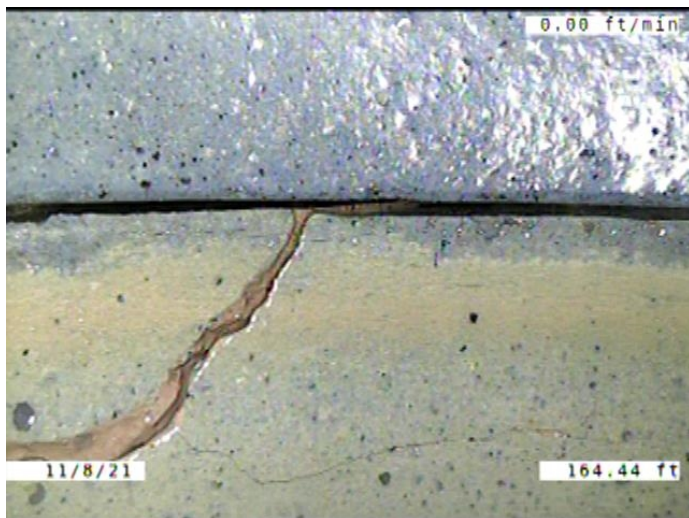
Code: **IRJ**  
Description: **Infiltration Runner Joint**

Distance (ft): **164.4**  
Structural Grade: **0**  
O&M Grade: **4**  
Clock Start/From: **11**  
Clock To: **12**  
1st Value:  
2nd Value:  
Value Percent:  
Continuous Index:  
Within 8" of Joint: **YES**  
Remarks:

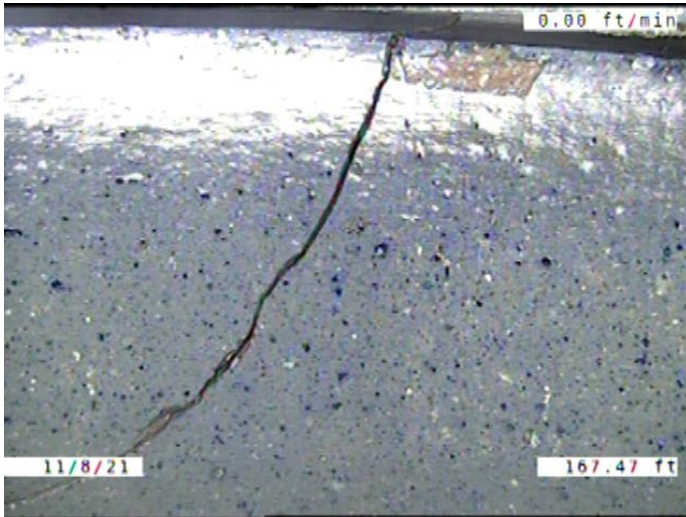
Code: **FM**  
 Description: **Fracture Multiple**

Distance (ft): **167.5**  
 Structural Grade: **4**  
 O&M Grade: **0**  
 Clock Start/From: **9**  
 Clock To: **4**  
 1st Value:  
 2nd Value:  
 Value Percent:  
 Continuous Index:  
 Within 8" of Joint: **YES**  
 Remarks:

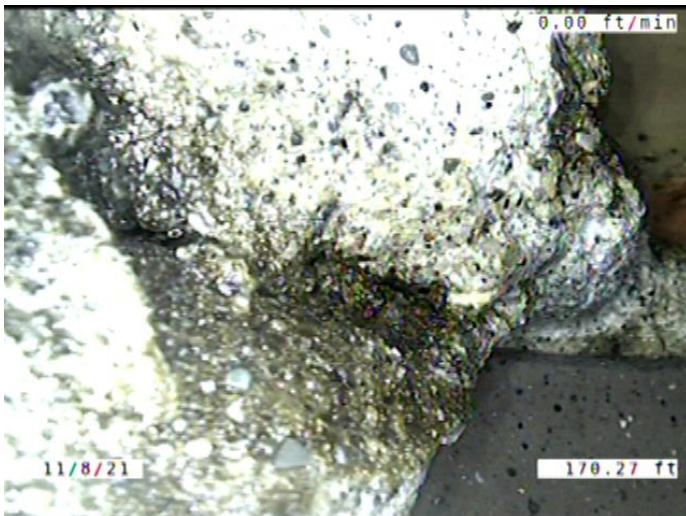
Code: **ISGT**  
 Description: **Intruding Sealing Material Grout**

Distance (ft): **170.3**  
 Structural Grade: **0**  
 O&M Grade: **2**  
 Clock Start/From: **3**  
 Clock To: **7**  
 1st Value:  
 2nd Value:  
 Value Percent: **5.000**  
 Continuous Index:  
 Within 8" of Joint: **NO**  
 Remarks:

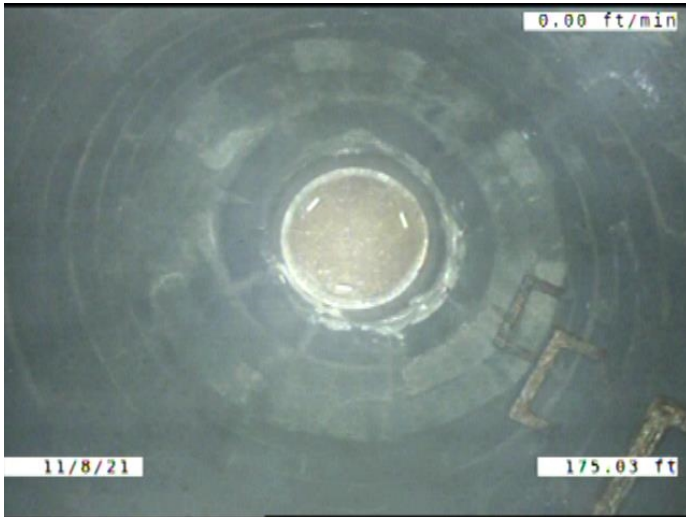
Code:	AMH
Description:	Manhole
Distance (ft):	175.0
Structural Grade:	0
O&M Grade:	0
Clock Start/From:	
Clock To:	
1st Value:	
2nd Value:	
Value Percent:	
Continuous Index:	
Within 8" of Joint:	NO
Remarks:	M-505-070
