Profile/Photo Observation Report

Date:	11/08/2021	Weather:		Coding:	PACP 7.0
Pipe Length (ft):	175.0	Owner:	City of Hobart	Pre Clean:	Heavy Cleaning
P.O.#:	YES502259	Surveyor:	Steven Bucklin	PSR:	P-505-070-001
Customer:	City of Hobart, IN (Red	Clean Date:	11/08/2021	Shape:	C

Street:	South Wilson Street	Flow Control:	Not Controlled
City:	City of Hobart	Year Renewed:	
Location:	Local rural streets with light traffic, t	Tape/Media #:	
Purpose:	Routine Assessment	Dia/Height:	10"
Use:	Sanitary Sewage Pipe	Material:	VCP
Drain Area:		Lining:	None
Category:	NA		
Comment:			
Location Details:		Direction of Survey:	Downstream
US MH:	M-404-001	DS MH:	M-505-070
		Total Length Surveyed (ft):	175.0

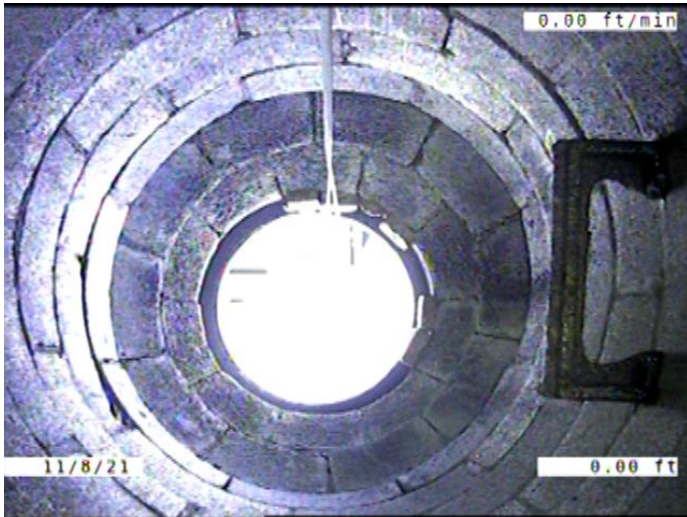
Code: **AMH**
Description: **Manhole**

Distance (ft): **.0**
Structural Grade: **0**
O&M Grade: **0**
Clock Start/From:
Clock To:
1st Value:
2nd Value:
Value Percent:
Continuous Index:
Within 8" of Joint: **NO**
Remarks: **M-404-001**

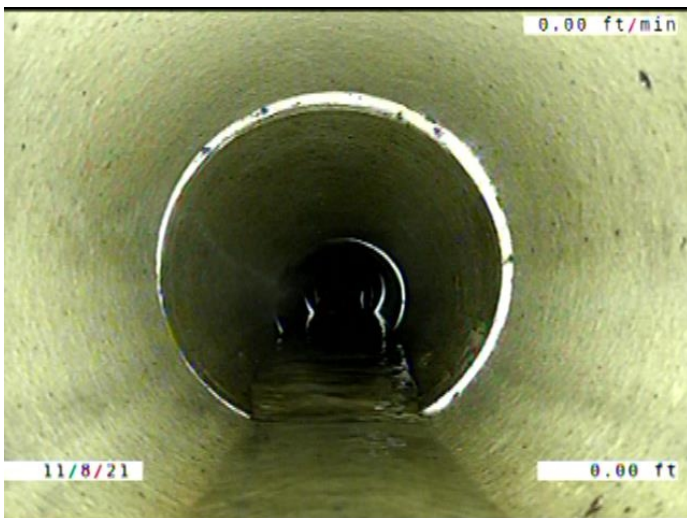
Code: **MWL**
Description: **Miscellaneous Water Level**

Distance (ft): **.0**
Structural Grade: **0**
O&M Grade: **0**
Clock Start/From:
Clock To:
1st Value:
2nd Value:
Value Percent: **10.000**
Continuous Index:
Within 8" of Joint: **NO**
Remarks:

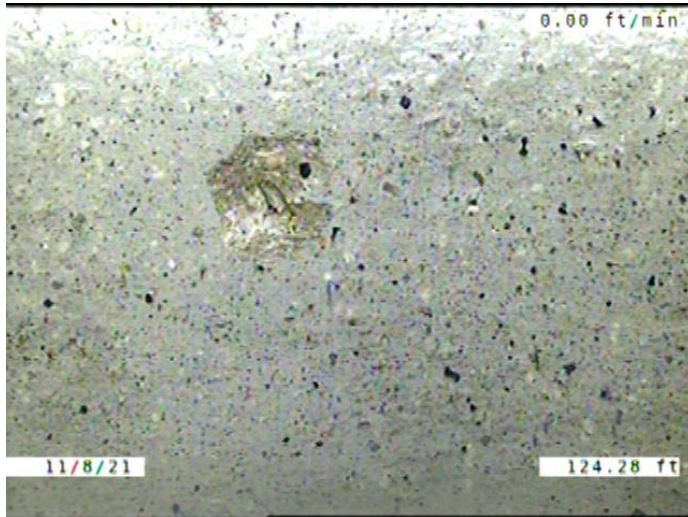
Code: **SSS**
Description: **Surface Damage Surface Spalling**

Distance (ft): **124.3**
Structural Grade: **2**
O&M Grade: **0**
Clock Start/From: **11**
Clock To:
1st Value:
2nd Value:
Value Percent:
Continuous Index:
Within 8" of Joint: **NO**
Remarks:

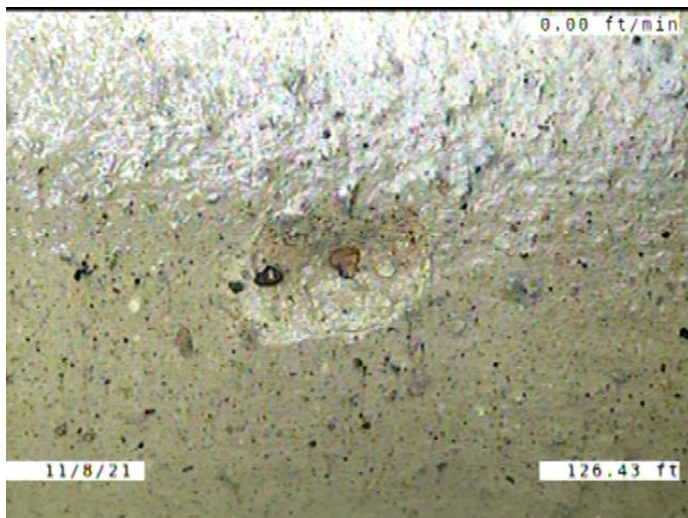
Code: **SSS**
Description: **Surface Damage Surface Spalling**

Distance (ft): **126.4**
Structural Grade: **2**
O&M Grade: **0**
Clock Start/From: **10**
Clock To:
1st Value:
2nd Value:
Value Percent:
Continuous Index:
Within 8" of Joint: **NO**
Remarks:

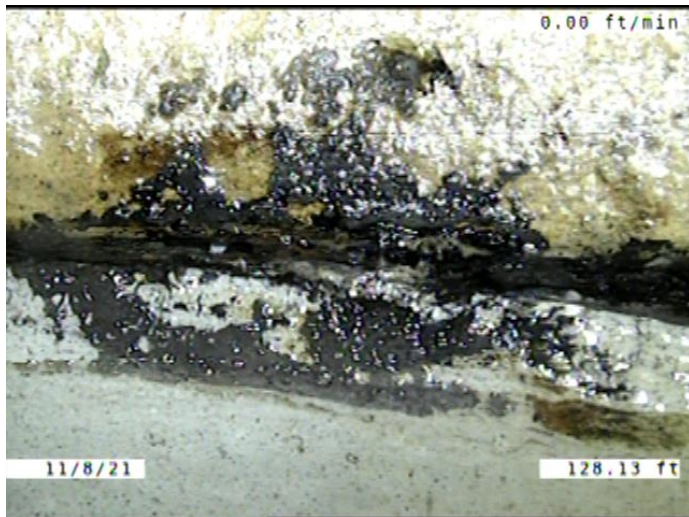
Code: **DAE**
 Description: **Deposits Attached Encrustation**

Distance (ft): **128.1**
 Structural Grade: **0**
 O&M Grade: **2**
 Clock Start/From: **10**
 Clock To: **2**
 1st Value:
 2nd Value:
 Value Percent: **5.000**
 Continuous Index:
 Within 8" of Joint: **YES**
 Remarks:

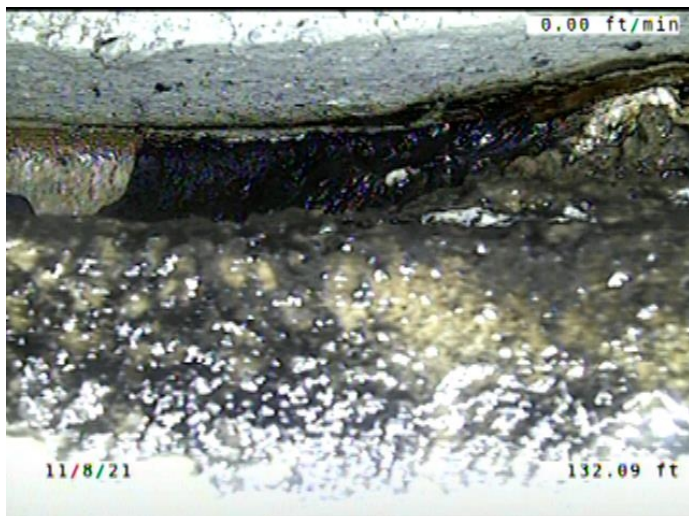
Code: **DAE**
 Description: **Deposits Attached Encrustation**

Distance (ft): **132.1**
 Structural Grade: **0**
 O&M Grade: **2**
 Clock Start/From: **8**
 Clock To: **4**
 1st Value:
 2nd Value:
 Value Percent: **5.000**
 Continuous Index:
 Within 8" of Joint: **YES**
 Remarks:

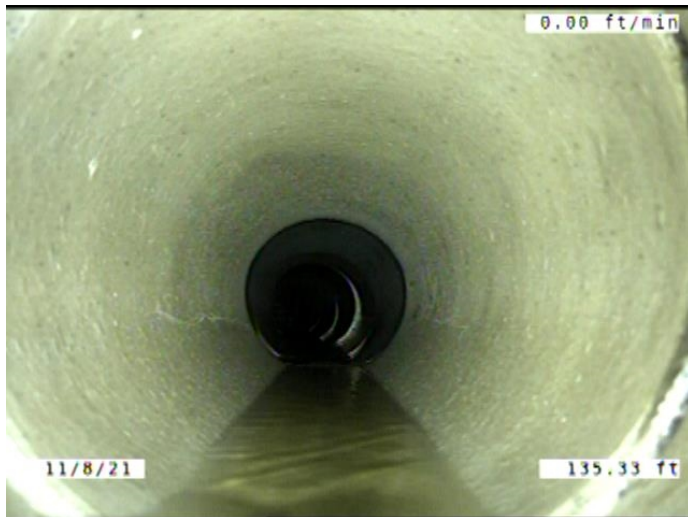
Code: **MWLS**
 Description: **Miscellaneous Water Level Sag**

Distance (ft): **135.3**
 Structural Grade: **3**
 O&M Grade: **0**
 Clock Start/From:
 Clock To:
 1st Value:
 2nd Value:
 Value Percent: **35.000**
 Continuous Index: **F01**
 Within 8" of Joint: **NO**
 Remarks:

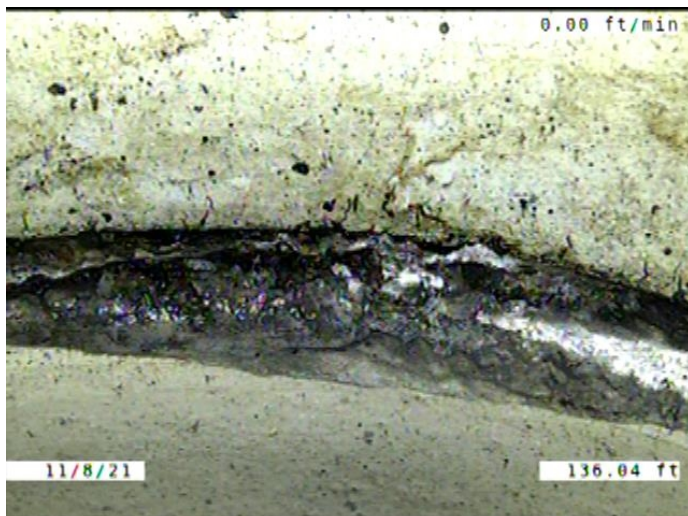
Code: **DAE**
 Description: **Deposits Attached Encrustation**

Distance (ft): **136.0**
 Structural Grade: **0**
 O&M Grade: **2**
 Clock Start/From: **8**
 Clock To: **4**
 1st Value:
 2nd Value:
 Value Percent: **5.000**
 Continuous Index:
 Within 8" of Joint: **YES**
 Remarks:

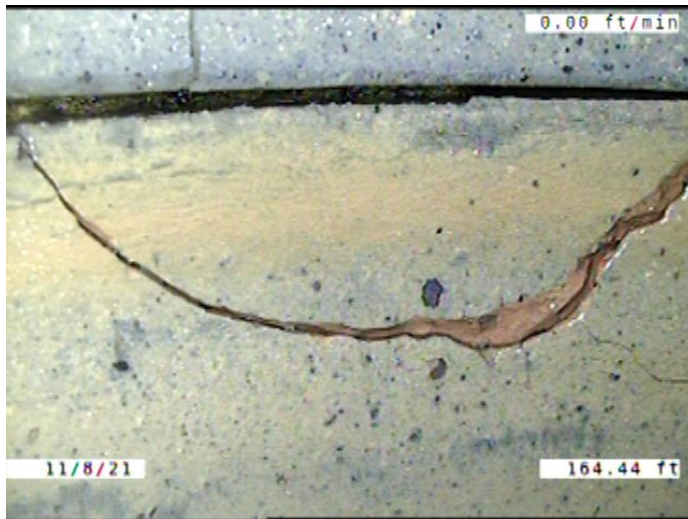
Code: **B**
 Description: **Broken**

Distance (ft): **164.4**
 Structural Grade: **4**
 O&M Grade: **0**
 Clock Start/From: **10**
 Clock To: **1**
 1st Value:
 2nd Value:
 Value Percent:
 Continuous Index:
 Within 8" of Joint: **YES**
 Remarks:

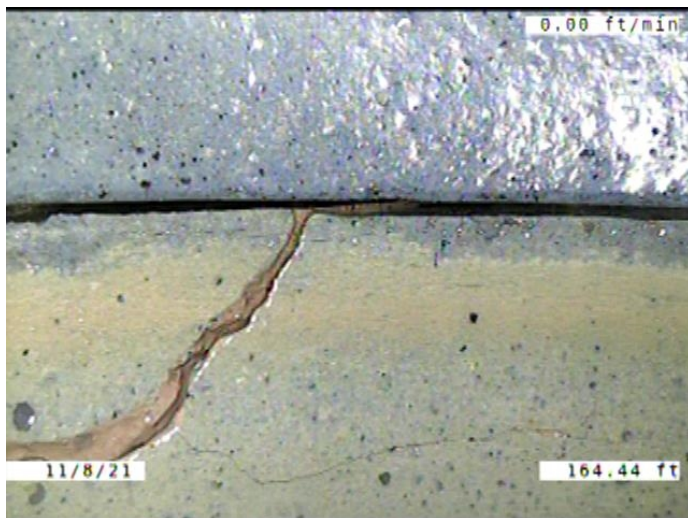
Code: **IRJ**
 Description: **Infiltration Runner Joint**

Distance (ft): **164.4**
 Structural Grade: **0**
 O&M Grade: **4**
 Clock Start/From: **11**
 Clock To: **12**
 1st Value:
 2nd Value:
 Value Percent:
 Continuous Index:
 Within 8" of Joint: **YES**
 Remarks:
