# Profile/Photo Observation Report

Date:	11/03/2021	Weather:		Coding:	PACP 7.0
Pipe Length (ft):	291.0	Owner:	City of Hobart	Pre Clean:	Heavy Cleaning
P.O.#:	YES502259	Surveyor:	S. Bucklin	PSR:	P-405-068-002
Customer:	City of Hobart	Clean Date:	10/29/2021	Shape:	C

Street:	South Wabash Street	Flow Control:	Not Controlled
City:	Hobart, IN	Year Renewed:	
Location:	Alley	Tape/Media #:	
Purpose:	Routine Assessment	Dia/Height:	12"
Use:	Sanitary Sewage Pipe	Material:	VCP
Drain Area:		Lining:	None
Category:	NA		
Comment:			
Location Details:		Direction of Survey:	Upstream
US MH:	M-404-002	DS MH:	M-405-068
		Total Length Surveyed (ft):	236.1

O&M Index:	2.00	O&M Quick:	3124	O&M Rating:	12.00
Structural Index:	2.54	Structural Quick:	5342	Structural Rating:	104.00
Overall Index:	2.47	Overall Quick:	5342	Overall Rating:	116.00

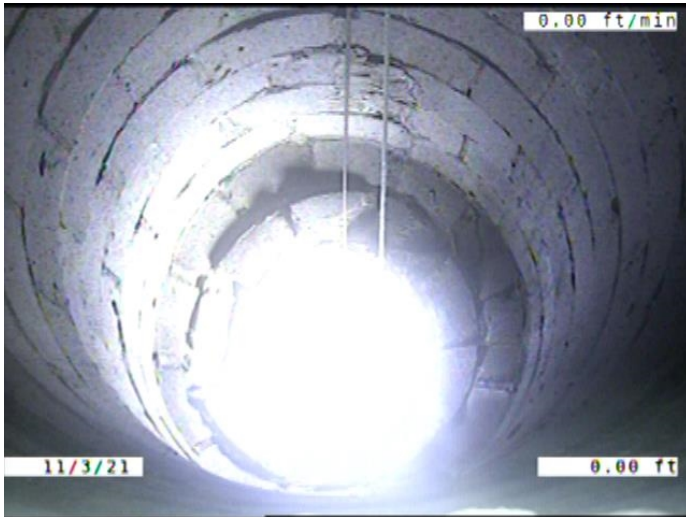
Code: **AMH**  
Description: **Manhole**

Distance (ft): **.0**  
Structural Grade: **0**  
O&M Grade: **0**  
Clock Start/From:  
Clock To:  
1st Value:  
2nd Value:  
Value Percent:  
Continuous Index:  
Within 8" of Joint: **NO**  
Remarks: **M-405-068**

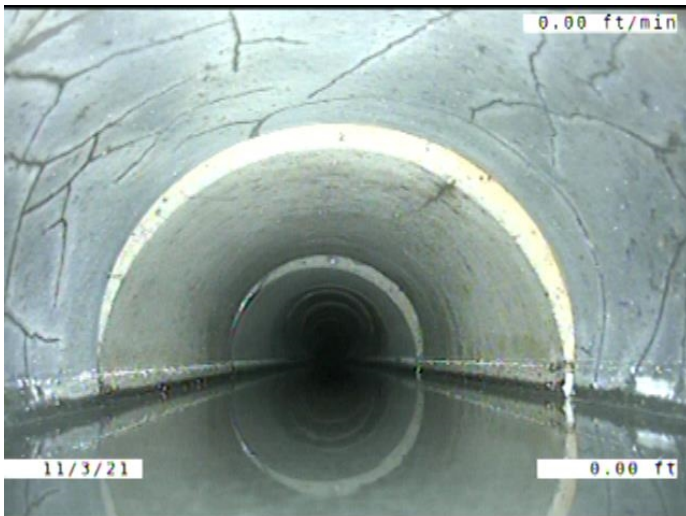
Code: **MWL**  
Description: **Miscellaneous Water Level**

Distance (ft): **.0**  
Structural Grade: **0**  
O&M Grade: **0**  
Clock Start/From:  
Clock To:  
1st Value:  
2nd Value:  
Value Percent: **15.000**  
Continuous Index:  
Within 8" of Joint: **NO**  
Remarks:

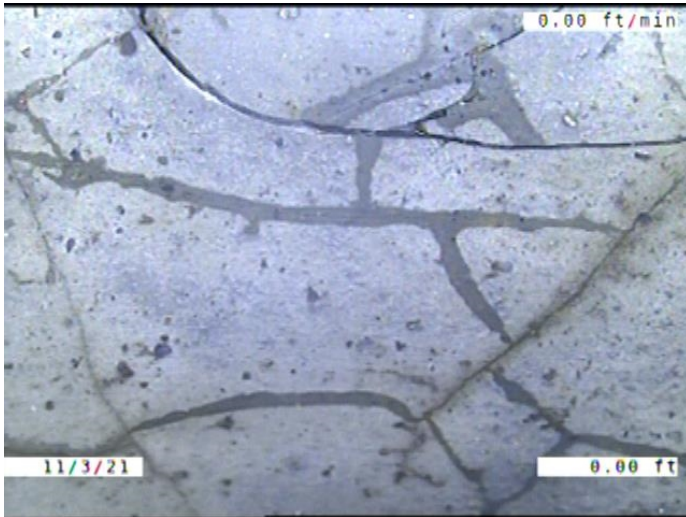
Code: **CM**  
Description: **Crack Multiple**

Distance (ft): **.0**  
Structural Grade: **3**  
O&M Grade: **0**  
Clock Start/From: **8**  
Clock To: **4**  
1st Value:  
2nd Value:  
Value Percent:  
Continuous Index:  
Within 8" of Joint: **YES**  
Remarks:

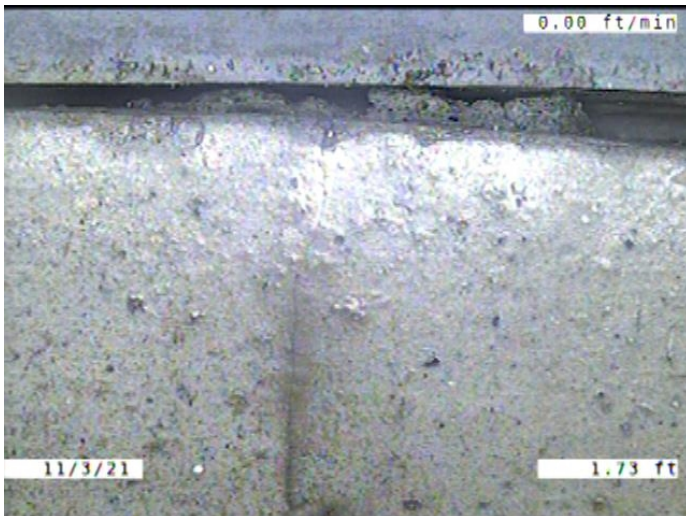
Code: **CL**  
Description: **Crack Longitudinal**

Distance (ft): **1.7**  
Structural Grade: **2**  
O&M Grade: **0**  
Clock Start/From: **1**  
Clock To:  
1st Value:  
2nd Value:  
Value Percent:  
Continuous Index:  
Within 8" of Joint: **YES**  
Remarks:

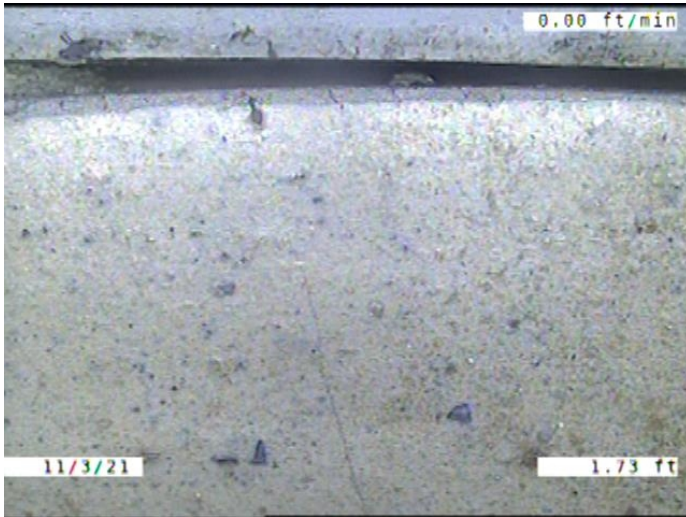
Code: **CL**  
Description: **Crack Longitudinal**

Distance (ft): **1.7**  
Structural Grade: **2**  
O&M Grade: **0**  
Clock Start/From: **11**  
Clock To:  
1st Value:  
2nd Value:  
Value Percent:  
Continuous Index:  
Within 8" of Joint: **YES**  
Remarks:

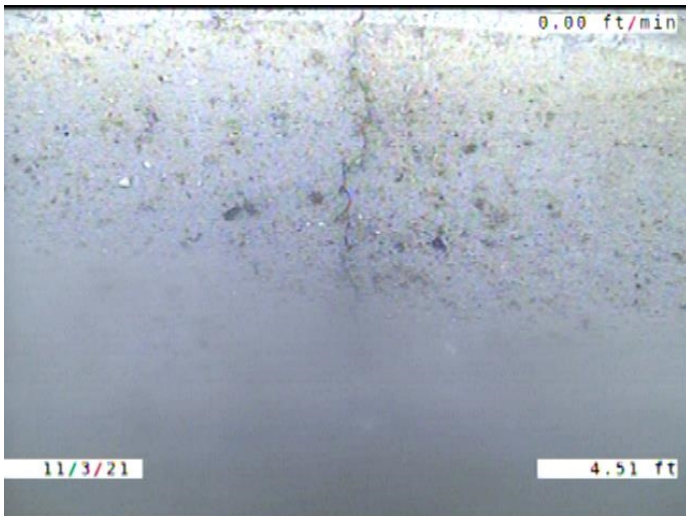
Code: **CL**  
Description: **Crack Longitudinal**

Distance (ft): **4.5**  
Structural Grade: **2**  
O&M Grade: **0**  
Clock Start/From: **1**  
Clock To:  
1st Value:  
2nd Value:  
Value Percent:  
Continuous Index:  
Within 8" of Joint: **YES**  
Remarks:

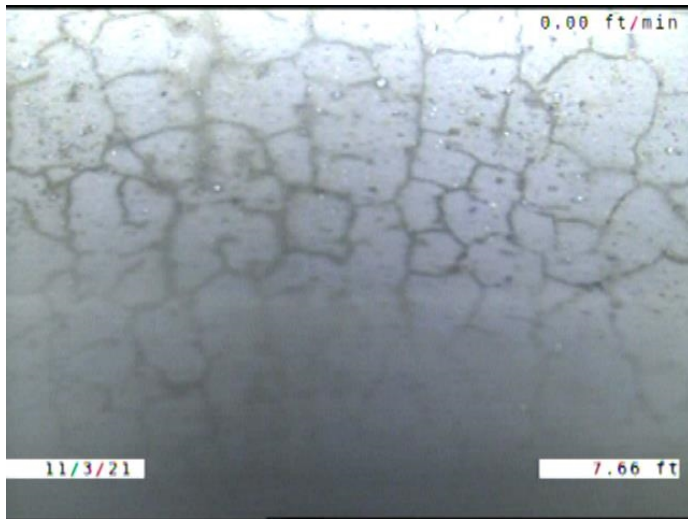
Code: **CM**  
 Description: **Crack Multiple**

Distance (ft): **7.7**  
 Structural Grade: **3**  
 O&M Grade: **0**  
 Clock Start/From: **8**  
 Clock To: **4**  
 1st Value:  
 2nd Value:  
 Value Percent:  
 Continuous Index: **S01**  
 Within 8" of Joint: **YES**  
 Remarks:

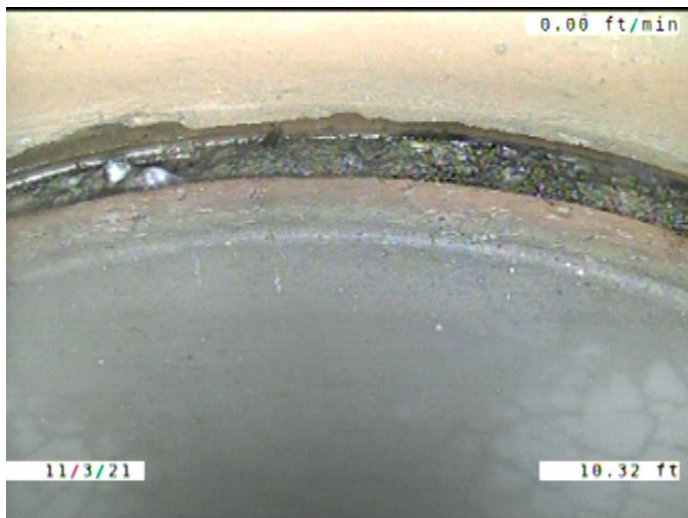
Code: **JOM**  
 Description: **Joint Offset Medium**

Distance (ft): **10.3**  
 Structural Grade: **3**  
 O&M Grade: **0**  
 Clock Start/From:  
 Clock To:  
 1st Value:  
 2nd Value:  
 Value Percent:  
 Continuous Index:  
 Within 8" of Joint: **NO**  
 Remarks:

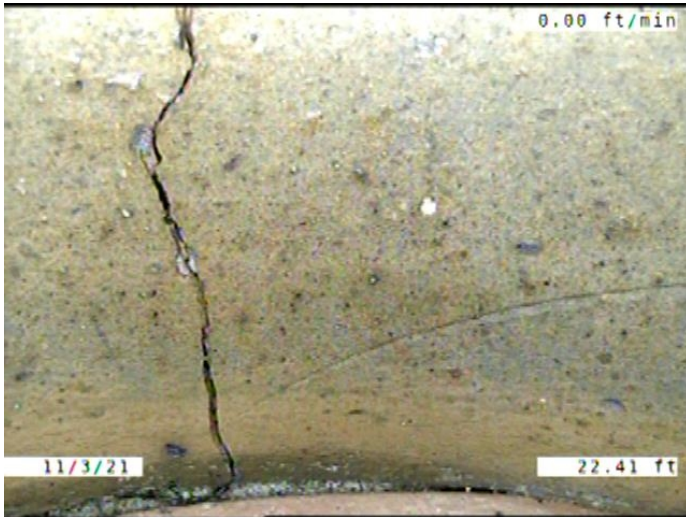
Code: **FS**  
Description: **Fracture Spiral**

Distance (ft): **22.4**  
Structural Grade: **3**  
O&M Grade: **0**  
Clock Start/From: **11**  
Clock To: **12**  
1st Value:  
2nd Value:  
Value Percent:  
Continuous Index:  
Within 8" of Joint: **YES**  
Remarks:

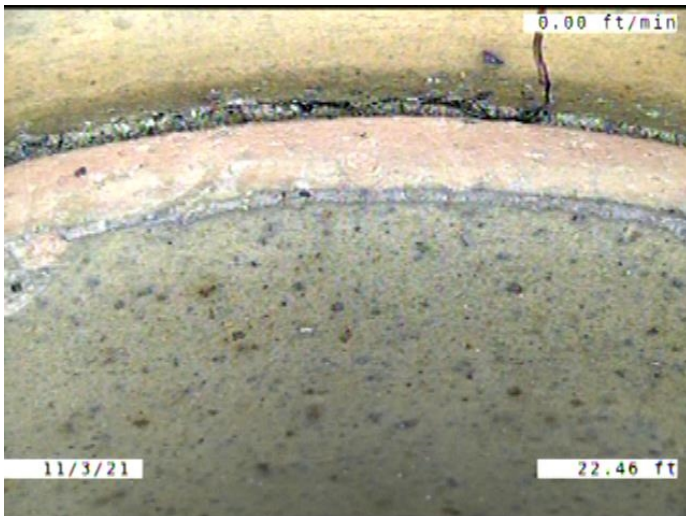
Code: **JOM**  
Description: **Joint Offset Medium**

Distance (ft): **22.5**  
Structural Grade: **3**  
O&M Grade: **0**  
Clock Start/From:  
Clock To:  
1st Value:  
2nd Value:  
Value Percent:  
Continuous Index:  
Within 8" of Joint: **NO**  
Remarks:

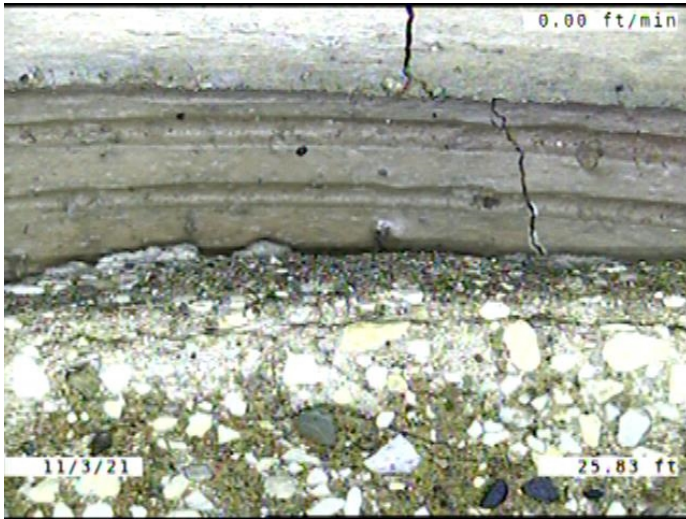
Code: **MMC**  
 Description: **Miscellaneous Material Change**

Distance (ft): **25.8**  
 Structural Grade: **0**  
 O&M Grade: **0**  
 Clock Start/From:  
 Clock To:  
 1st Value:  
 2nd Value:  
 Value Percent:  
 Continuous Index:  
 Within 8" of Joint: **NO**  
 Remarks: **VCP TO CONCRETE**

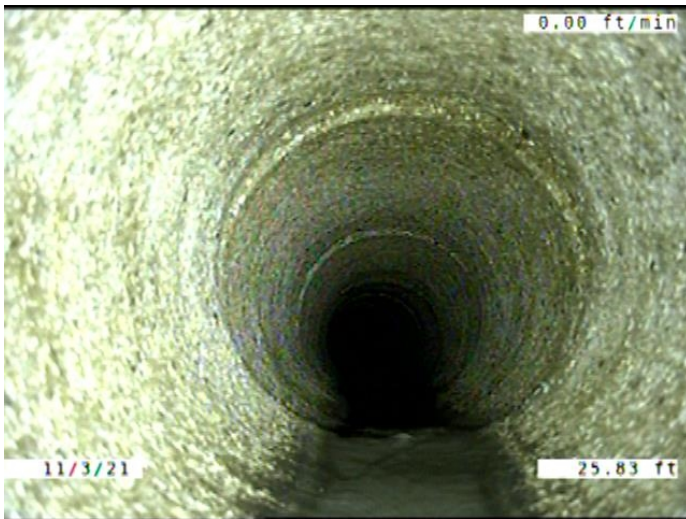
Code: **CM**  
 Description: **Crack Multiple**

Distance (ft): **25.8**  
 Structural Grade: **3**  
 O&M Grade: **0**  
 Clock Start/From: **8**  
 Clock To: **4**  
 1st Value:  
 2nd Value:  
 Value Percent:  
 Continuous Index: **F01**  
 Within 8" of Joint: **YES**  
 Remarks:

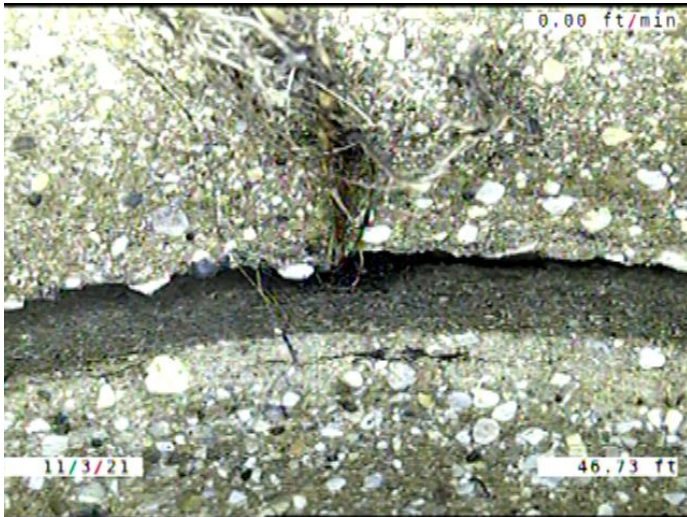
Code: **RFJ**  
 Description: **Roots Fine Joint**

Distance (ft): **46.7**  
 Structural Grade: **0**  
 O&M Grade: **1**  
 Clock Start/From: **9**  
 Clock To: **11**  
 1st Value:  
 2nd Value:  
 Value Percent:  
 Continuous Index:  
 Within 8" of Joint: **YES**  
 Remarks:

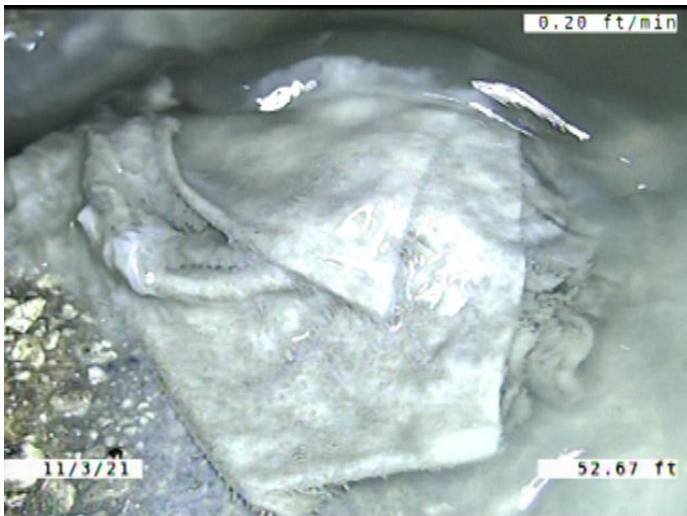
Code: **DAR**  
 Description: **Deposits Attached Ragging**

Distance (ft): **52.7**  
 Structural Grade: **0**  
 O&M Grade: **2**  
 Clock Start/From: **7**  
 Clock To:  
 1st Value:  
 2nd Value:  
 Value Percent: **5.000**  
 Continuous Index:  
 Within 8" of Joint: **YES**  
 Remarks:

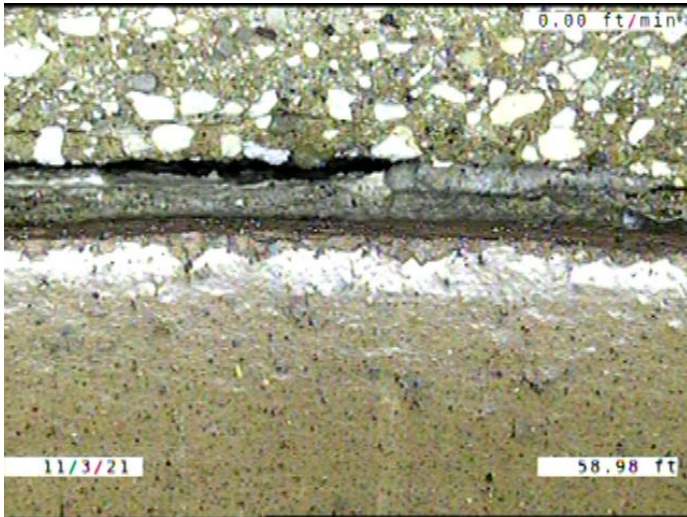
Code: **MMC**  
 Description: **Miscellaneous Material Change**

Distance (ft): **59.0**  
 Structural Grade: **0**  
 O&M Grade: **0**  
 Clock Start/From:  
 Clock To:  
 1st Value:  
 2nd Value:  
 Value Percent:  
 Continuous Index:  
 Within 8" of Joint: **NO**  
 Remarks: **CONCRETE TO VCP**

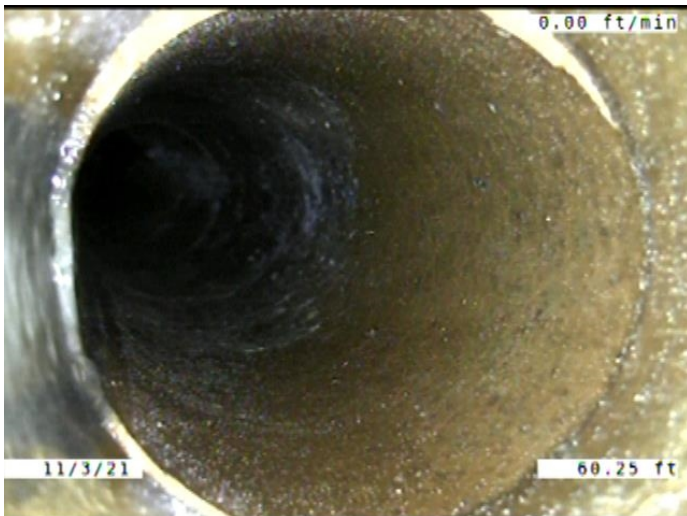
Code: **TF**  
 Description: **Tap Factory**

Distance (ft): **60.3**  
 Structural Grade: **0**  
 O&M Grade: **0**  
 Clock Start/From: **10**  
 Clock To:  
 1st Value: **4.000**  
 2nd Value:  
 Value Percent:  
 Continuous Index:  
 Within 8" of Joint: **YES**  
 Remarks: **CONSTANTLY RUNNING WATER**

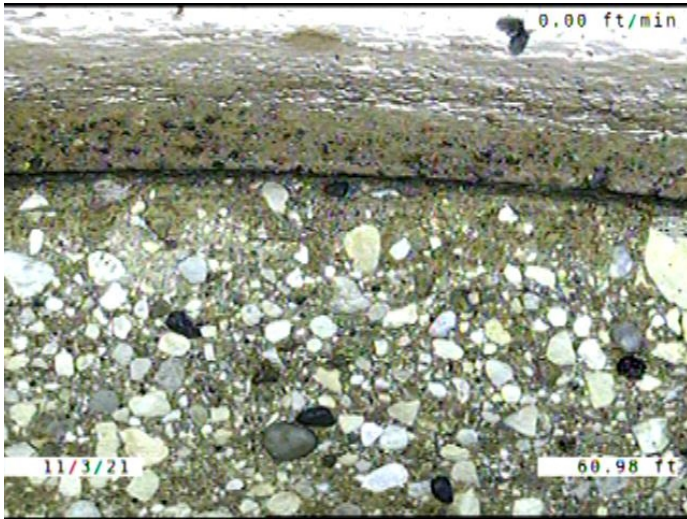
Code: **MMC**  
 Description: **Miscellaneous Material Change**

Distance (ft): **61.0**  
 Structural Grade: **0**  
 O&M Grade: **0**  
 Clock Start/From:  
 Clock To:  
 1st Value:  
 2nd Value:  
 Value Percent:  
 Continuous Index:  
 Within 8" of Joint: **NO**  
 Remarks: **VCP TO CONCRETE**

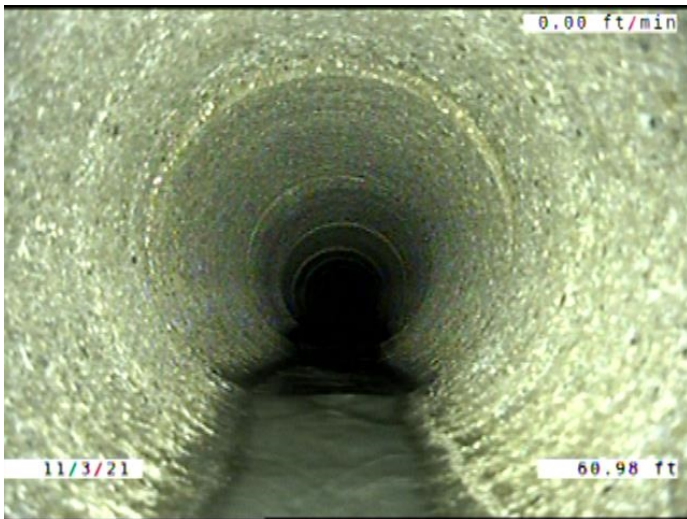
Code: **MWL**  
 Description: **Miscellaneous Water Level**

Distance (ft): **61.0**  
 Structural Grade: **0**  
 O&M Grade: **0**  
 Clock Start/From:  
 Clock To:  
 1st Value:  
 2nd Value:  
 Value Percent: **5.000**  
 Continuous Index:  
 Within 8" of Joint: **NO**  
 Remarks:

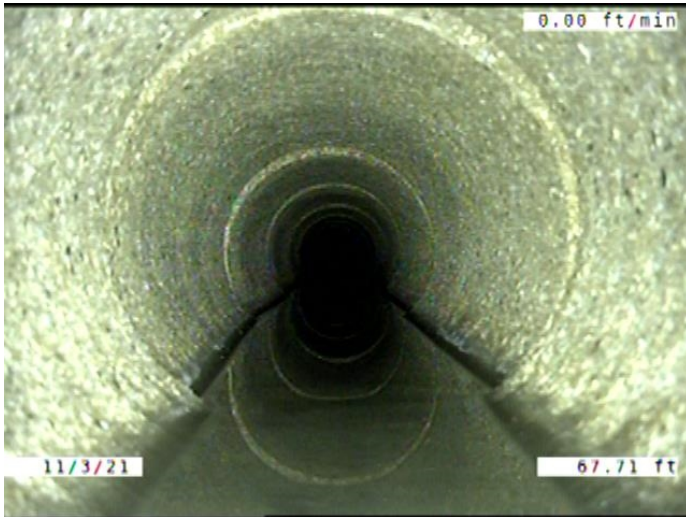
Code: **MWLS**  
Description: **Miscellaneous Water Level Sag**

Distance (ft): **67.7**  
Structural Grade: **2**  
O&M Grade: **0**  
Clock Start/From:  
Clock To:  
1st Value:  
2nd Value:  
Value Percent: **5.000**  
Continuous Index: **S02**  
Within 8" of Joint: **NO**  
Remarks:

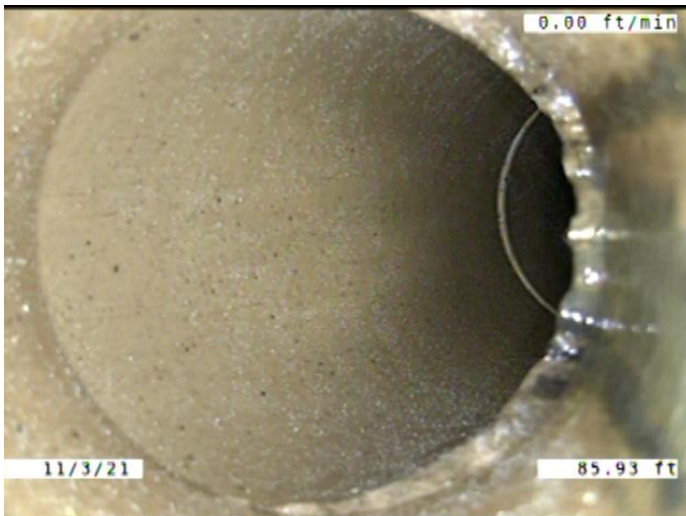
Code: **TB**  
Description: **Tap Break-in/Hammer**

Distance (ft): **85.9**  
Structural Grade: **0**  
O&M Grade: **0**  
Clock Start/From: **2**  
Clock To:  
1st Value: **4.000**  
2nd Value:  
Value Percent:  
Continuous Index:  
Within 8" of Joint: **YES**  
Remarks: **CONSTANTLY RUNNING WATER**

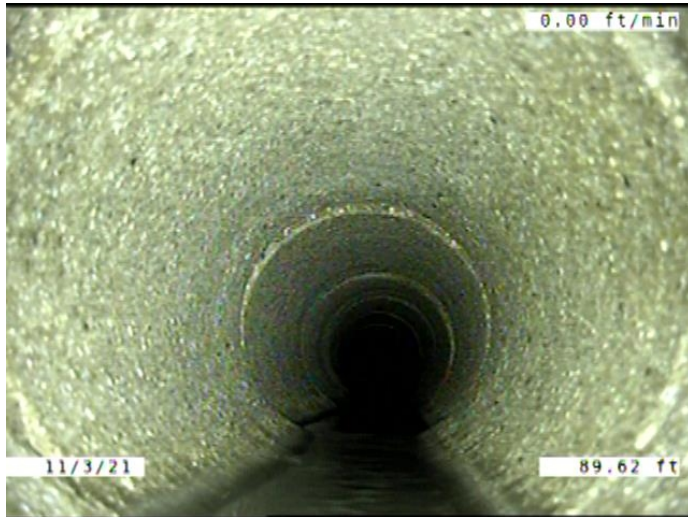
Code: **MWLS**  
Description: **Miscellaneous Water Level Sag**

Distance (ft): **89.6**  
Structural Grade: **2**  
O&M Grade: **0**  
Clock Start/From:  
Clock To:  
1st Value:  
2nd Value:  
Value Percent: **5.000**  
Continuous Index: **F02**  
Within 8" of Joint: **NO**  
Remarks:

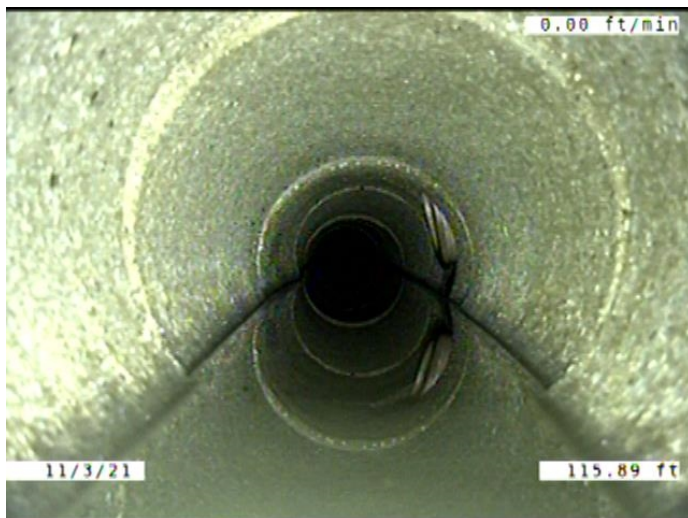
Code: **MWLS**  
Description: **Miscellaneous Water Level Sag**

Distance (ft): **115.9**  
Structural Grade: **2**  
O&M Grade: **0**  
Clock Start/From:  
Clock To:  
1st Value:  
2nd Value:  
Value Percent: **15.000**  
Continuous Index: **S03**  
Within 8" of Joint: **NO**  
Remarks:

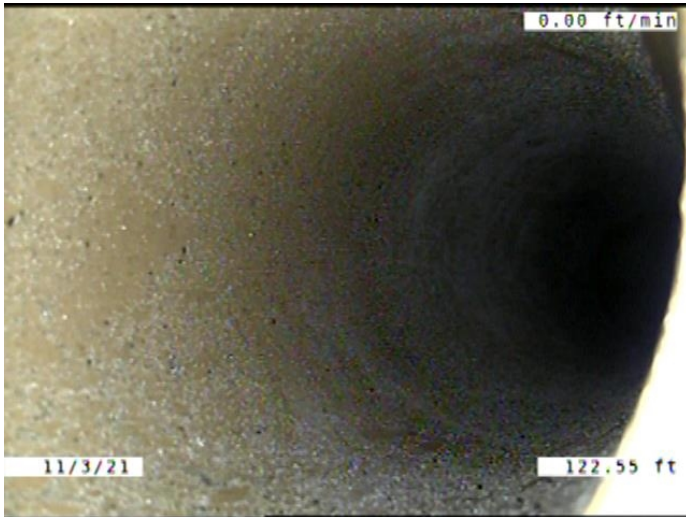
Code:	<b>TBI</b>
Description:	<b>Tap Break-in Intruding</b>
Distance (ft):	<b>122.5</b>
Structural Grade:	<b>0</b>
O&M Grade:	<b>2</b>
Clock Start/From:	<b>2</b>
Clock To:	
1st Value:	<b>4.000</b>
2nd Value:	<b>1.000</b>
Value Percent:	
Continuous Index:	
Within 8" of Joint:	<b>YES</b>
Remarks:

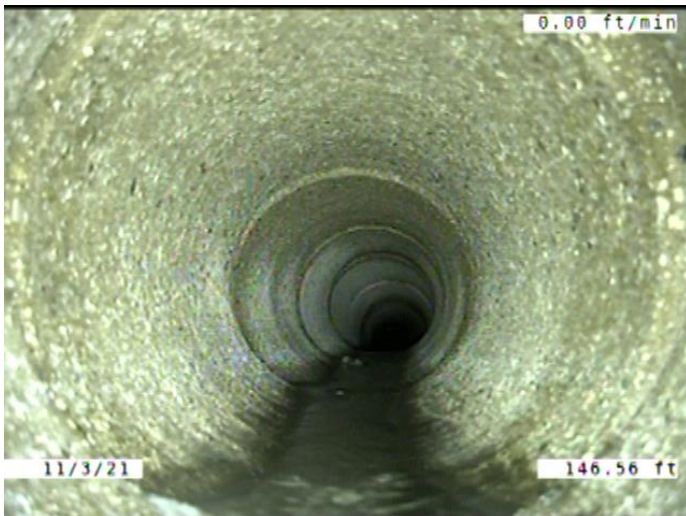
Code:	<b>MWLS</b>
Description:	<b>Miscellaneous Water Level Sag</b>
Distance (ft):	<b>146.6</b>
Structural Grade:	<b>2</b>
O&M Grade:	<b>0</b>
Clock Start/From:	
Clock To:	
1st Value:	
2nd Value:	
Value Percent:	<b>15.000</b>
Continuous Index:	<b>F03</b>
Within 8" of Joint:	<b>NO</b>
Remarks:

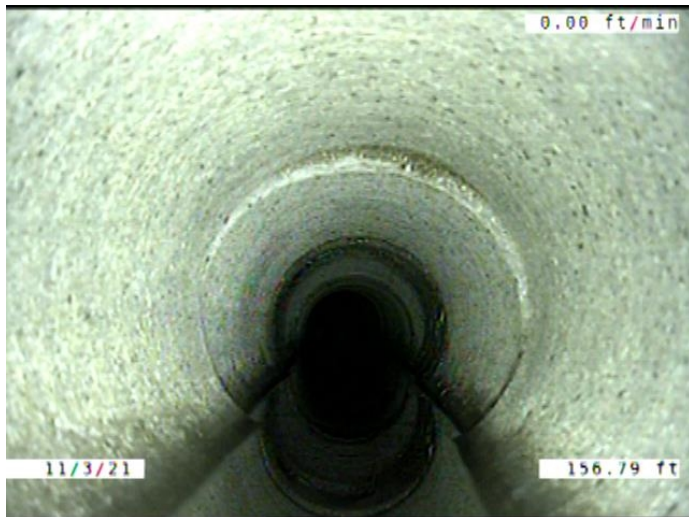
Code: **MWLS**  
 Description: **Miscellaneous Water Level Sag**

Distance (ft): **156.8**  
 Structural Grade: **2**  
 O&M Grade: **0**  
 Clock Start/From:  
 Clock To:  
 1st Value:  
 2nd Value:  
 Value Percent: **10.000**  
 Continuous Index: **S04**  
 Within 8" of Joint: **NO**  
 Remarks:

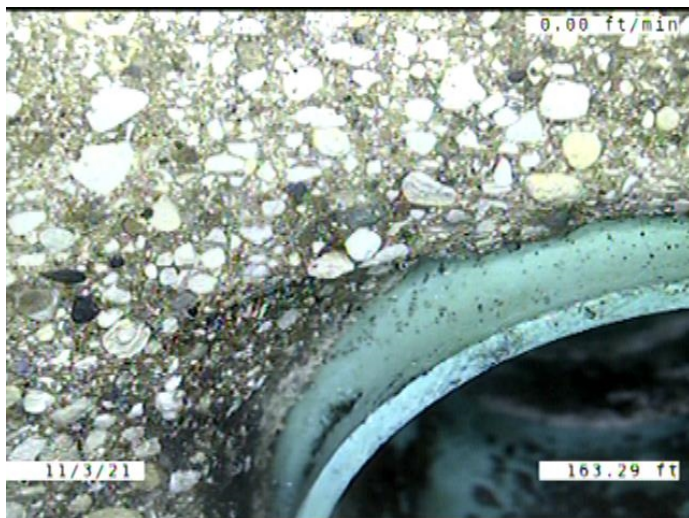
Code: **B**  
 Description: **Broken**

Distance (ft): **163.3**  
 Structural Grade: **4**  
 O&M Grade: **0**  
 Clock Start/From: **11**  
 Clock To:  
 1st Value:  
 2nd Value:  
 Value Percent:  
 Continuous Index:  
 Within 8" of Joint: **YES**  
 Remarks:

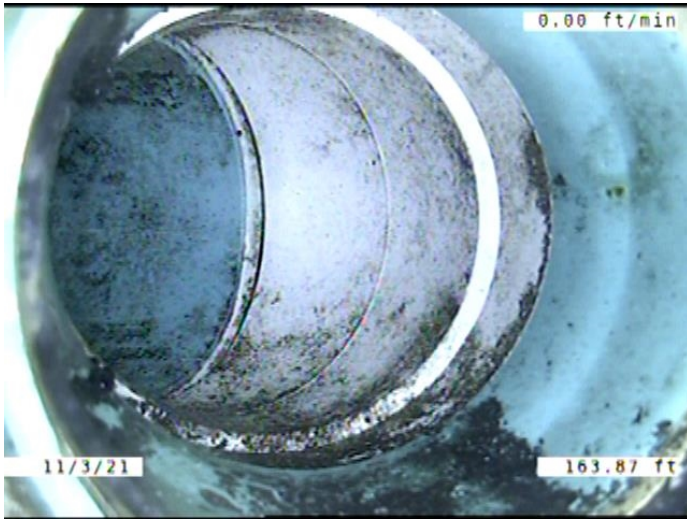
Code: **TBI**  
Description: **Tap Break-in Intruding**

Distance (ft): **163.9**  
Structural Grade: **0**  
O&M Grade: **2**  
Clock Start/From: **11**  
Clock To:  
1st Value: **4.000**  
2nd Value: **1.000**  
Value Percent:  
Continuous Index:  
Within 8" of Joint: **YES**  
Remarks:

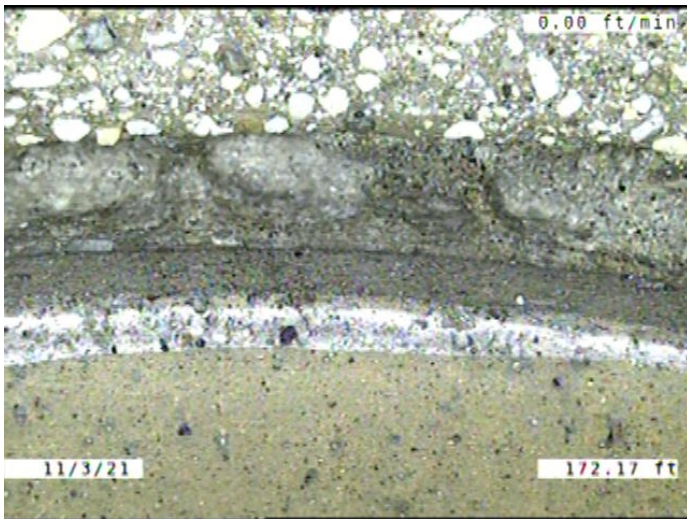
Code: **MMC**  
Description: **Miscellaneous Material Change**

Distance (ft): **172.2**  
Structural Grade: **0**  
O&M Grade: **0**  
Clock Start/From:  
Clock To:  
1st Value:  
2nd Value:  
Value Percent:  
Continuous Index:  
Within 8" of Joint: **NO**  
Remarks: **CONCRETE TO VCP**

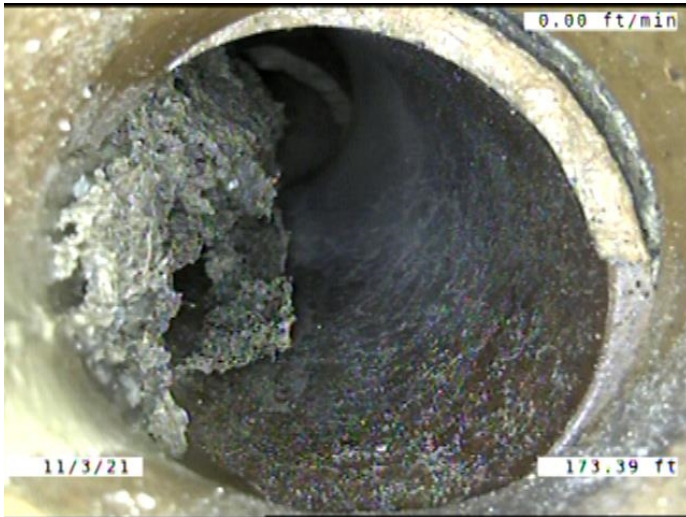
Code: **TFD**  
Description: **Tap Factory Defective**

Distance (ft): **173.4**  
Structural Grade: **0**  
O&M Grade: **3**  
Clock Start/From: **10**  
Clock To:  
1st Value: **4.000**  
2nd Value:  
Value Percent:  
Continuous Index:  
Within 8" of Joint: **YES**  
Remarks: **BROKEN. OFFSET. SOIL VISIBLE**

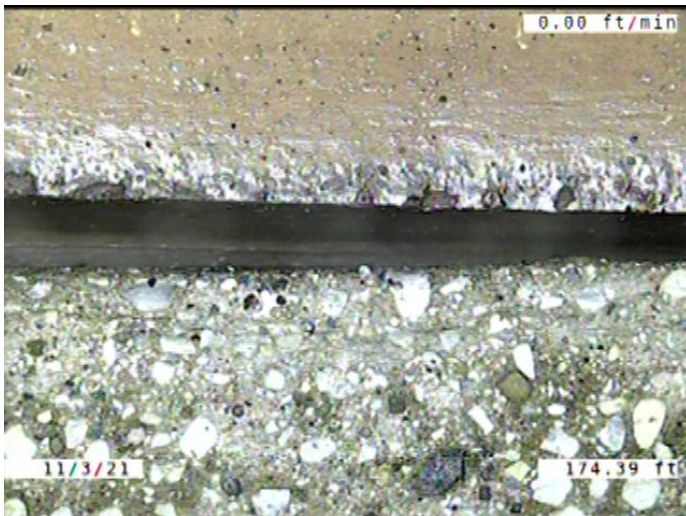
Code: **MMC**  
Description: **Miscellaneous Material Change**

Distance (ft): **174.4**  
Structural Grade: **0**  
O&M Grade: **0**  
Clock Start/From:  
Clock To:  
1st Value:  
2nd Value:  
Value Percent:  
Continuous Index:  
Within 8" of Joint: **NO**  
Remarks: **VCP TO CONCRETE**

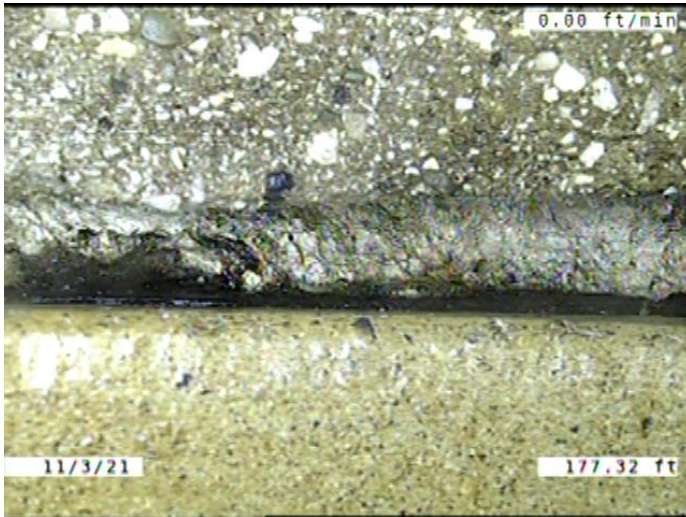
Code: **MMC**  
Description: **Miscellaneous Material Change**

Distance (ft): **177.3**  
Structural Grade: **0**  
O&M Grade: **0**  
Clock Start/From:  
Clock To:  
1st Value:  
2nd Value:  
Value Percent:  
Continuous Index:  
Within 8" of Joint: **NO**  
Remarks: **CONCRETE TO VCP**

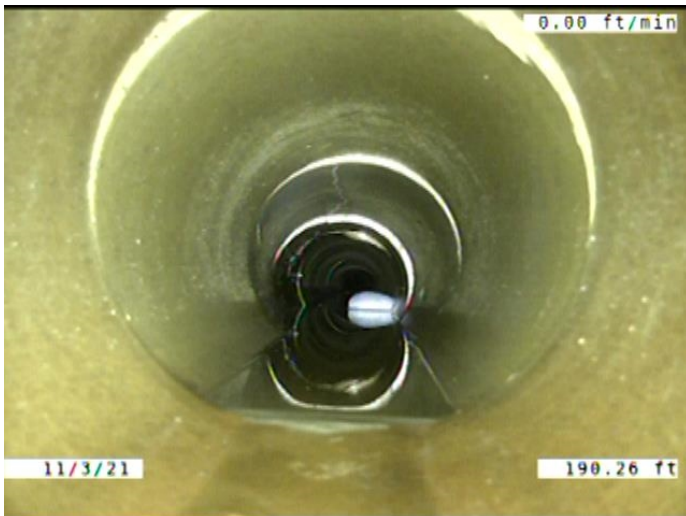
Code: **MWLS**  
Description: **Miscellaneous Water Level Sag**

Distance (ft): **190.3**  
Structural Grade: **2**  
O&M Grade: **0**  
Clock Start/From:  
Clock To:  
1st Value:  
2nd Value:  
Value Percent: **10.000**  
Continuous Index: **F04**  
Within 8" of Joint: **NO**  
Remarks:

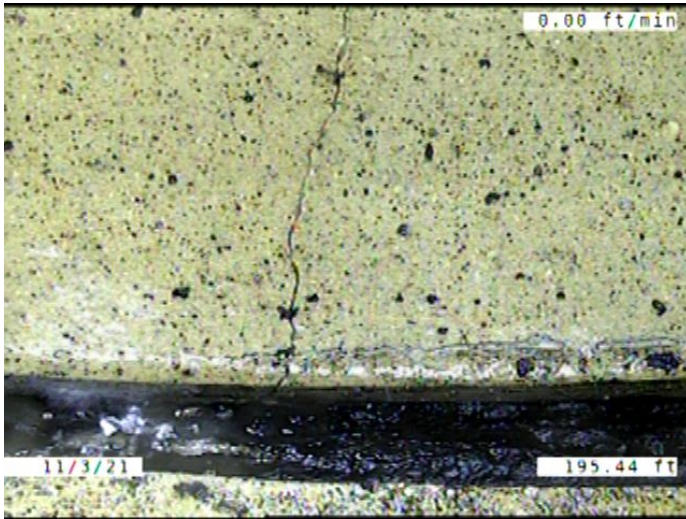
Code: **FM**  
 Description: **Fracture Multiple**

Distance (ft): **195.4**  
 Structural Grade: **4**  
 O&M Grade: **0**  
 Clock Start/From: **8**  
 Clock To: **4**  
 1st Value:  
 2nd Value:  
 Value Percent:  
 Continuous Index: **S05**  
 Within 8" of Joint: **YES**  
 Remarks:

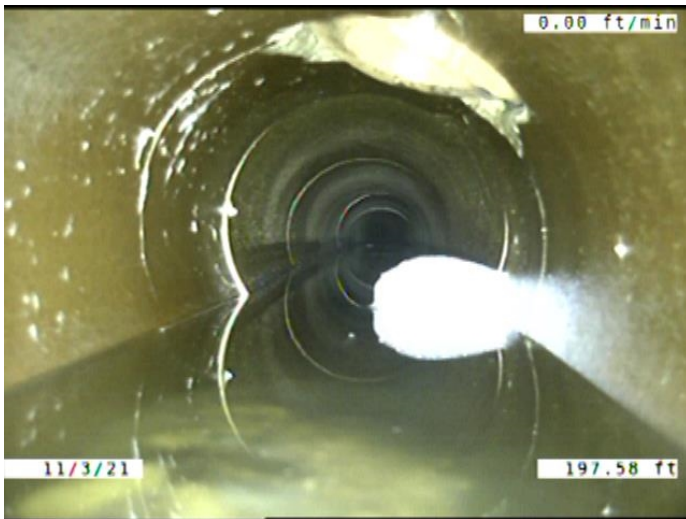
Code: **MWLS**  
 Description: **Miscellaneous Water Level Sag**

Distance (ft): **197.6**  
 Structural Grade: **2**  
 O&M Grade: **0**  
 Clock Start/From:  
 Clock To:  
 1st Value:  
 2nd Value:  
 Value Percent: **15.000**  
 Continuous Index: **S06**  
 Within 8" of Joint: **NO**  
 Remarks:

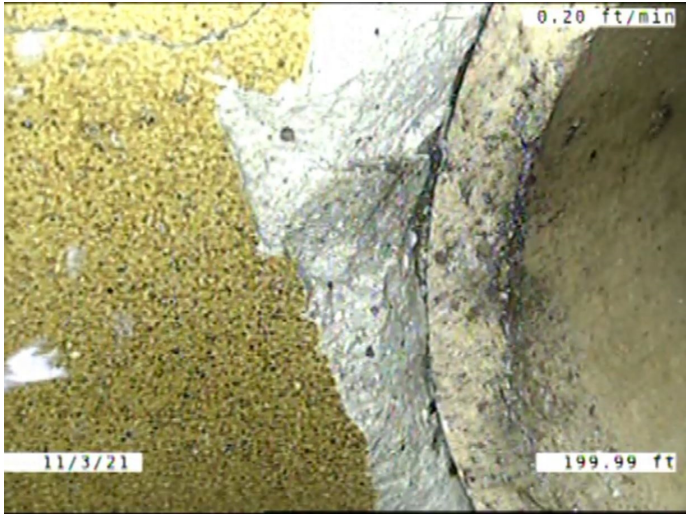
Code: **SSS**  
 Description: **Surface Damage Surface Spalling**

Distance (ft): **200.0**  
 Structural Grade: **2**  
 O&M Grade: **0**  
 Clock Start/From: **12**  
 Clock To: **2**  
 1st Value:  
 2nd Value:  
 Value Percent:  
 Continuous Index:  
 Within 8" of Joint: **NO**  
 Remarks:

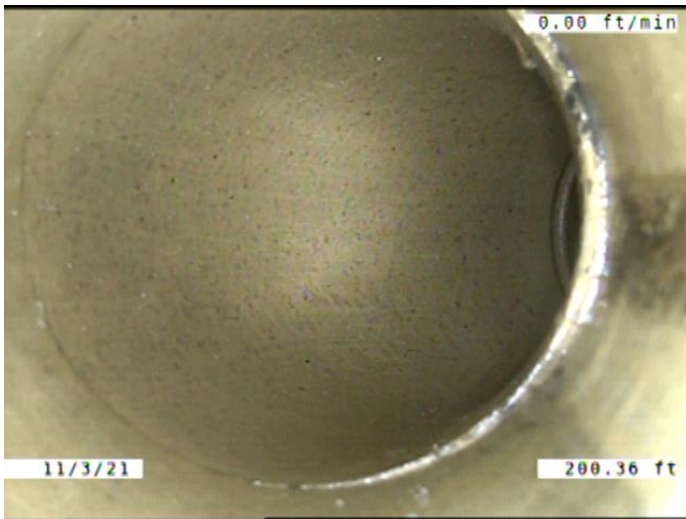
Code: **TBI**  
 Description: **Tap Break-in Intruding**

Distance (ft): **200.4**  
 Structural Grade: **0**  
 O&M Grade: **2**  
 Clock Start/From: **1**  
 Clock To:  
 1st Value: **4.000**  
 2nd Value: **1.000**  
 Value Percent:  
 Continuous Index:  
 Within 8" of Joint: **YES**  
 Remarks:

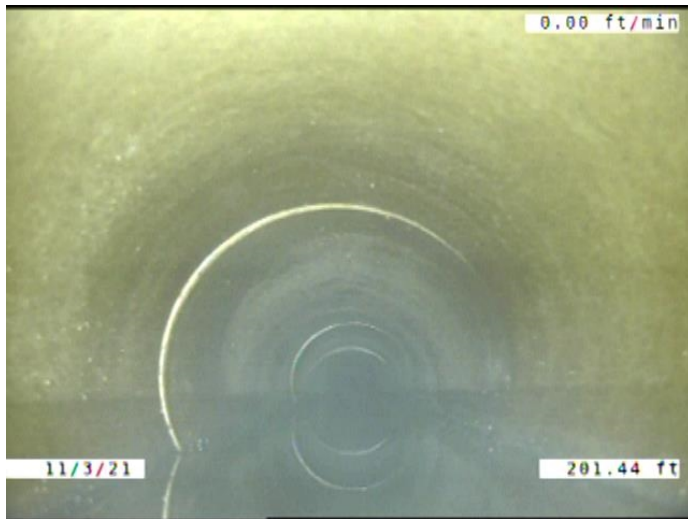
Code: **FM**  
Description: **Fracture Multiple**

Distance (ft): **201.4**  
Structural Grade: **4**  
O&M Grade: **0**  
Clock Start/From: **8**  
Clock To: **4**  
1st Value:  
2nd Value:  
Value Percent:  
Continuous Index: **F05**  
Within 8" of Joint: **YES**  
Remarks:

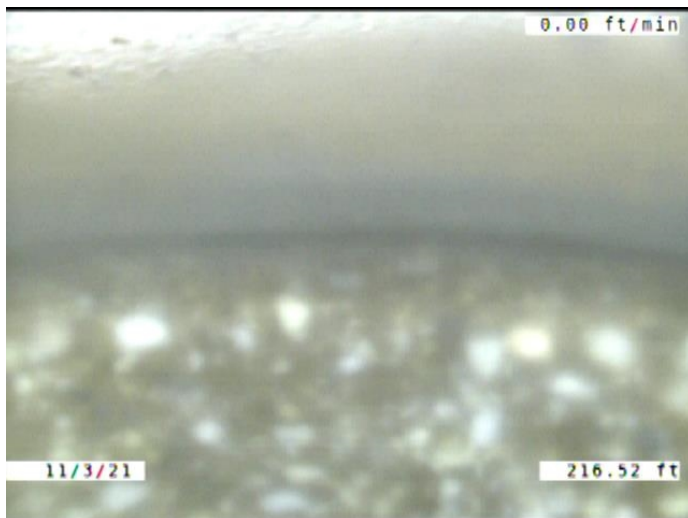
Code: **MMC**  
Description: **Miscellaneous Material Change**

Distance (ft): **216.5**  
Structural Grade: **0**  
O&M Grade: **0**  
Clock Start/From:  
Clock To:  
1st Value:  
2nd Value:  
Value Percent:  
Continuous Index:  
Within 8" of Joint: **NO**  
Remarks: **VCP TO CONCRETE**

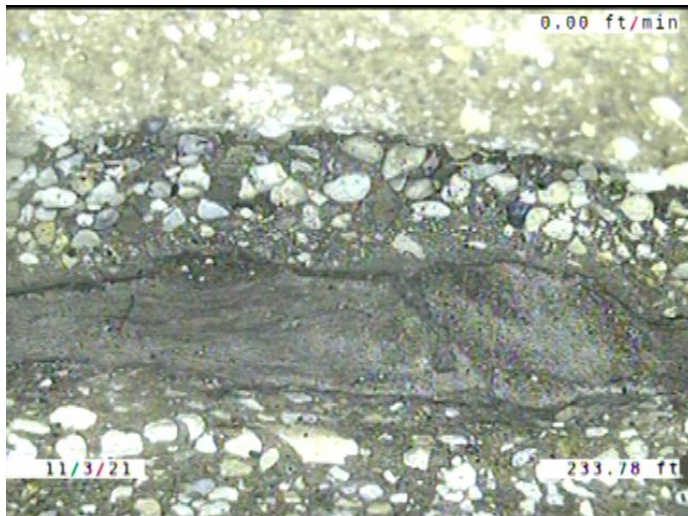
Code: **SMW**  
 Description: **Surface Damage Missing Wall**

Distance (ft): **233.8**  
 Structural Grade: **5**  
 O&M Grade: **0**  
 Clock Start/From: **12**  
 Clock To: **2**  
 1st Value:  
 2nd Value:  
 Value Percent:  
 Continuous Index:  
 Within 8" of Joint: **YES**  
 Remarks: **INSIDE OF THE JOINT**

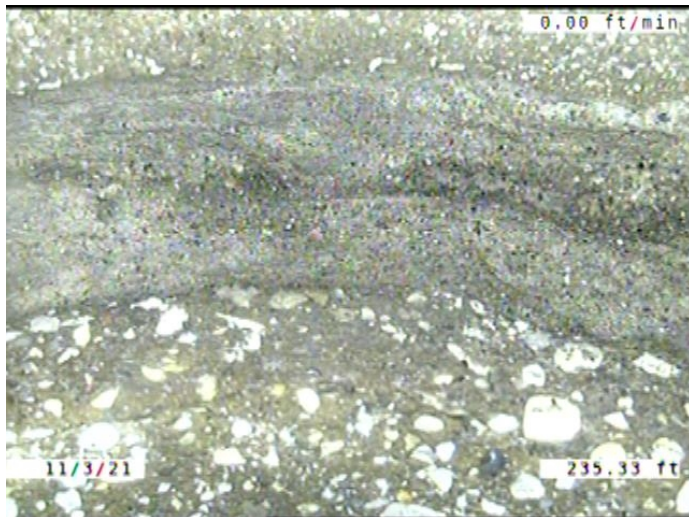
Code: **JOMD**  
 Description: **Joint Offset Medium Defective**

Distance (ft): **235.3**  
 Structural Grade: **3**  
 O&M Grade: **0**  
 Clock Start/From:  
 Clock To:  
 1st Value:  
 2nd Value:  
 Value Percent:  
 Continuous Index:  
 Within 8" of Joint: **NO**  
 Remarks:

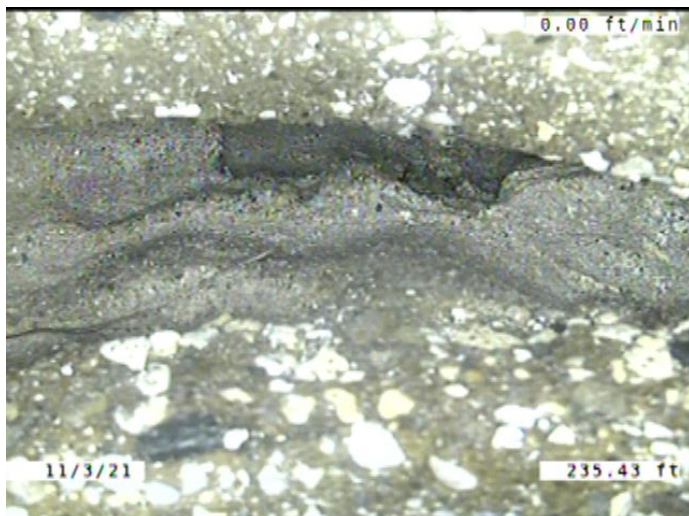
Code: **BSV**  
 Description: **Broken Soil Visible**

Distance (ft): **235.4**  
 Structural Grade: **5**  
 O&M Grade: **0**  
 Clock Start/From: **1**  
 Clock To: **2**  
 1st Value:  
 2nd Value:  
 Value Percent:  
 Continuous Index:  
 Within 8" of Joint: **YES**  
 Remarks:

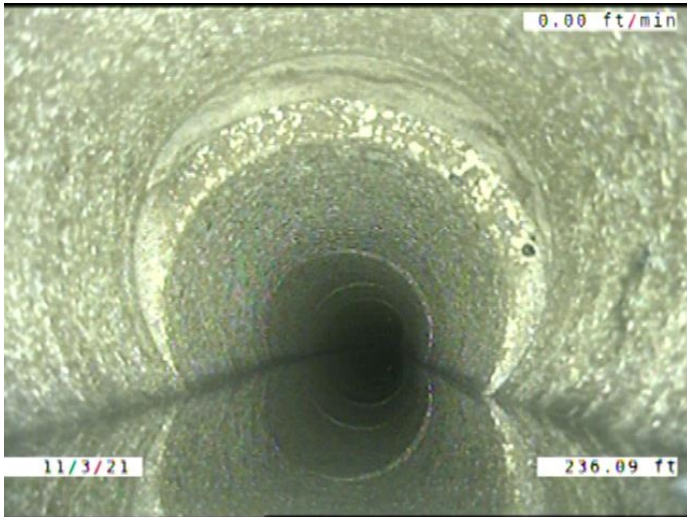
Code: **MSC**  
 Description: **Miscellaneous Shape/Size Change**

Distance (ft): **236.1**  
 Structural Grade: **0**  
 O&M Grade: **0**  
 Clock Start/From:  
 Clock To:  
 1st Value: **10.000**  
 2nd Value:  
 Value Percent:  
 Continuous Index:  
 Within 8" of Joint: **NO**  
 Remarks:

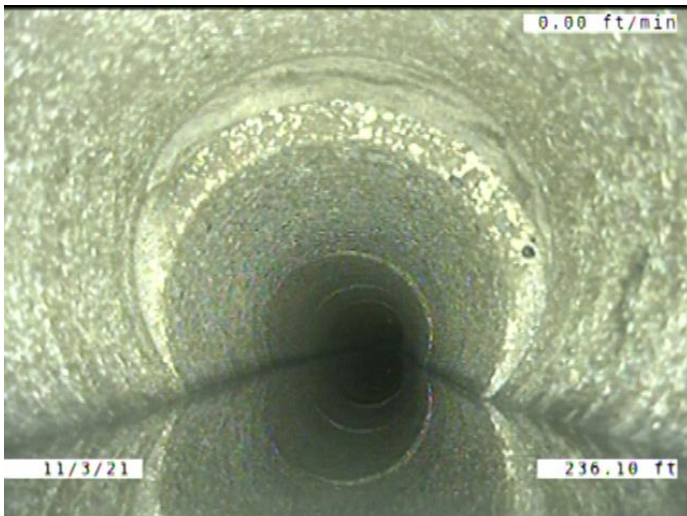
Code: **MSA**  
 Description: **Miscellaneous Survey Abandoned**

Distance (ft): **236.1**  
 Structural Grade: **0**  
 O&M Grade: **0**  
 Clock Start/From:  
 Clock To:  
 1st Value:  
 2nd Value:  
 Value Percent:  
 Continuous Index:  
 Within 8" of Joint: **NO**  
 Remarks: **CAMERA CANT FIT INTO 10" PIPE.**
