Profile/Photo Observation Report

Date:	11/03/2021	Weather:		Coding:	PACP 7.0
Pipe Length (ft):	291.0	Owner:	City of Hobart	Pre Clean:	Heavy Cleaning
P.O.#:	YES502259	Surveyor:	S. Bucklin	PSR:	P-405-068-002
Customer:	City of Hobart	Clean Date:	10/29/2021	Shape:	C

Street:	South Wabash Street	Flow Control:	Not Controlled
City:	Hobart, IN	Year Renewed:	
Location:	Alley	Tape/Media #:	
Purpose:	Routine Assessment	Dia/Height:	12"
Use:	Sanitary Sewage Pipe	Material:	VCP
Drain Area:		Lining:	None
Category:	NA		
Comment:			
Location Details:		Direction of Survey:	Upstream
US MH:	M-404-002	DS MH:	M-405-068
		Total Length Surveyed (ft):	236.1

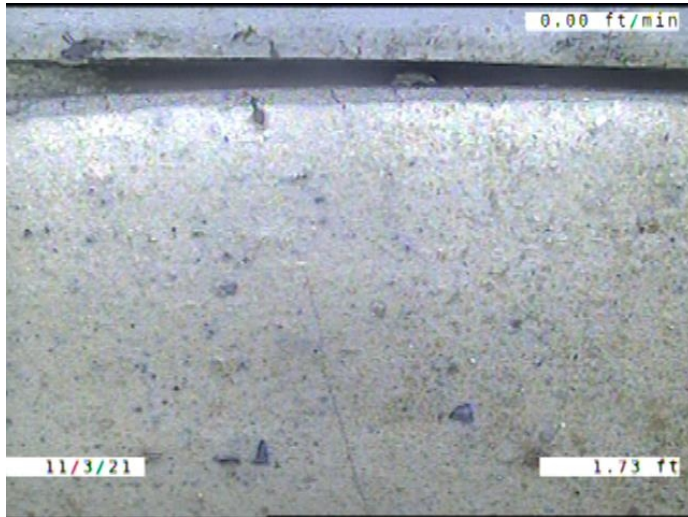
Code: **CL**
Description: **Crack Longitudinal**

Distance (ft): **1.7**
Structural Grade: **2**
O&M Grade: **0**
Clock Start/From: **11**
Clock To:
1st Value:
2nd Value:
Value Percent:
Continuous Index:
Within 8" of Joint: **YES**
Remarks:

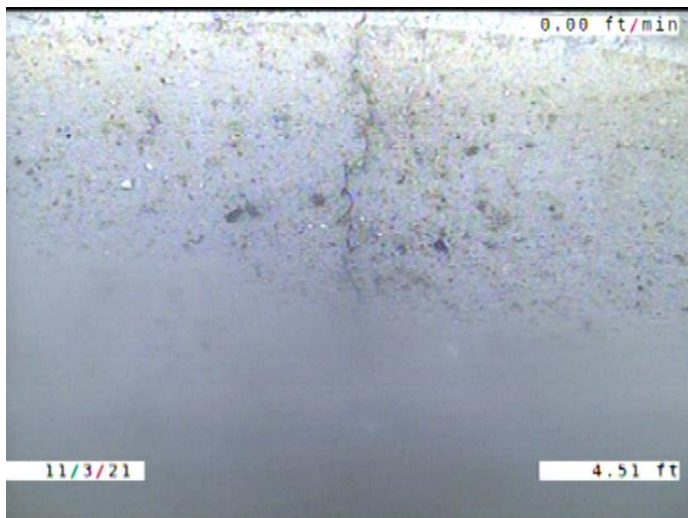
Code: **CL**
Description: **Crack Longitudinal**

Distance (ft): **4.5**
Structural Grade: **2**
O&M Grade: **0**
Clock Start/From: **1**
Clock To:
1st Value:
2nd Value:
Value Percent:
Continuous Index:
Within 8" of Joint: **YES**
Remarks:

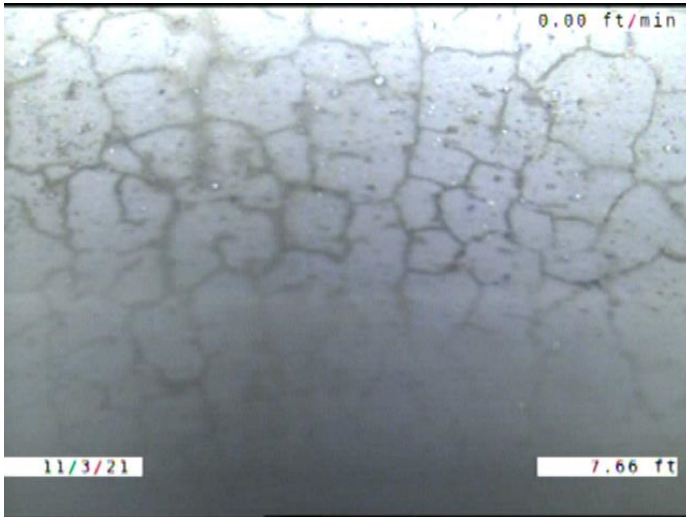
Code: **CM**
Description: **Crack Multiple**

Distance (ft): **7.7**
Structural Grade: **3**
O&M Grade: **0**
Clock Start/From: **8**
Clock To: **4**
1st Value:
2nd Value:
Value Percent:
Continuous Index: **S01**
Within 8" of Joint: **YES**
Remarks:

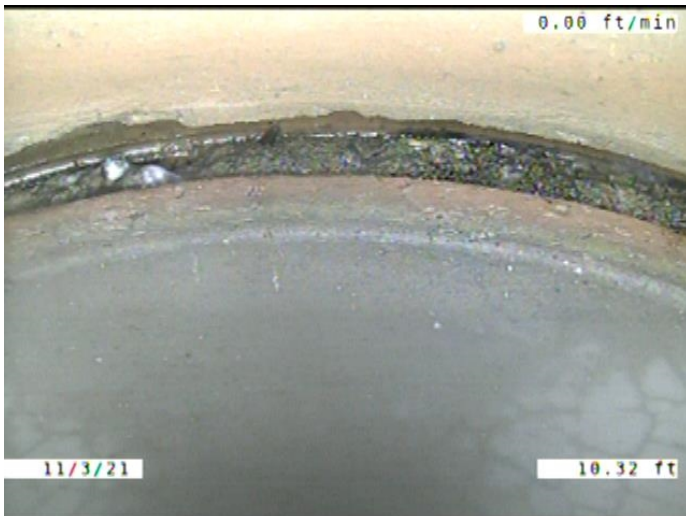
Code: **JOM**
Description: **Joint Offset Medium**

Distance (ft): **10.3**
Structural Grade: **3**
O&M Grade: **0**
Clock Start/From:
Clock To:
1st Value:
2nd Value:
Value Percent:
Continuous Index:
Within 8" of Joint: **NO**
Remarks:

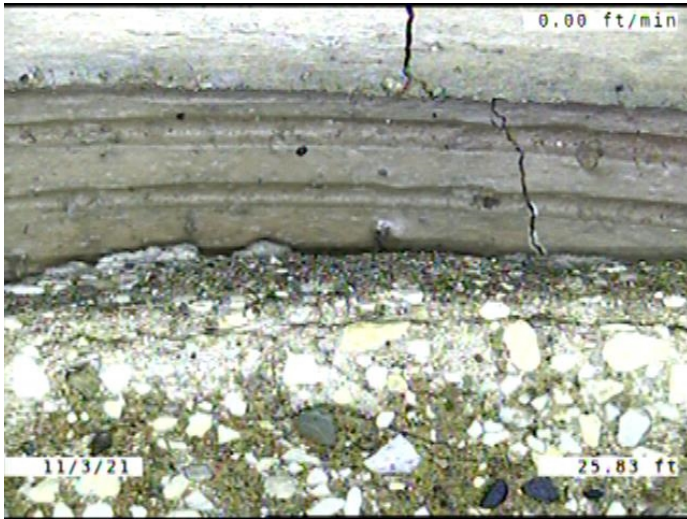
Code: **MMC**
 Description: **Miscellaneous Material Change**

Distance (ft): **25.8**
 Structural Grade: **0**
 O&M Grade: **0**
 Clock Start/From:
 Clock To:
 1st Value:
 2nd Value:
 Value Percent:
 Continuous Index:
 Within 8" of Joint: **NO**
 Remarks: **VCP TO CONCRETE**

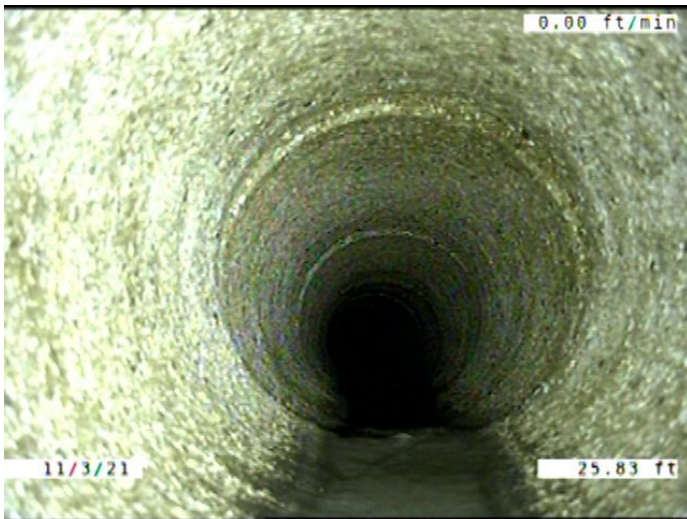
Code: **CM**
 Description: **Crack Multiple**

Distance (ft): **25.8**
 Structural Grade: **3**
 O&M Grade: **0**
 Clock Start/From: **8**
 Clock To: **4**
 1st Value:
 2nd Value:
 Value Percent:
 Continuous Index: **F01**
 Within 8" of Joint: **YES**
 Remarks:

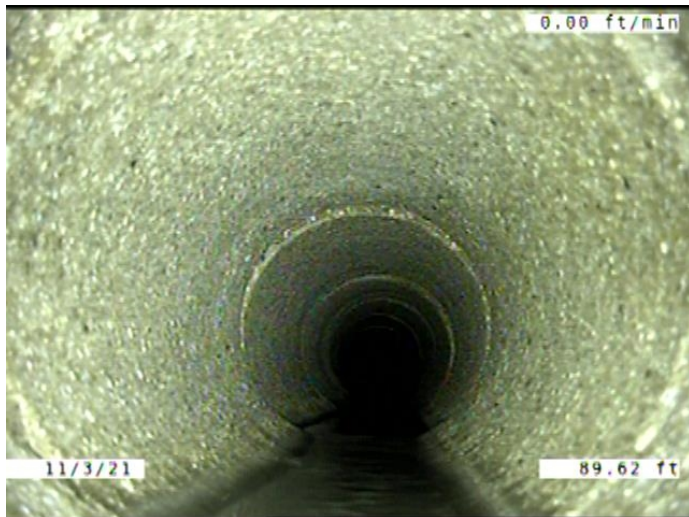
Code: **MWLS**
 Description: **Miscellaneous Water Level Sag**

Distance (ft): **89.6**
 Structural Grade: **2**
 O&M Grade: **0**
 Clock Start/From:
 Clock To:
 1st Value:
 2nd Value:
 Value Percent: **5.000**
 Continuous Index: **F02**
 Within 8" of Joint: **NO**
 Remarks:

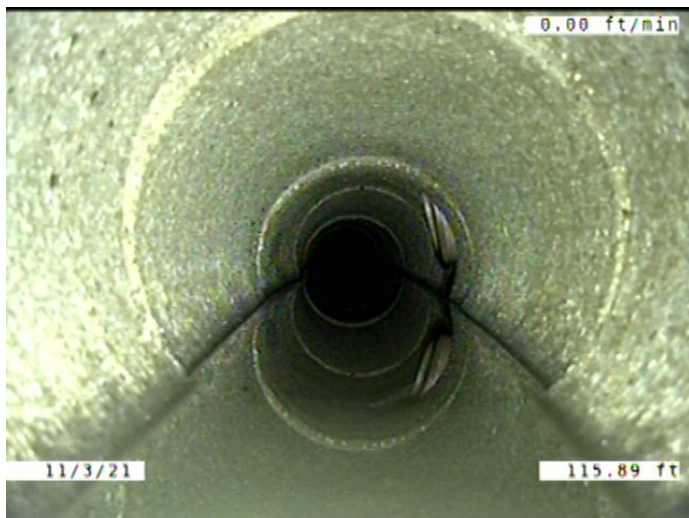
Code: **MWLS**
 Description: **Miscellaneous Water Level Sag**

Distance (ft): **115.9**
 Structural Grade: **2**
 O&M Grade: **0**
 Clock Start/From:
 Clock To:
 1st Value:
 2nd Value:
 Value Percent: **15.000**
 Continuous Index: **S03**
 Within 8" of Joint: **NO**
 Remarks:

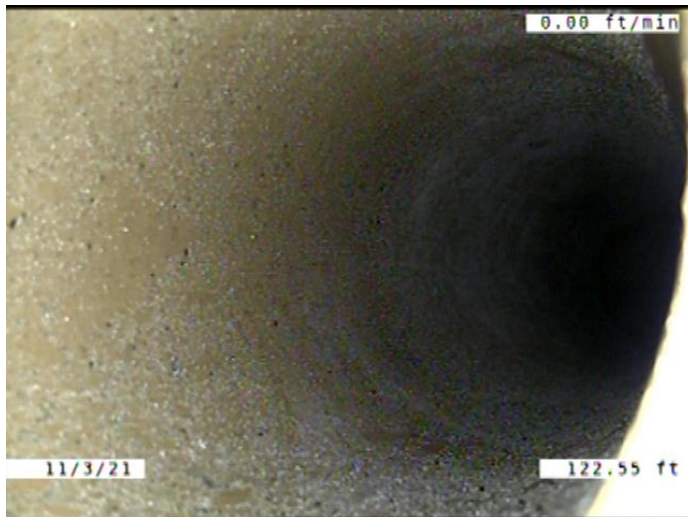
Code: **TBI**
 Description: **Tap Break-in Intruding**

Distance (ft): **122.5**
 Structural Grade: **0**
 O&M Grade: **2**
 Clock Start/From: **2**
 Clock To:
 1st Value: **4.000**
 2nd Value: **1.000**
 Value Percent:
 Continuous Index:
 Within 8" of Joint: **YES**
 Remarks:

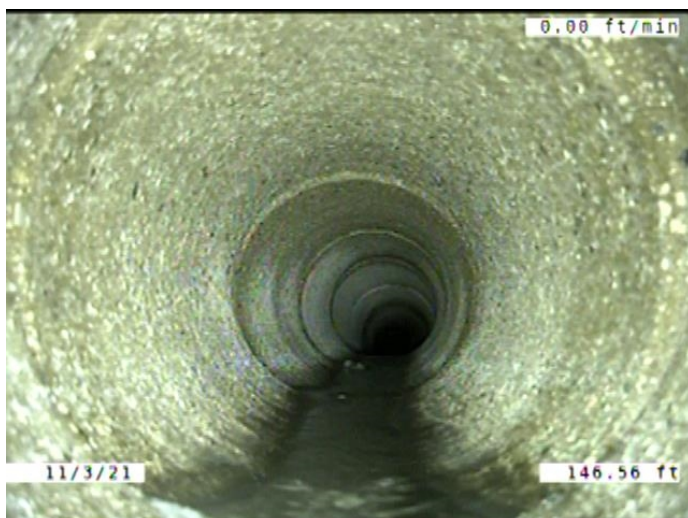
Code: **MWLS**
 Description: **Miscellaneous Water Level Sag**

Distance (ft): **146.6**
 Structural Grade: **2**
 O&M Grade: **0**
 Clock Start/From:
 Clock To:
 1st Value:
 2nd Value:
 Value Percent: **15.000**
 Continuous Index: **F03**
 Within 8" of Joint: **NO**
 Remarks:

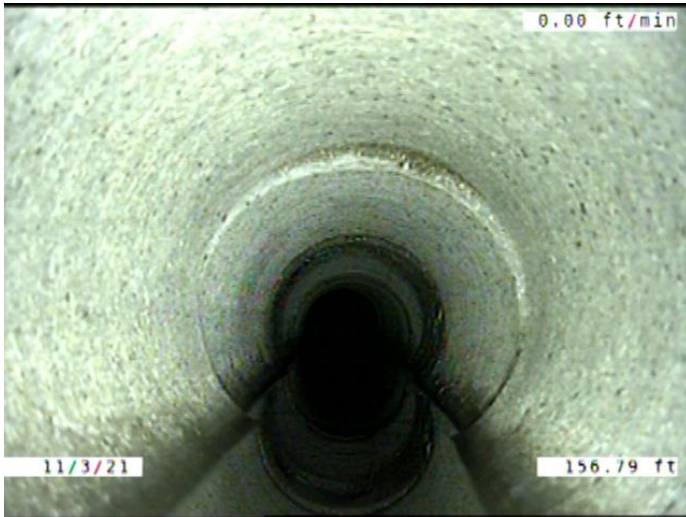
Code: **MWLS**
 Description: **Miscellaneous Water Level Sag**

Distance (ft): **156.8**
 Structural Grade: **2**
 O&M Grade: **0**
 Clock Start/From:
 Clock To:
 1st Value:
 2nd Value:
 Value Percent: **10.000**
 Continuous Index: **S04**
 Within 8" of Joint: **NO**
 Remarks:

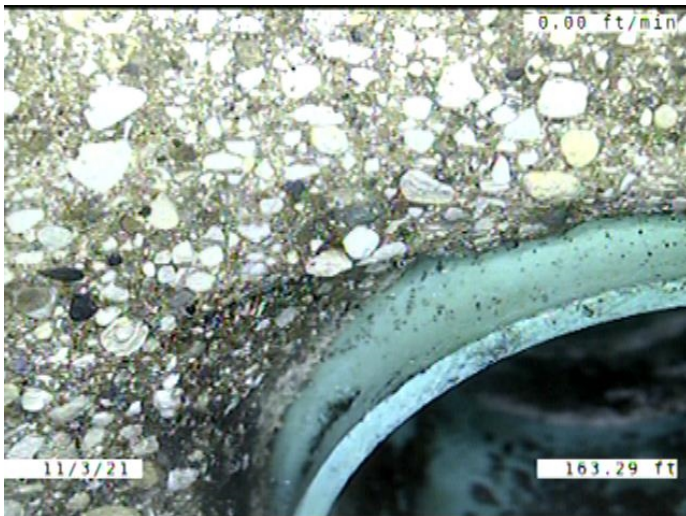
Code: **B**
 Description: **Broken**

Distance (ft): **163.3**
 Structural Grade: **4**
 O&M Grade: **0**
 Clock Start/From: **11**
 Clock To:
 1st Value:
 2nd Value:
 Value Percent:
 Continuous Index:
 Within 8" of Joint: **YES**
 Remarks:

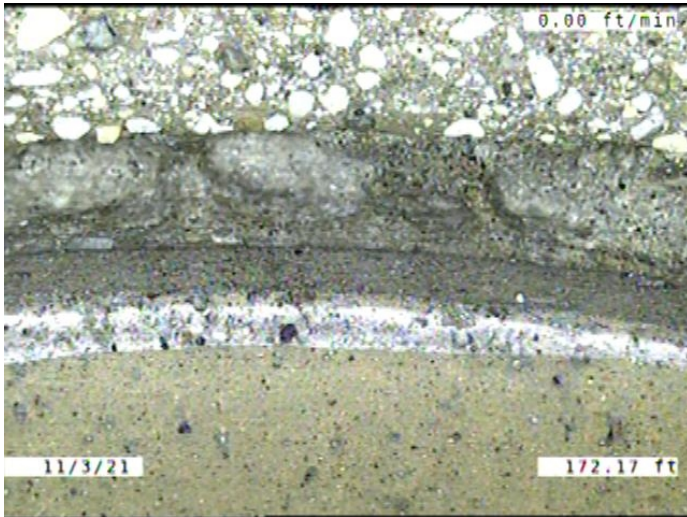
Code: **MMC**
 Description: **Miscellaneous Material Change**

Distance (ft): **172.2**
 Structural Grade: **0**
 O&M Grade: **0**
 Clock Start/From:
 Clock To:
 1st Value:
 2nd Value:
 Value Percent:
 Continuous Index:
 Within 8" of Joint: **NO**
 Remarks: **CONCRETE TO VCP**

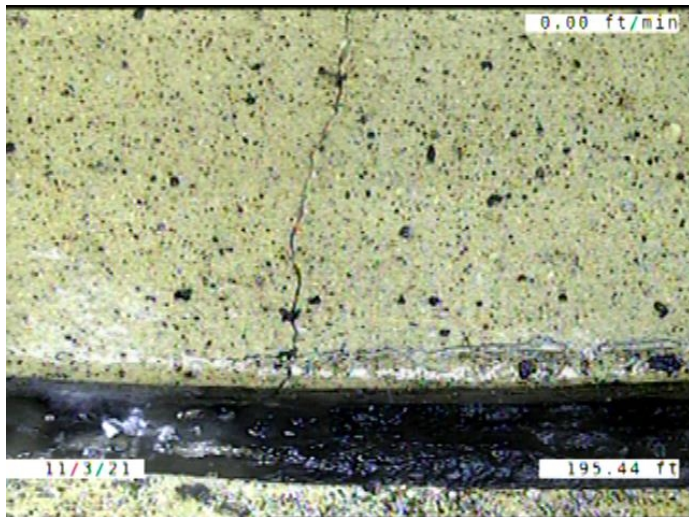
Code: **FM**
 Description: **Fracture Multiple**

Distance (ft): **195.4**
 Structural Grade: **4**
 O&M Grade: **0**
 Clock Start/From: **8**
 Clock To: **4**
 1st Value:
 2nd Value:
 Value Percent:
 Continuous Index: **S05**
 Within 8" of Joint: **YES**
 Remarks:

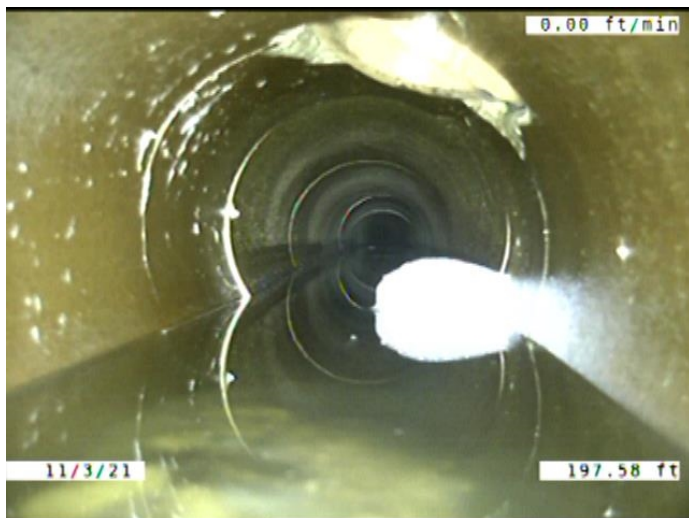
Code: **MWLS**
 Description: **Miscellaneous Water Level Sag**

Distance (ft): **197.6**
 Structural Grade: **2**
 O&M Grade: **0**
 Clock Start/From:
 Clock To:
 1st Value:
 2nd Value:
 Value Percent: **15.000**
 Continuous Index: **S06**
 Within 8" of Joint: **NO**
 Remarks:

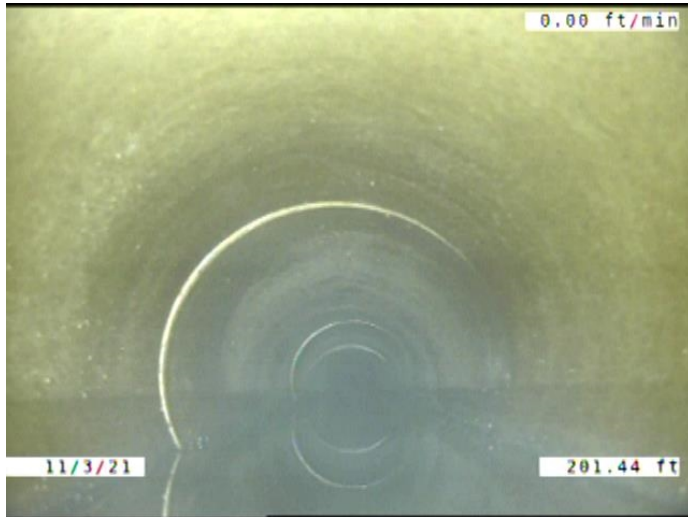
Code: **FM**
Description: **Fracture Multiple**

Distance (ft): **201.4**
Structural Grade: **4**
O&M Grade: **0**
Clock Start/From: **8**
Clock To: **4**
1st Value:
2nd Value:
Value Percent:
Continuous Index: **F05**
Within 8" of Joint: **YES**
Remarks:

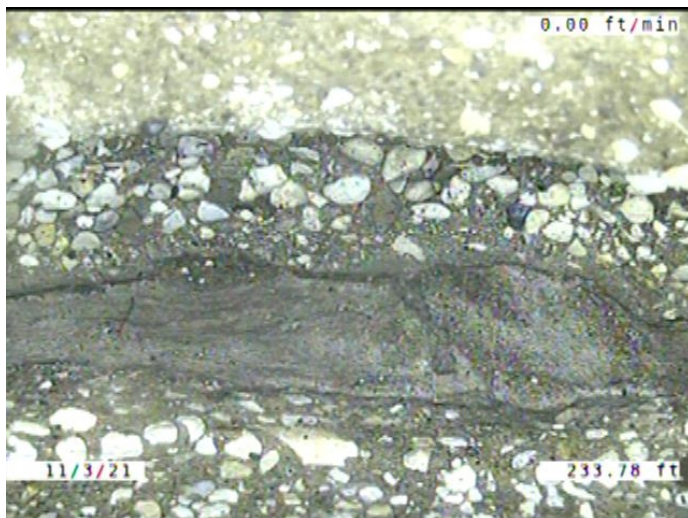
Code: **SMW**
Description: **Surface Damage Missing Wall**

Distance (ft): **233.8**
Structural Grade: **5**
O&M Grade: **0**
Clock Start/From: **12**
Clock To: **2**
1st Value:
2nd Value:
Value Percent:
Continuous Index:
Within 8" of Joint: **YES**
Remarks: **INSIDE OF THE JOINT**

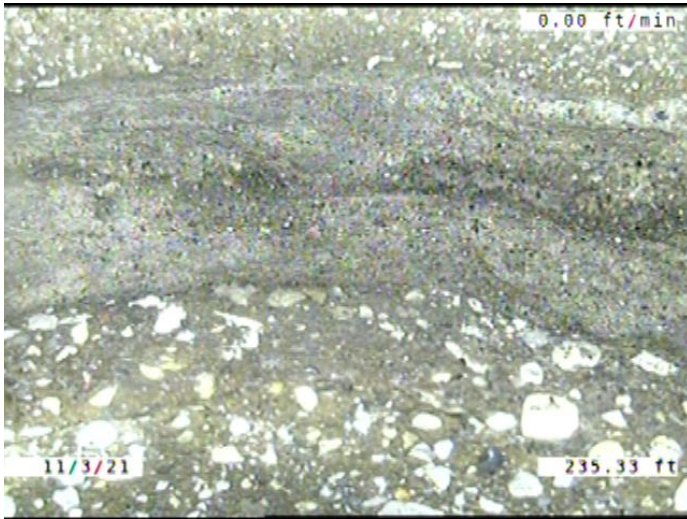
Code: **JOMD**
Description: **Joint Offset Medium Defective**

Distance (ft): **235.3**
Structural Grade: **3**
O&M Grade: **0**
Clock Start/From:
Clock To:
1st Value:
2nd Value:
Value Percent:
Continuous Index:
Within 8" of Joint: **NO**
Remarks:

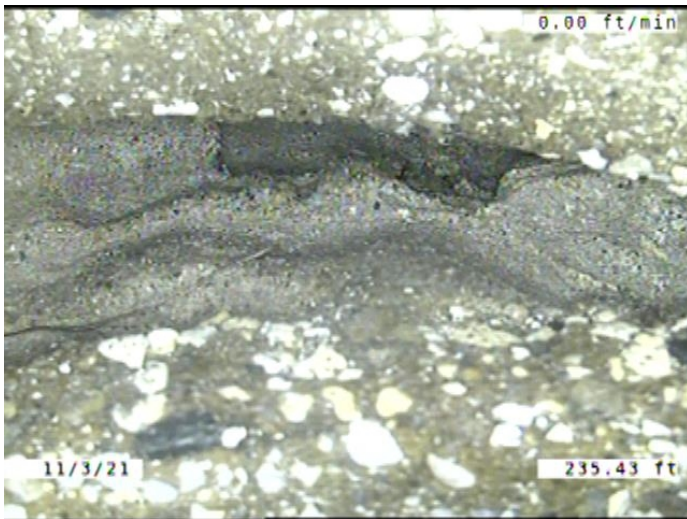
Code: **BSV**
Description: **Broken Soil Visible**

Distance (ft): **235.4**
Structural Grade: **5**
O&M Grade: **0**
Clock Start/From: **1**
Clock To: **2**
1st Value:
2nd Value:
Value Percent:
Continuous Index:
Within 8" of Joint: **YES**
Remarks:

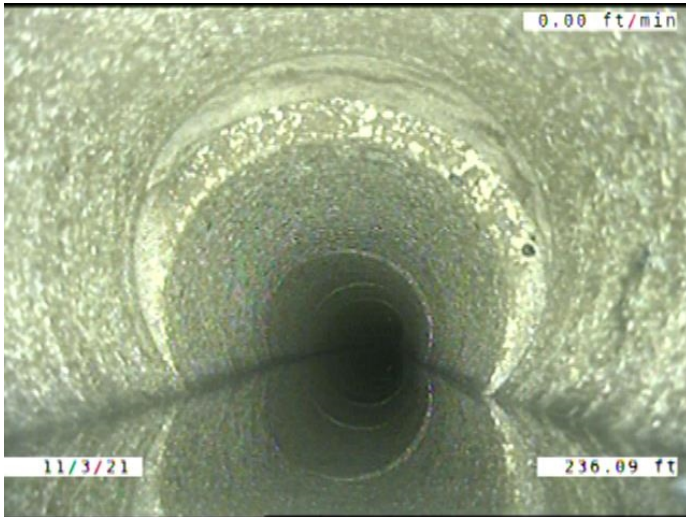
Code: **MSC**
 Description: **Miscellaneous Shape/Size Change**

Distance (ft): **236.1**
 Structural Grade: **0**
 O&M Grade: **0**
 Clock Start/From:
 Clock To:
 1st Value: **10.000**
 2nd Value:
 Value Percent:
 Continuous Index:
 Within 8" of Joint: **NO**
 Remarks:

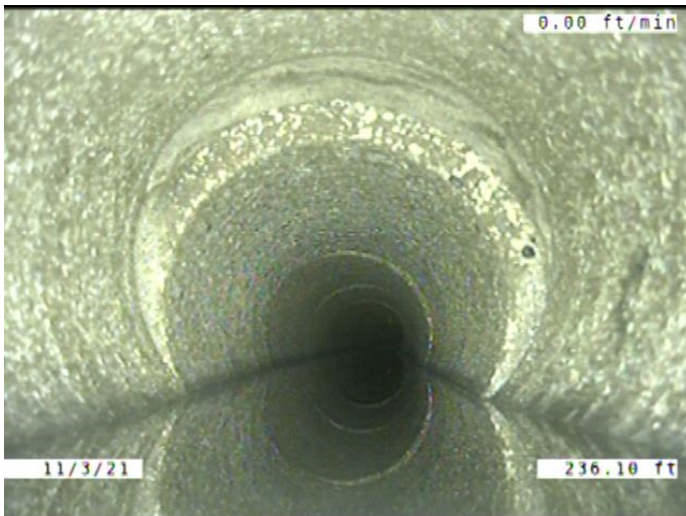
Code: **MSA**
 Description: **Miscellaneous Survey Abandoned**

Distance (ft): **236.1**
 Structural Grade: **0**
 O&M Grade: **0**
 Clock Start/From:
 Clock To:
 1st Value:
 2nd Value:
 Value Percent:
 Continuous Index:
 Within 8" of Joint: **NO**
 Remarks: **CAMERA CANT FIT INTO 10" PIPE.**
