## **Profile/Photo Observation Report**

Date: 11/04/2021 Weather: **PACP 7.0** Coding: Pipe Length (ft): 291.0 Owner: **City of Hobart** Pre Clean: **Heavy Cleaning** P.O.#: YES502259 S. Bucklin PSR: P-405-068-002 Surveyor:

Street: South Wabash Street Flow Control: Not Controlled
City: Hobart, IN Year Renewed:

US MH: M-404-002 DS MH: M-405-068 Total Length Surveyed (ft): 58.2

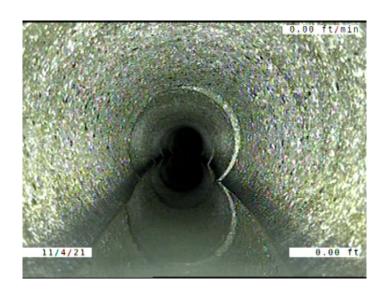
Code: MWL

Description: Miscellaneous Water Level

Distance (ft): .0
Structural Grade: 0
O&M Grade: 0

10.000

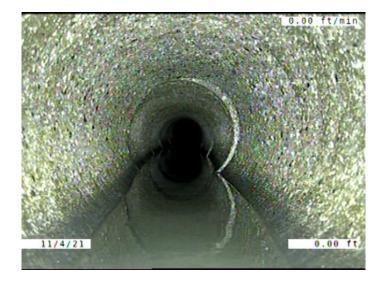
Code: MGO

Description: Miscellaneous General Observation

Remarks: PIPE SIZE AT THE UPSTREAM

MANHOLE IS 10".

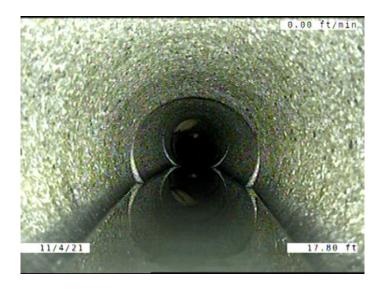
Code: MWLS

Description: Miscellaneous Water Level Sag

Distance (ft): 17.8
Structural Grade: 2
O&M Grade: 0

Value Percent: 10.000
Continuous Index: S01
Within 8" of Joint: NO

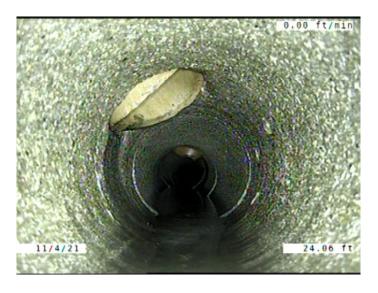
Code: MWLS

Description: Miscellaneous Water Level Sag

Distance (ft): 24.1
Structural Grade: 2
O&M Grade: 0

Value Percent: 10.000
Continuous Index: F01
Within 8" of Joint: NO

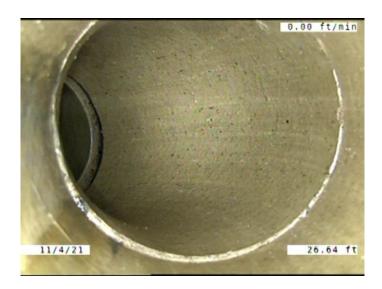
Code: **TBI**

Description: Tap Break-in Intruding

Distance (ft): 26.6
Structural Grade: 0
O&M Grade: 2
Clock Start/From: 11

1st Value:
 4.000

2nd Value:
 1.000

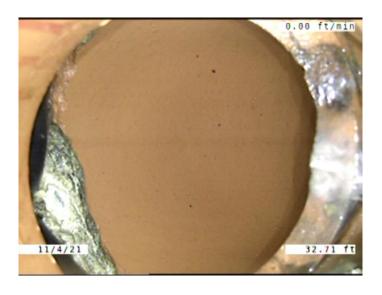
Code: TBI

Description: Tap Break-in Intruding

Distance (ft): 32.7
Structural Grade: 0
O&M Grade: 2
Clock Start/From: 1

1st Value:
 4.000

2nd Value:
 2.000

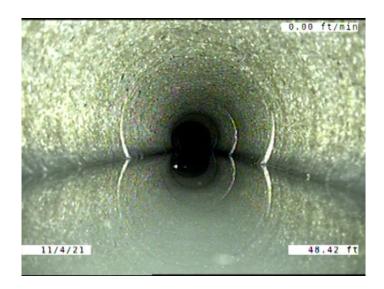
Code: MWLS

Description: Miscellaneous Water Level Sag

Distance (ft): 48.4
Structural Grade: 2
O&M Grade: 0

Value Percent: 15.000
Continuous Index: S02
Within 8" of Joint: NO

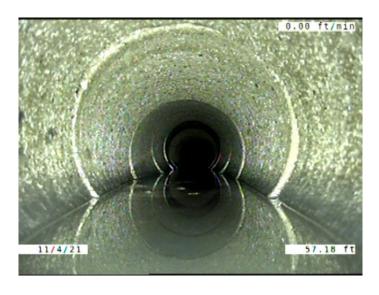
Code: MWLS

Description: Miscellaneous Water Level Sag

Distance (ft): 57.2
Structural Grade: 2
O&M Grade: 0

Value Percent: 15.000
Continuous Index: F02
Within 8" of Joint: NO

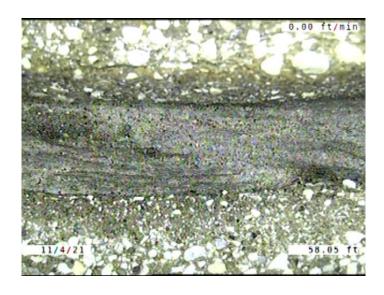
Code: MSC

Description: Miscellaneous Shape/Size Change

Distance (ft): 58.1
Structural Grade: 0

1st Value: **12.000**

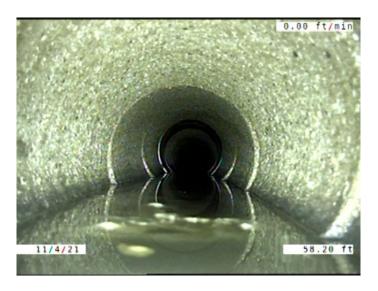
Code: MSA

Description: Miscellaneous Survey Abandoned

Distance (ft): 58.2
Structural Grade: 0

Remarks: MADE IT TO THE POINT OF OVERLAP.
