Profile/Photo Observation Report

Street:	FOXCROFT STREET	Flow Control:	Not Controlled
City:	Hobart, IN	Year Renewed:	
Location:	Light Highway	Tape/Media #:	
Purpose:	Routine Assessment	Dia/Height:	12"
Use:	Sanitary	Material:	VCP
Drain Area:	NA	Lining:	
Category:	NA		
Comment:	P_C at 94 ft lateral .		
Location Details:		Direction of Survey:	Upstream
US MH:	M-404-004	DS MH:	M-404-002
		Total Length Surveyed (ft):	95.3

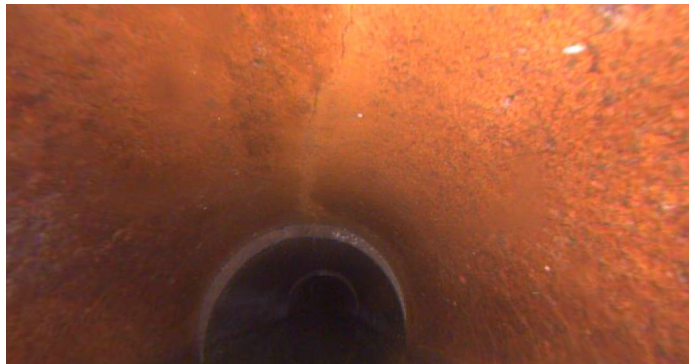
Code: **CS**
Description: **Crack Spiral**

Distance (ft): **3.1**
Structural Grade: **2**
O&M Grade: **0**
Clock Start/From: **12**
Clock To: **5**
1st Value:
2nd Value:
Value Percent:
Continuous Index:
Within 8" of Joint:
Remarks:

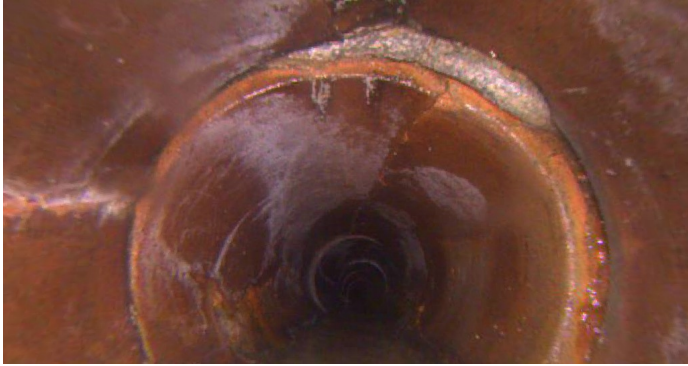
Code: **FM**
Description: **Fracture Multiple**

Distance (ft): **4.8**
Structural Grade: **4**
O&M Grade: **0**
Clock Start/From: **7**
Clock To: **5**
1st Value:
2nd Value:
Value Percent:
Continuous Index: **S01**
Within 8" of Joint:
Remarks:

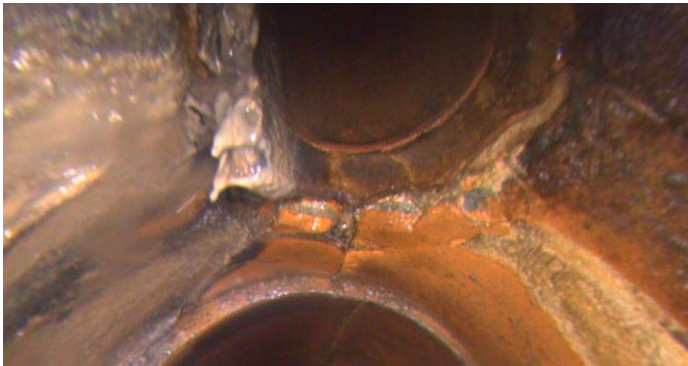
Code: **TB**
Description: **Tap Break-in**

Distance (ft): **16.5**
Structural Grade: **0**
O&M Grade: **0**
Clock Start/From: **12**
Clock To:
1st Value: **4.000**
2nd Value:
Value Percent:
Continuous Index:
Within 8" of Joint:
Remarks:

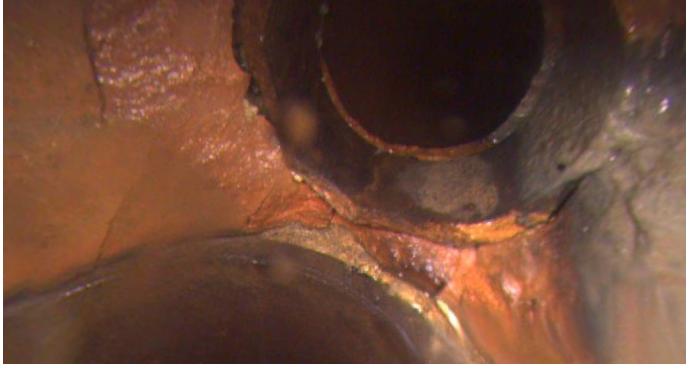
Code: **TB**
Description: **Tap Break-in**

Distance (ft): **28.8**
Structural Grade: **0**
O&M Grade: **0**
Clock Start/From: **2**
Clock To:
1st Value: **4.000**
2nd Value:
Value Percent:
Continuous Index:
Within 8" of Joint:
Remarks:

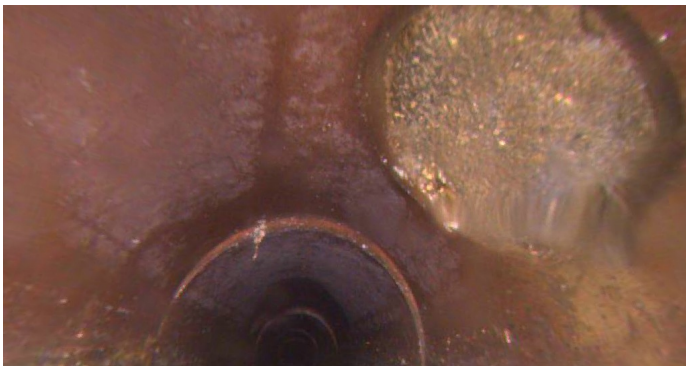
Code: **TFC**
Description: **Tap Factory Capped**

Distance (ft): **31.1**
Structural Grade: **0**
O&M Grade: **0**
Clock Start/From: **2**
Clock To:
1st Value: **4.000**
2nd Value:
Value Percent:
Continuous Index:
Within 8" of Joint:
Remarks:

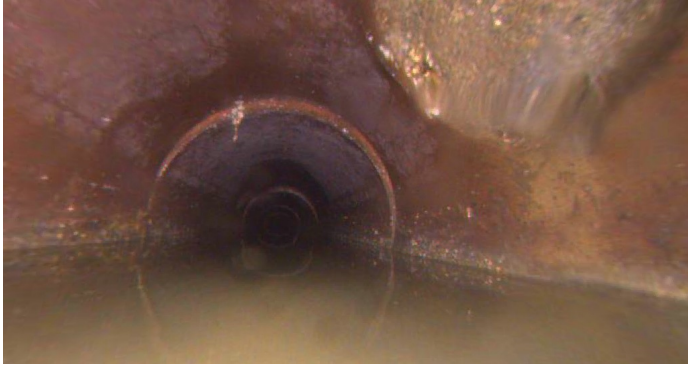
Code: **FM**
Description: **Fracture Multiple**

Distance (ft): **31.1**
Structural Grade: **4**
O&M Grade: **0**
Clock Start/From: **7**
Clock To: **5**
1st Value:
2nd Value:
Value Percent:
Continuous Index: **F01**
Within 8" of Joint:
Remarks:

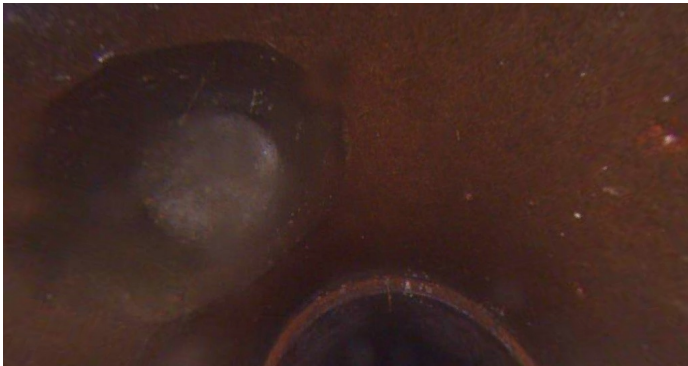
Code: **TFC**
Description: **Tap Factory Capped**

Distance (ft): **34.1**
Structural Grade: **0**
O&M Grade: **0**
Clock Start/From: **10**
Clock To:
1st Value: **4.000**
2nd Value:
Value Percent:
Continuous Index:
Within 8" of Joint:
Remarks:

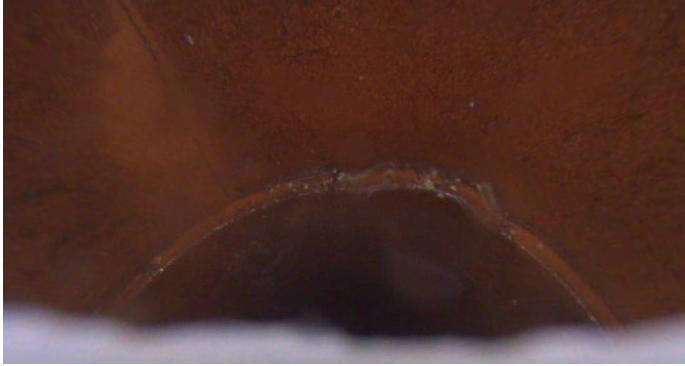
Code: **CL**
Description: **Crack Longitudinal**

Distance (ft): **37.8**
Structural Grade: **2**
O&M Grade: **0**
Clock Start/From: **10**
Clock To:
1st Value:
2nd Value:
Value Percent:
Continuous Index:
Within 8" of Joint: **YES**
Remarks:

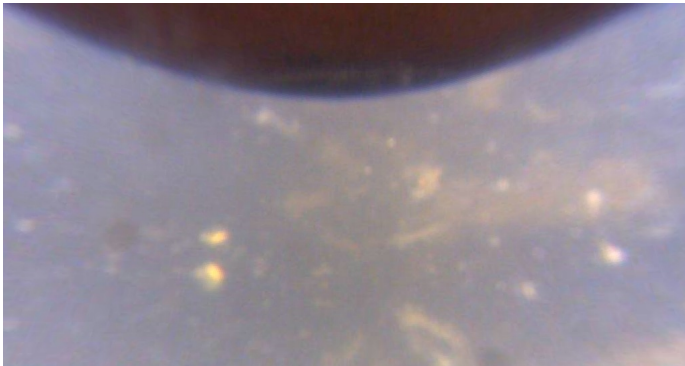
Code: **MCU**
Description: **Camera Underwater**

Distance (ft): **40.5**
Structural Grade: **0**
O&M Grade: **4**
Clock Start/From:
Clock To:
1st Value:
2nd Value:
Value Percent:
Continuous Index:
Within 8" of Joint: **NO**
Remarks:

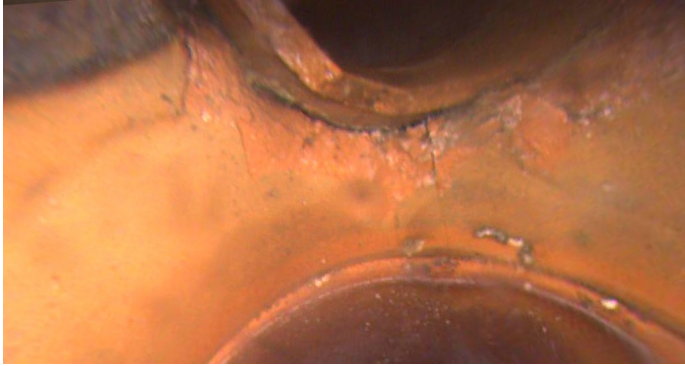
Code: **TB**
Description: **Tap Break-in**

Distance (ft): **78.7**
Structural Grade: **0**
O&M Grade: **0**
Clock Start/From: **12**
Clock To:
1st Value: **4.000**
2nd Value:
Value Percent:
Continuous Index:
Within 8" of Joint:
Remarks:

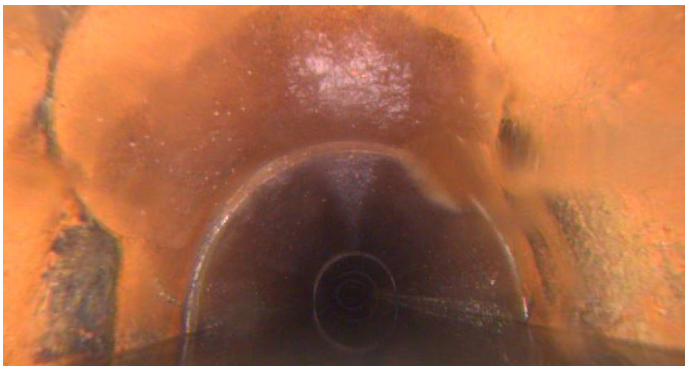
Code: **CS**
Description: **Crack Spiral**

Distance (ft): **81.5**
Structural Grade: **2**
O&M Grade: **0**
Clock Start/From: **7**
Clock To: **5**
1st Value:
2nd Value:
Value Percent:
Continuous Index:
Within 8" of Joint: **YES**
Remarks:

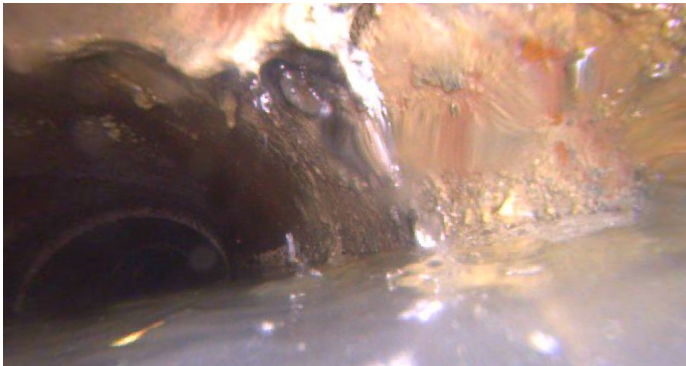
Code: **MSA**
Description: **Abandoned Survey**

Distance (ft): **95.3**
Structural Grade: **0**
O&M Grade: **0**
Clock Start/From:
Clock To:
1st Value:
2nd Value:
Value Percent:
Continuous Index:
Within 8" of Joint: **NO**
Remarks: **Debris**
