Profile/Photo Observation Report

Date:	11/06/2021	Weather:		Coding:	PACP 7.0
Pipe Length (ft):	353.7	Owner:	City of Hobart	Pre Clean:	Heavy Cleaning
P.O.#:	YES502259	Surveyor:	S. Bucklin	PSR:	P-404-004-002
Customer:	City of Hobart	Clean Date:	11/06/2021	Shape:	C

Street:	North Wabash Street	Flow Control:	Not Controlled
City:	Hobart, IN	Year Renewed:	
Location:	Alley	Tape/Media #:	
Purpose:	Routine Assessment	Dia/Height:	12"
Use:	Sanitary Sewage Pipe	Material:	VCP
Drain Area:		Lining:	None
Category:	NA		
Comment:			
Location Details:		Direction of Survey:	Downstream
US MH:	M-404-004	DS MH:	M-404-002
		Total Length Surveyed (ft):	353.7

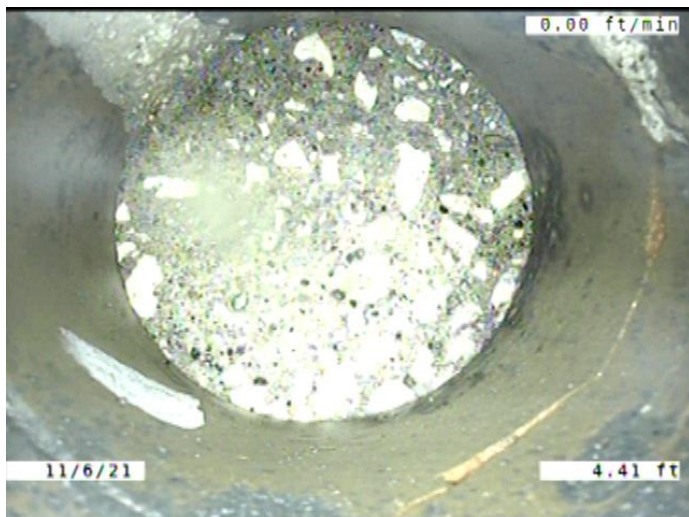
Code:	TFD
Description:	Tap Factory Defective
Distance (ft):	4.4
Structural Grade:	0
O&M Grade:	3
Clock Start/From:	11
Clock To:	
1st Value:	4.000
2nd Value:	
Value Percent:	
Continuous Index:	
Within 8" of Joint:	YES
Remarks:	CAPPED. BROKEN. ENCRUSTATION AROUND THE CAP

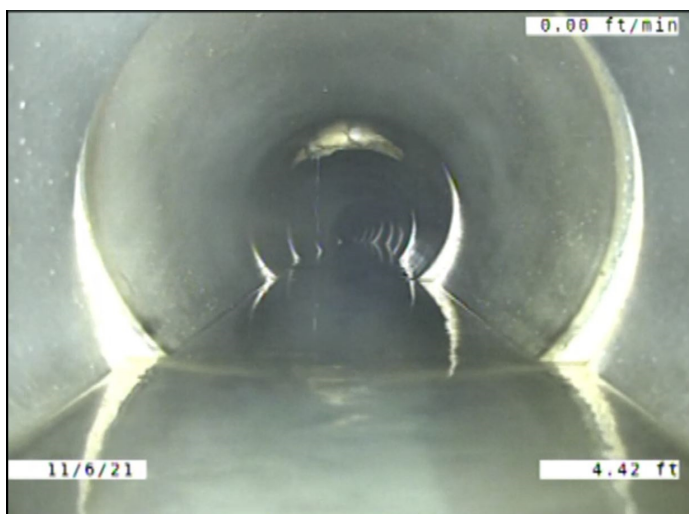
Code:	B
Description:	Broken
Distance (ft):	4.4
Structural Grade:	4
O&M Grade:	0
Clock Start/From:	12
Clock To:	12
1st Value:	
2nd Value:	
Value Percent:	
Continuous Index:	F01
Within 8" of Joint:	YES
Remarks:

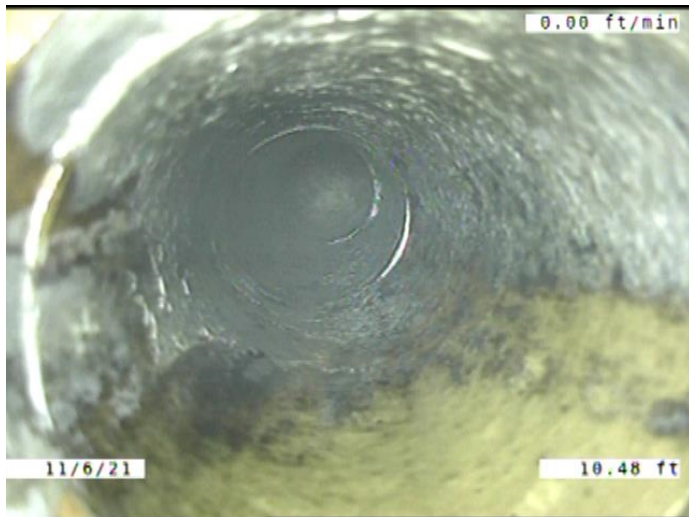
Code: **TBI**
 Description: **Tap Break-in Intruding**

Distance (ft): **10.5**
 Structural Grade: **0**
 O&M Grade: **2**
 Clock Start/From: **12**
 Clock To:
 1st Value: **4.000**
 2nd Value: **1.000**
 Value Percent:
 Continuous Index:
 Within 8" of Joint: **YES**
 Remarks: **CONSTANTLY RUNNING WATER.**

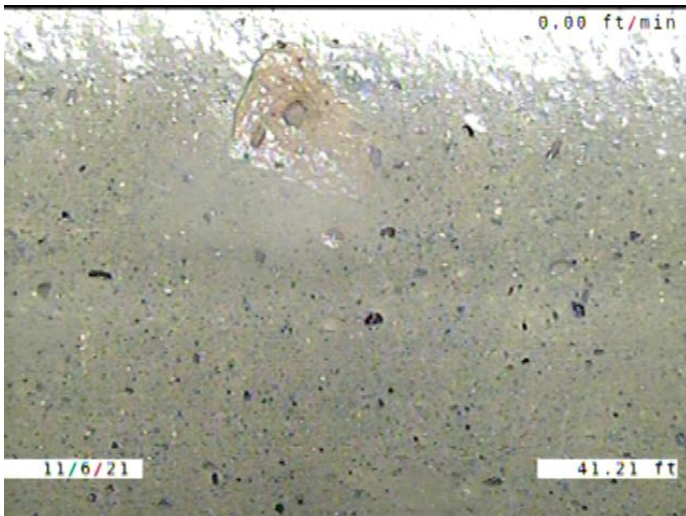
Code: **SSS**
 Description: **Surface Damage Surface Spalling**

Distance (ft): **41.2**
 Structural Grade: **2**
 O&M Grade: **0**
 Clock Start/From: **1**
 Clock To:
 1st Value:
 2nd Value:
 Value Percent:
 Continuous Index:
 Within 8" of Joint: **NO**
 Remarks:

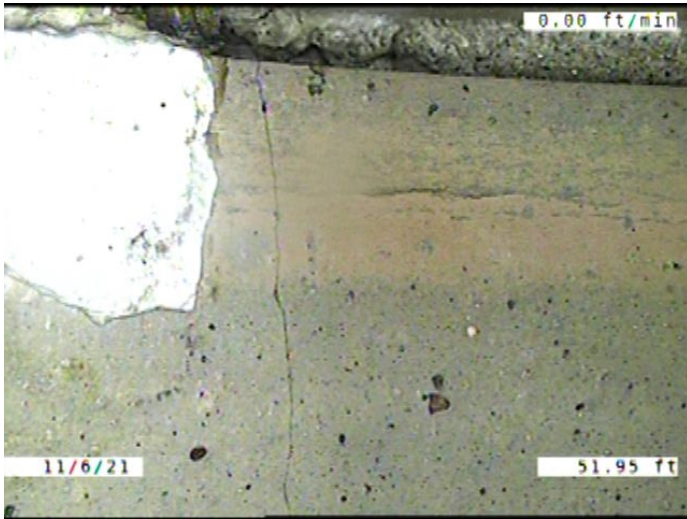
Code: **CL**
Description: **Crack Longitudinal**

Distance (ft): **51.9**
Structural Grade: **2**
O&M Grade: **0**
Clock Start/From: **10**
Clock To:
1st Value:
2nd Value:
Value Percent:
Continuous Index:
Within 8" of Joint: **YES**
Remarks:

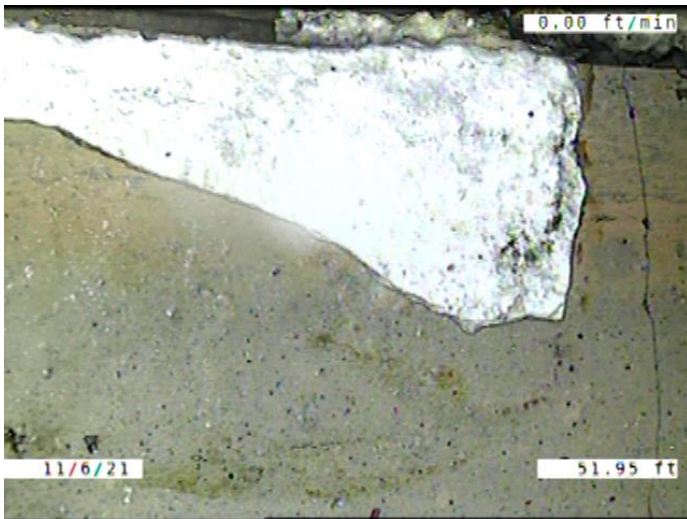
Code: **DAE**
Description: **Deposits Attached Encrustation**

Distance (ft): **51.9**
Structural Grade: **0**
O&M Grade: **2**
Clock Start/From: **8**
Clock To: **10**
1st Value:
2nd Value:
Value Percent: **5.000**
Continuous Index:
Within 8" of Joint: **YES**
Remarks:

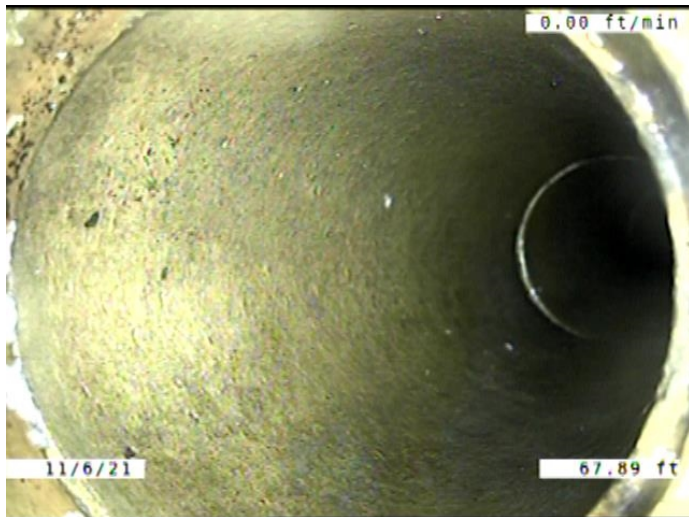
Code: **TBI**
 Description: **Tap Break-in Intruding**

Distance (ft): **67.9**
 Structural Grade: **0**
 O&M Grade: **2**
 Clock Start/From: **12**
 Clock To:
 1st Value: **4.000**
 2nd Value: **1.000**
 Value Percent:
 Continuous Index:
 Within 8" of Joint: **YES**
 Remarks: **CONSTANTLY RUNNING WATER.**

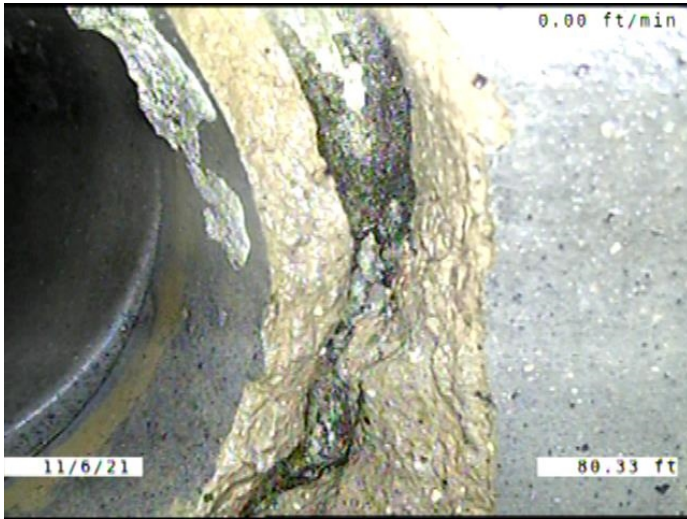
Code: **SSS**
Description: **Surface Damage Surface Spalling**

Distance (ft): **80.3**
Structural Grade: **2**
O&M Grade: **0**
Clock Start/From: **10**
Clock To: **1**
1st Value:
2nd Value:
Value Percent:
Continuous Index:
Within 8" of Joint: **YES**
Remarks:

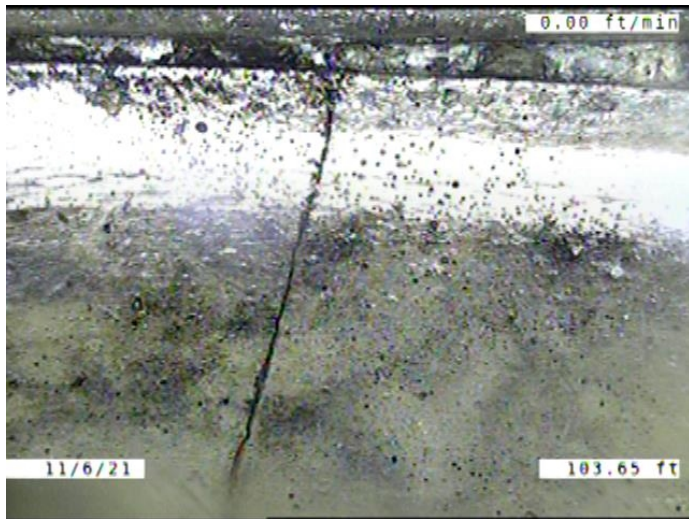
Code: **CL**
 Description: **Crack Longitudinal**

Distance (ft): **103.7**
 Structural Grade: **2**
 O&M Grade: **0**
 Clock Start/From: **12**
 Clock To:
 1st Value:
 2nd Value:
 Value Percent:
 Continuous Index:
 Within 8" of Joint: **YES**
 Remarks:

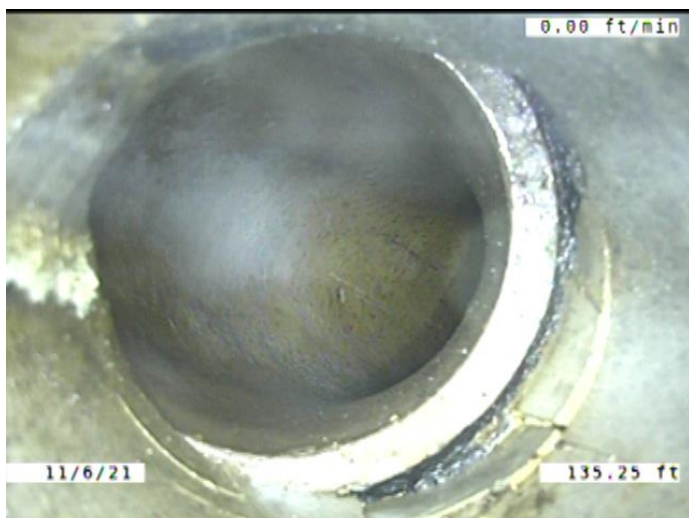
Code: **TFD**
 Description: **Tap Factory Defective**

Distance (ft): **135.3**
 Structural Grade: **0**
 O&M Grade: **3**
 Clock Start/From: **11**
 Clock To:
 1st Value: **4.000**
 2nd Value:
 Value Percent:
 Continuous Index:
 Within 8" of Joint: **YES**
 Remarks: **BROKEN. OFFSET. CONSTANTLY RUNNING WATER.**

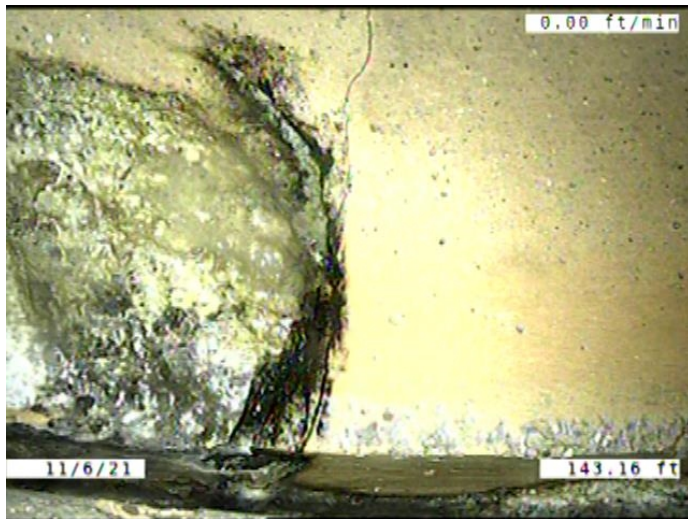
Code: **CL**
 Description: **Crack Longitudinal**

Distance (ft): **143.2**
 Structural Grade: **2**
 O&M Grade: **0**
 Clock Start/From: **3**
 Clock To:
 1st Value:
 2nd Value:
 Value Percent:
 Continuous Index:
 Within 8" of Joint: **YES**
 Remarks:

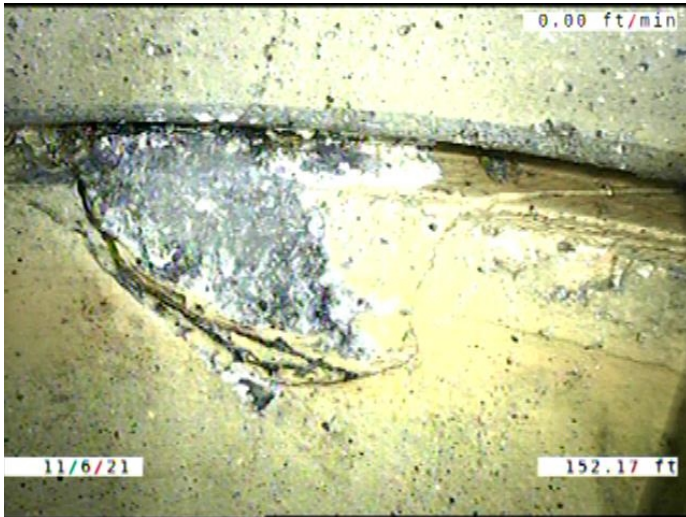
Code: **B**
Description: **Broken**

Distance (ft): **152.2**
Structural Grade: **4**
O&M Grade: **0**
Clock Start/From: **2**
Clock To: **3**
1st Value:
2nd Value:
Value Percent:
Continuous Index:
Within 8" of Joint: **YES**
Remarks:

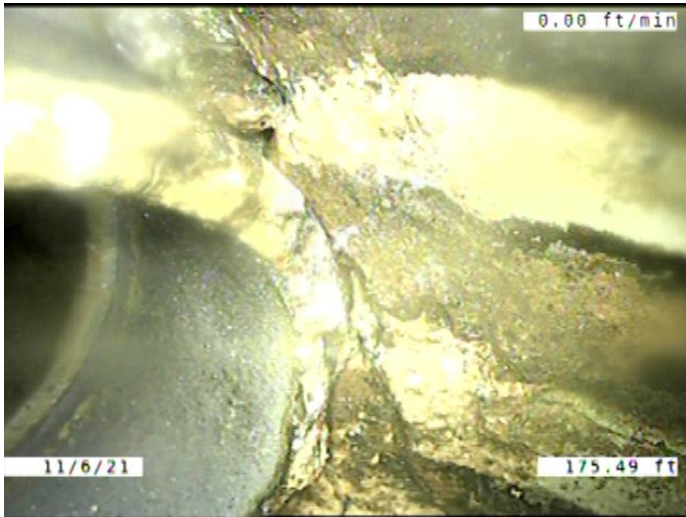
Code: **SSS**
Description: **Surface Damage Surface Spalling**

Distance (ft): **175.5**
Structural Grade: **2**
O&M Grade: **0**
Clock Start/From: **10**
Clock To: **1**
1st Value:
2nd Value:
Value Percent:
Continuous Index:
Within 8" of Joint: **YES**
Remarks:

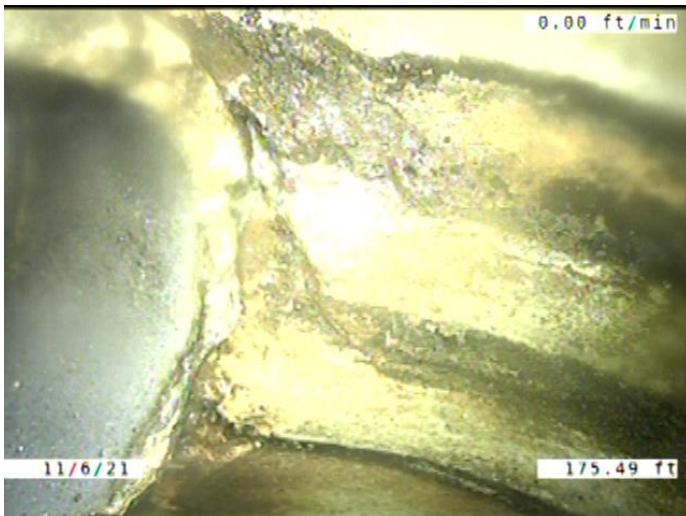
Code: **ISC**
Description: **Infiltration Stain Connection**

Distance (ft): **175.5**
Structural Grade: **0**
O&M Grade: **1**
Clock Start/From: **9**
Clock To: **3**
1st Value:
2nd Value:
Value Percent:
Continuous Index:
Within 8" of Joint: **YES**
Remarks:

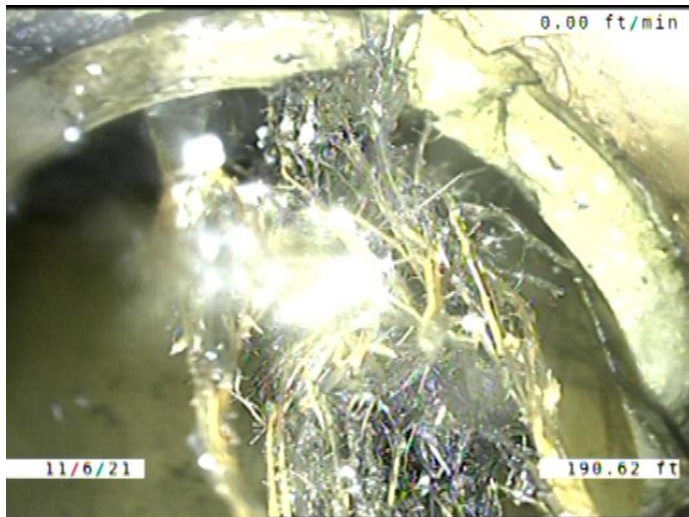
Code: **RML**
 Description: **Roots Medium Lateral**

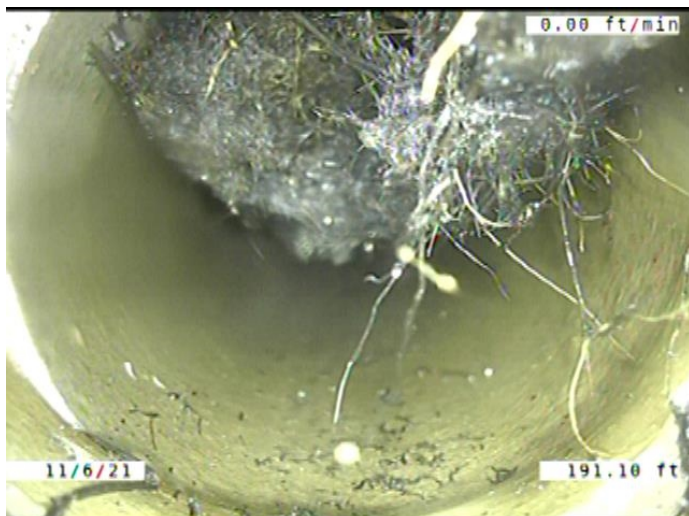
Code: **TBD**
 Description: **Tap Break-in/Hammer Defective**

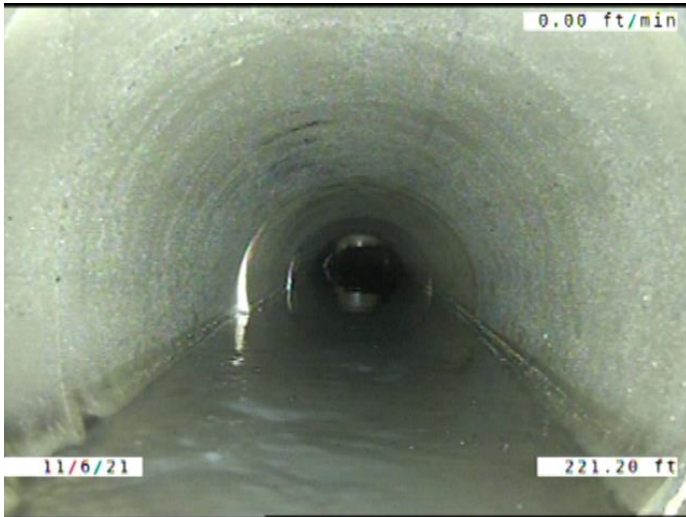
Code: **MWLS**
 Description: **Miscellaneous Water Level Sag**

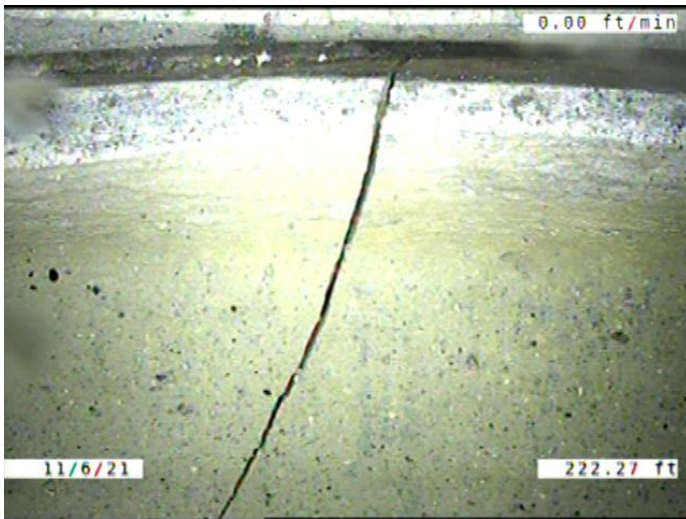
Code: **B**
 Description: **Broken**

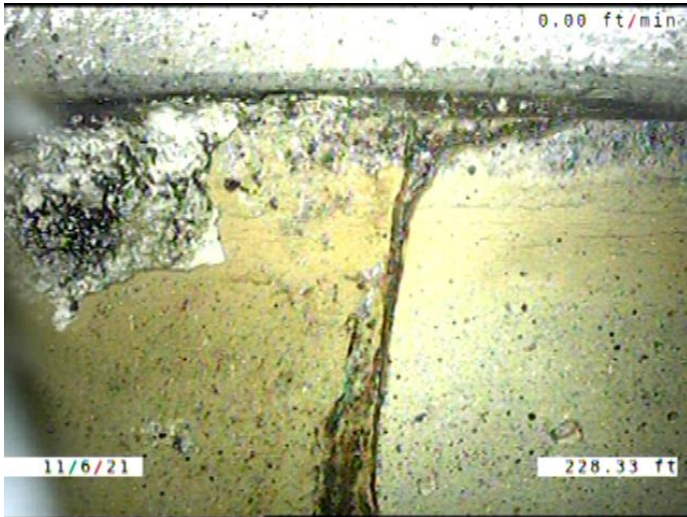
Code: **FL**
 Description: **Fracture Longitudinal**

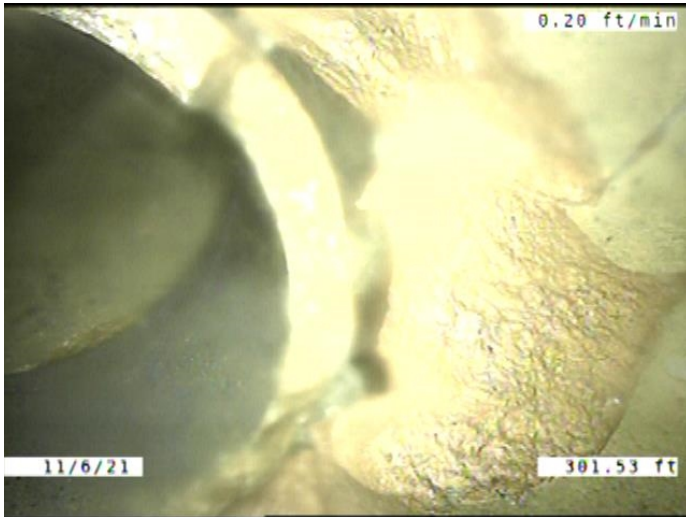
Code: **BSV**
Description: **Broken Soil Visible**

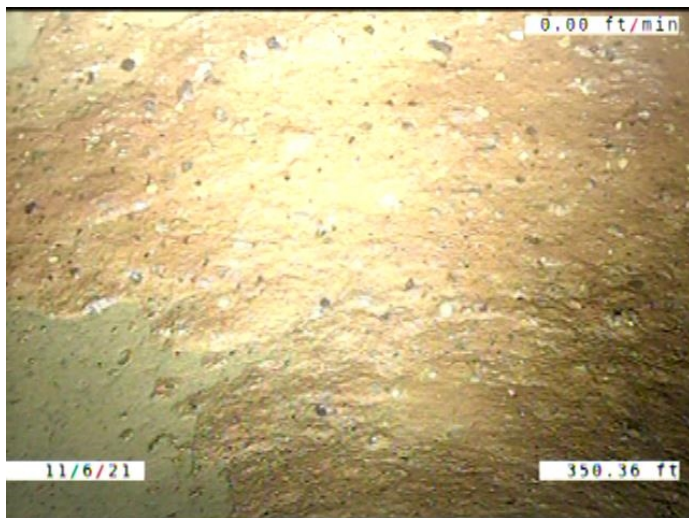
Code:	SSS
Description:	Surface Damage Surface Spalling
Distance (ft):	350.4
Structural Grade:	2
O&M Grade:	0
Clock Start/From:	10
Clock To:	1
1st Value:	
2nd Value:	
Value Percent:	
Continuous Index:	
Within 8" of Joint:	YES
Remarks:
