Profile/Photo Observation Report

Date:	11/06/2021	Weather:		Coding:	PACP 7.0
Pipe Length (ft):	353.7	Owner:	City of Hobart	Pre Clean:	Heavy Cleaning
P.O.#:	YES502259	Surveyor:	S. Bucklin	PSR:	P-404-004-002
Customer:	City of Hobart	Clean Date:	11/06/2021	Shape:	C

Street:	North Wabash Street	Flow Control:	Not Controlled
City:	Hobart, IN	Year Renewed:	
Location:	Alley	Tape/Media #:	
Purpose:	Routine Assessment	Dia/Height:	12"
Use:	Sanitary Sewage Pipe	Material:	VCP
Drain Area:		Lining:	None
Category:	NA		
Comment:			
Location Details:		Direction of Survey:	Downstream
US MH:	M-404-004	DS MH:	M-404-002
		Total Length Surveyed (ft):	353.7

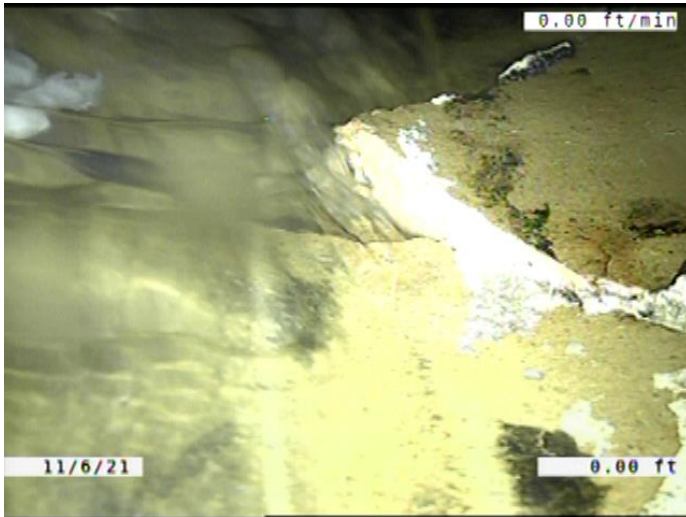
Code: **B**
 Description: **Broken**

Distance (ft): **.0**
 Structural Grade: **4**
 O&M Grade: **0**
 Clock Start/From: **12**
 Clock To: **12**
 1st Value:
 2nd Value:
 Value Percent:
 Continuous Index: **S01**
 Within 8" of Joint: **YES**
 Remarks:

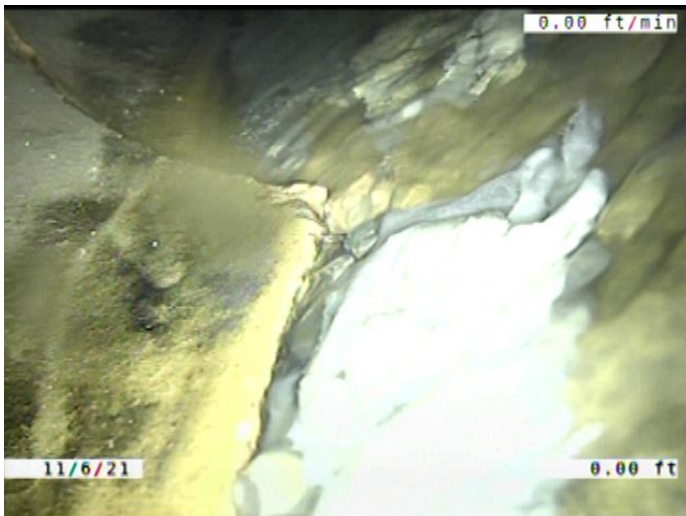
Code: **DR**
 Description: **Deformed Rigid**

Distance (ft): **.0**
 Structural Grade: **4**
 O&M Grade: **0**
 Clock Start/From:
 Clock To:
 1st Value:
 2nd Value:
 Value Percent: **5.000**
 Continuous Index:
 Within 8" of Joint: **NO**
 Remarks:

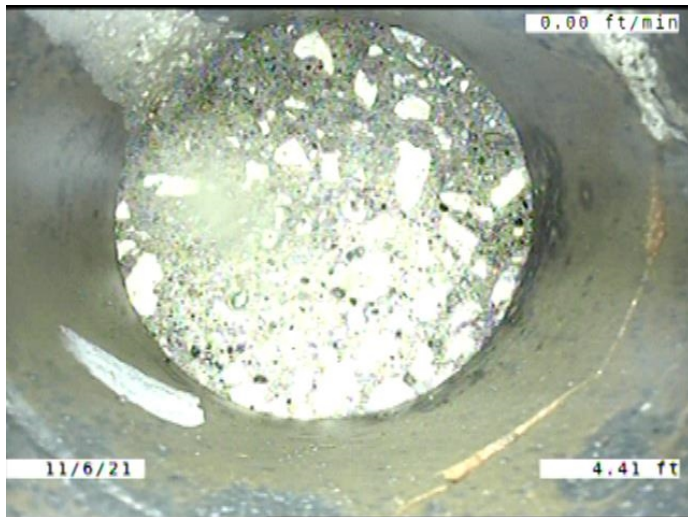
Code:	TFD
Description:	Tap Factory Defective
Distance (ft):	4.4
Structural Grade:	0
O&M Grade:	3
Clock Start/From:	11
Clock To:	
1st Value:	4.000
2nd Value:	
Value Percent:	
Continuous Index:	
Within 8" of Joint:	YES
Remarks:	CAPPED. BROKEN. ENCRUSTATION AROUND THE CAP

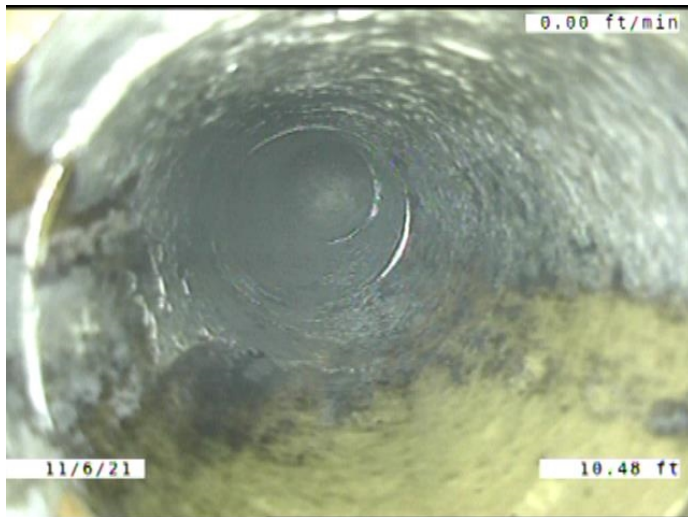
Code: **TBI**
 Description: **Tap Break-in Intruding**

Distance (ft): **10.5**
 Structural Grade: **0**
 O&M Grade: **2**
 Clock Start/From: **12**
 Clock To:
 1st Value: **4.000**
 2nd Value: **1.000**
 Value Percent:
 Continuous Index:
 Within 8" of Joint: **YES**
 Remarks: **CONSTANTLY RUNNING WATER.**

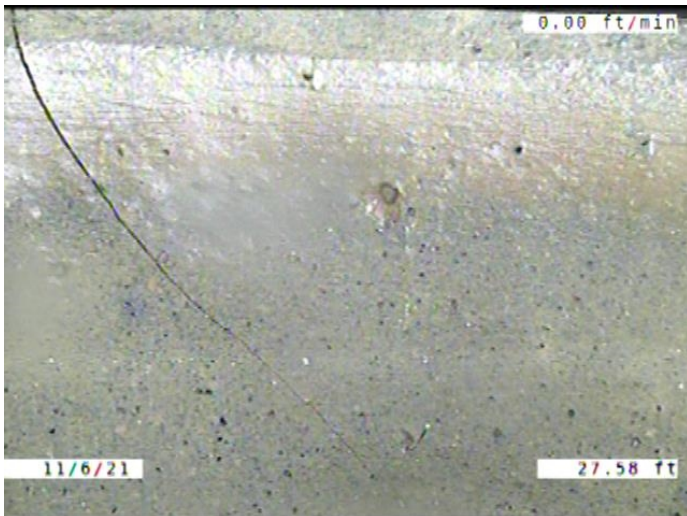
Code: **CM**
 Description: **Crack Multiple**

Distance (ft): **27.6**
 Structural Grade: **3**
 O&M Grade: **0**
 Clock Start/From: **12**
 Clock To: **3**
 1st Value:
 2nd Value:
 Value Percent:
 Continuous Index:
 Within 8" of Joint: **YES**
 Remarks:

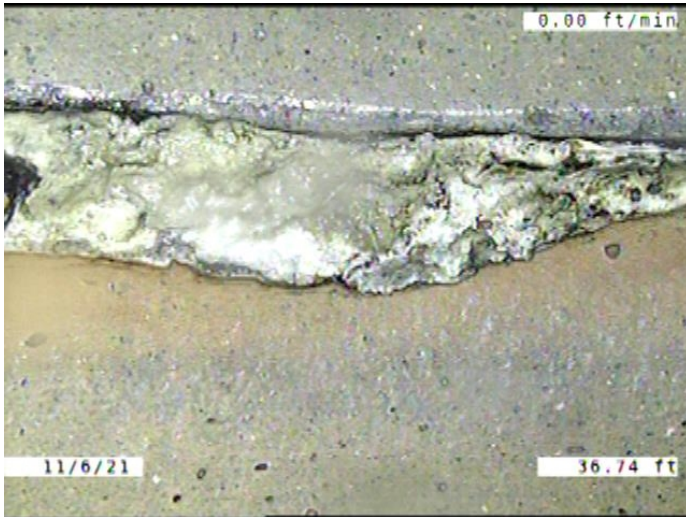
Code: **DAE**
 Description: **Deposits Attached Encrustation**

Distance (ft): **36.7**
 Structural Grade: **0**
 O&M Grade: **2**
 Clock Start/From: **9**
 Clock To: **4**
 1st Value:
 2nd Value:
 Value Percent: **5.000**
 Continuous Index:
 Within 8" of Joint: **YES**
 Remarks:

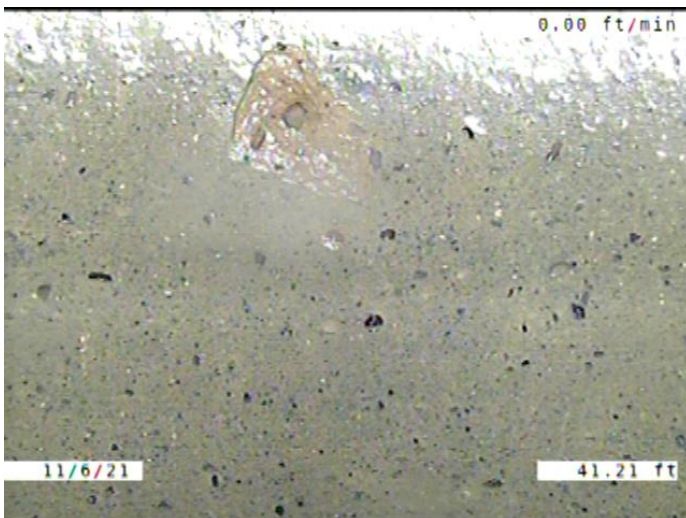
Code: **SSS**
 Description: **Surface Damage Surface Spalling**

Distance (ft): **41.2**
 Structural Grade: **2**
 O&M Grade: **0**
 Clock Start/From: **1**
 Clock To:
 1st Value:
 2nd Value:
 Value Percent:
 Continuous Index:
 Within 8" of Joint: **NO**
 Remarks:

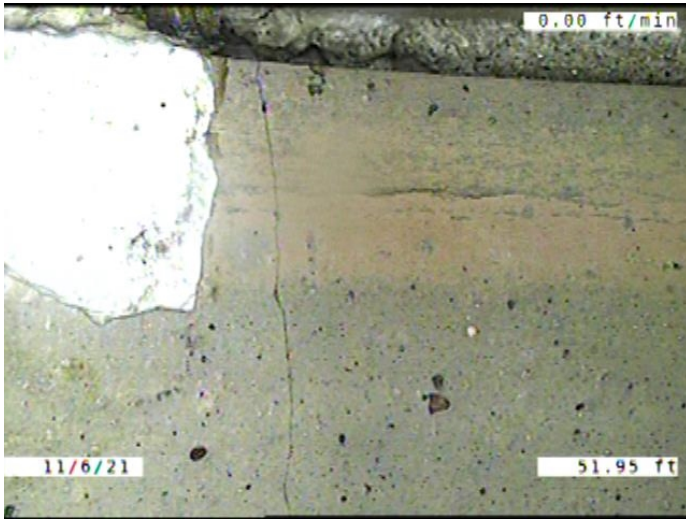
Code: **CL**
 Description: **Crack Longitudinal**

Distance (ft): **51.9**
 Structural Grade: **2**
 O&M Grade: **0**
 Clock Start/From: **10**
 Clock To:
 1st Value:
 2nd Value:
 Value Percent:
 Continuous Index:
 Within 8" of Joint: **YES**
 Remarks:

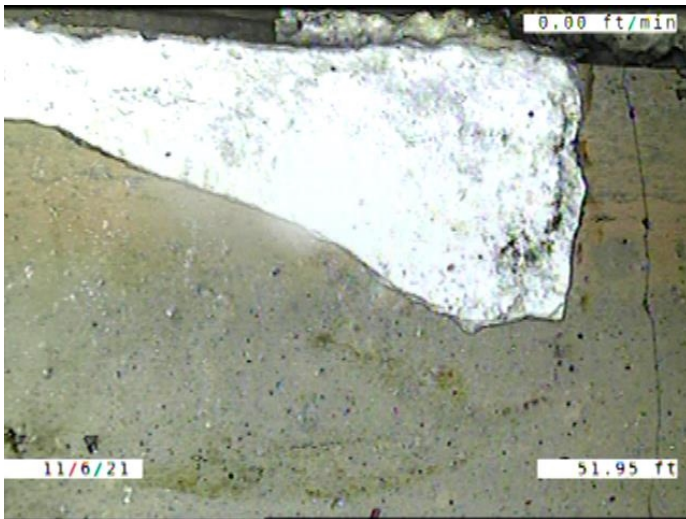
Code: **DAE**
 Description: **Deposits Attached Encrustation**

Distance (ft): **51.9**
 Structural Grade: **0**
 O&M Grade: **2**
 Clock Start/From: **8**
 Clock To: **10**
 1st Value:
 2nd Value:
 Value Percent: **5.000**
 Continuous Index:
 Within 8" of Joint: **YES**
 Remarks:

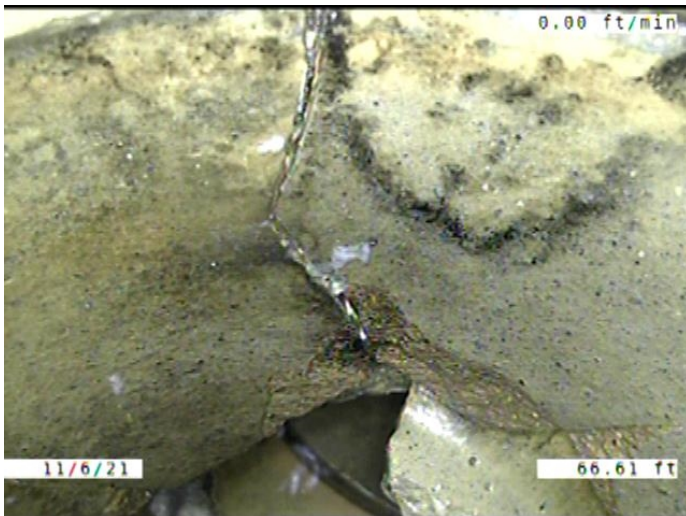
Code: **B**
Description: **Broken**

Distance (ft): **66.6**
Structural Grade: **4**
O&M Grade: **0**
Clock Start/From: **8**
Clock To: **4**
1st Value:
2nd Value:
Value Percent:
Continuous Index:
Within 8" of Joint: **YES**
Remarks:

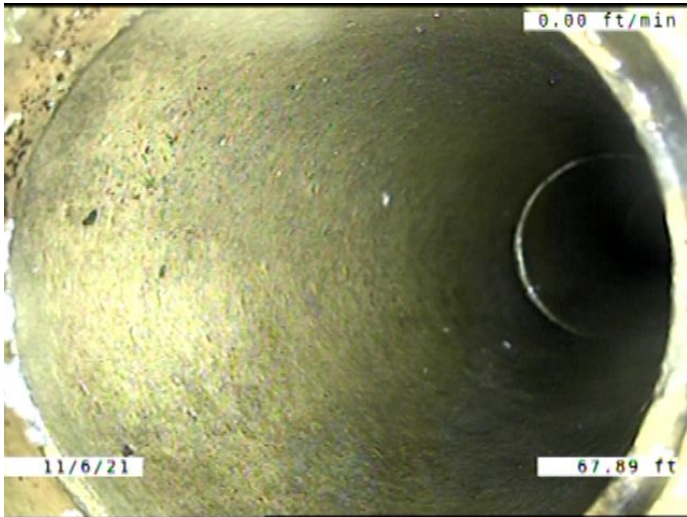
Code: **TBI**
 Description: **Tap Break-in Intruding**

Distance (ft): **67.9**
 Structural Grade: **0**
 O&M Grade: **2**
 Clock Start/From: **12**
 Clock To:
 1st Value: **4.000**
 2nd Value: **1.000**
 Value Percent:
 Continuous Index:
 Within 8" of Joint: **YES**
 Remarks: **CONSTANTLY RUNNING WATER.**

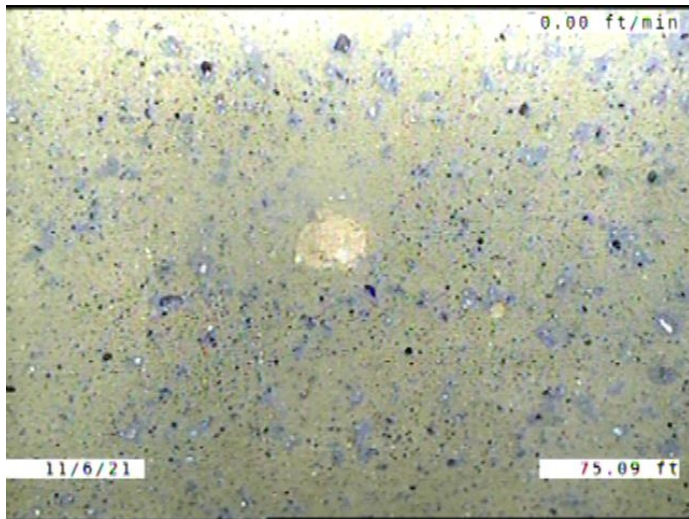
Code: **SSS**
 Description: **Surface Damage Surface Spalling**

Distance (ft): **75.1**
 Structural Grade: **2**
 O&M Grade: **0**
 Clock Start/From: **10**
 Clock To:
 1st Value:
 2nd Value:
 Value Percent:
 Continuous Index:
 Within 8" of Joint: **NO**
 Remarks:

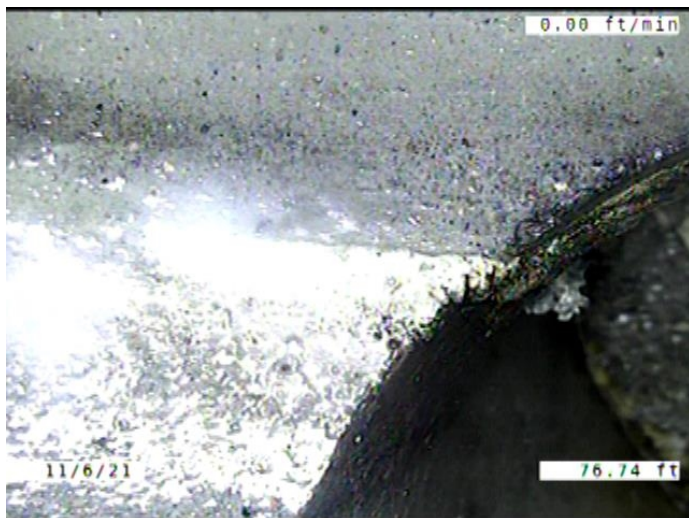
Code: **DAE**
 Description: **Deposits Attached Encrustation**

Distance (ft): **76.7**
 Structural Grade: **0**
 O&M Grade: **2**
 Clock Start/From: **9**
 Clock To: **11**
 1st Value:
 2nd Value:
 Value Percent: **5.000**
 Continuous Index:
 Within 8" of Joint: **YES**
 Remarks:

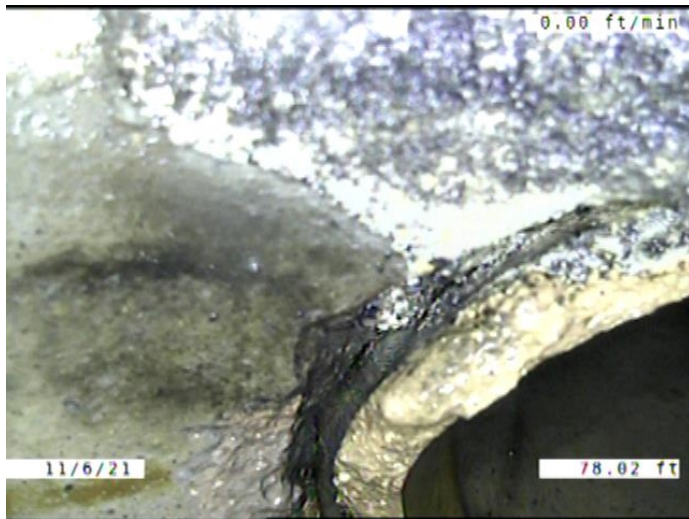
Code: **SSS**
Description: **Surface Damage Surface Spalling**

Distance (ft): **78.0**
Structural Grade: **2**
O&M Grade: **0**
Clock Start/From: **10**
Clock To: **1**
1st Value:
2nd Value:
Value Percent:
Continuous Index:
Within 8" of Joint: **YES**
Remarks:

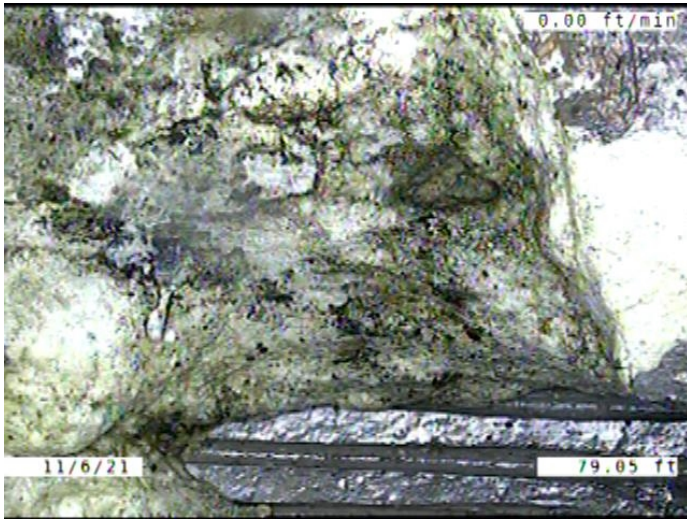
Code: **SMW**
 Description: **Surface Damage Missing Wall**

Distance (ft): **79.1**
 Structural Grade: **5**
 O&M Grade: **0**
 Clock Start/From: **10**
 Clock To: **12**
 1st Value:
 2nd Value:
 Value Percent:
 Continuous Index:
 Within 8" of Joint: **YES**
 Remarks:

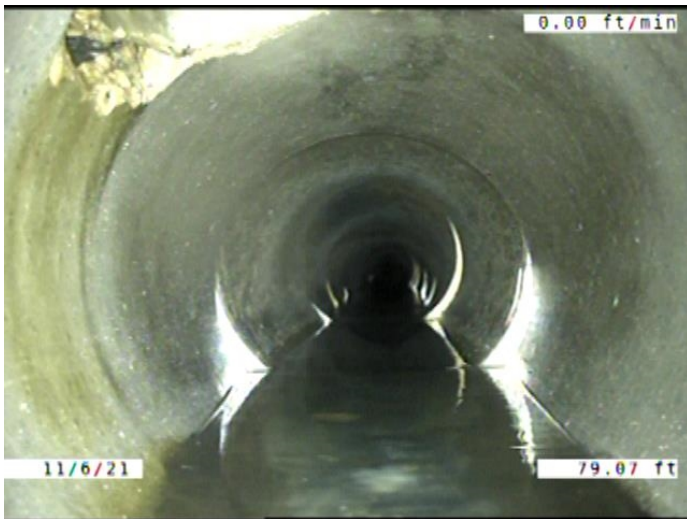
Code: **MWLS**
 Description: **Miscellaneous Water Level Sag**

Distance (ft): **79.1**
 Structural Grade: **2**
 O&M Grade: **0**
 Clock Start/From:
 Clock To:
 1st Value:
 2nd Value:
 Value Percent: **10.000**
 Continuous Index: **F02**
 Within 8" of Joint: **NO**
 Remarks:

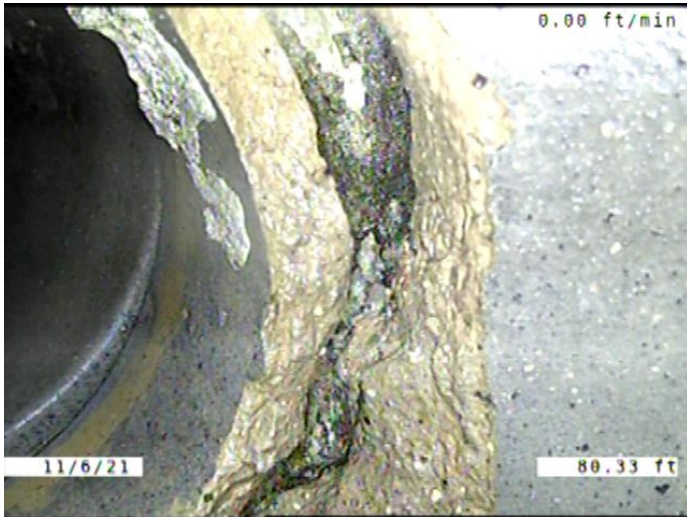
Code: **SSS**
Description: **Surface Damage Surface Spalling**

Distance (ft): **80.3**
Structural Grade: **2**
O&M Grade: **0**
Clock Start/From: **10**
Clock To: **1**
1st Value:
2nd Value:
Value Percent:
Continuous Index:
Within 8" of Joint: **YES**
Remarks:

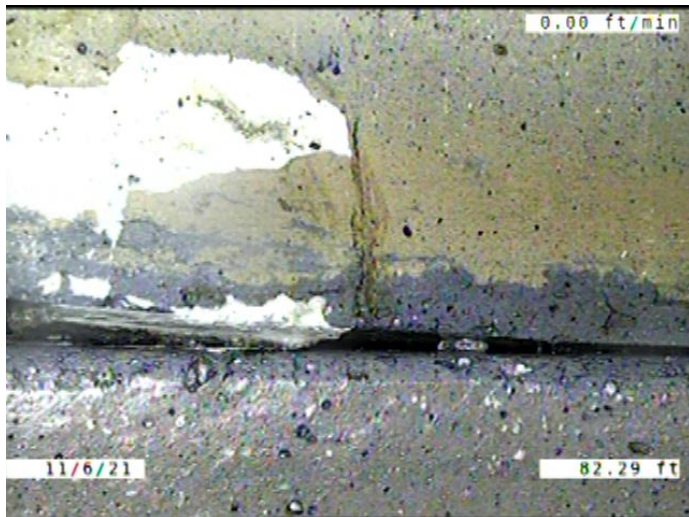
Code: **CL**
 Description: **Crack Longitudinal**

Distance (ft): **82.3**
 Structural Grade: **2**
 O&M Grade: **0**
 Clock Start/From: **2**
 Clock To:
 1st Value:
 2nd Value:
 Value Percent:
 Continuous Index:
 Within 8" of Joint: **YES**
 Remarks:

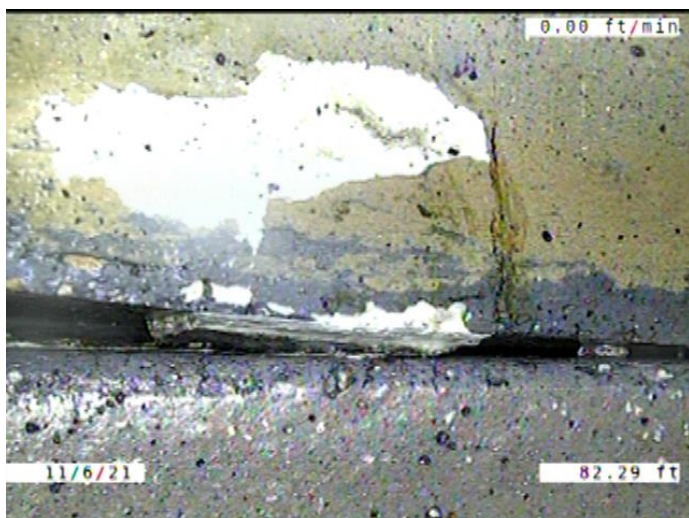
Code: **DAE**
 Description: **Deposits Attached Encrustation**

Distance (ft): **82.3**
 Structural Grade: **0**
 O&M Grade: **2**
 Clock Start/From: **3**
 Clock To:
 1st Value:
 2nd Value:
 Value Percent: **5.000**
 Continuous Index:
 Within 8" of Joint: **YES**
 Remarks:

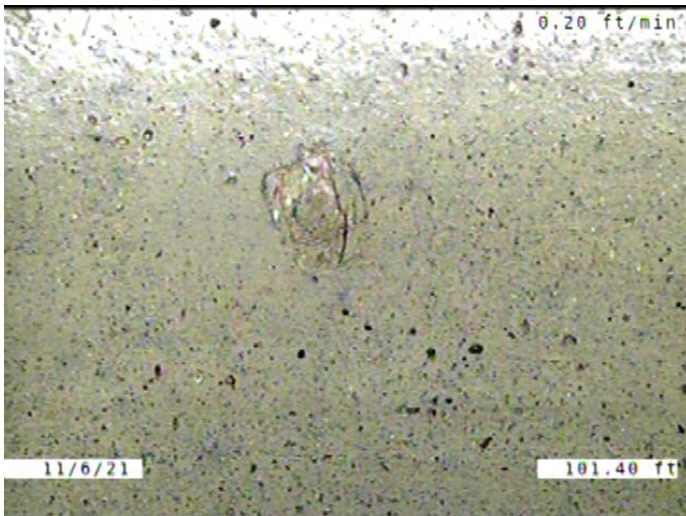
Code: **SSS**
 Description: **Surface Damage Surface Spalling**

Distance (ft): **101.4**
 Structural Grade: **2**
 O&M Grade: **0**
 Clock Start/From: **1**
 Clock To:
 1st Value:
 2nd Value:
 Value Percent:
 Continuous Index:
 Within 8" of Joint: **NO**
 Remarks:

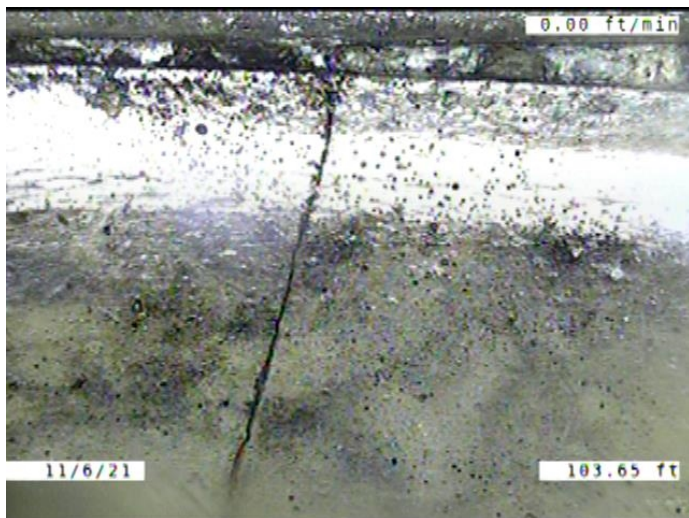
Code: **CL**
 Description: **Crack Longitudinal**

Distance (ft): **103.7**
 Structural Grade: **2**
 O&M Grade: **0**
 Clock Start/From: **12**
 Clock To:
 1st Value:
 2nd Value:
 Value Percent:
 Continuous Index:
 Within 8" of Joint: **YES**
 Remarks:

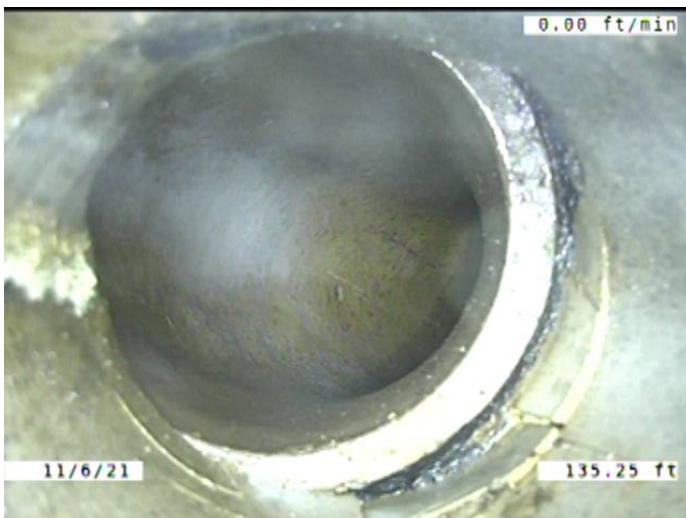
Code: **TFD**
 Description: **Tap Factory Defective**

Distance (ft): **135.3**
 Structural Grade: **0**
 O&M Grade: **3**
 Clock Start/From: **11**
 Clock To:
 1st Value: **4.000**
 2nd Value:
 Value Percent:
 Continuous Index:
 Within 8" of Joint: **YES**
 Remarks: **BROKEN. OFFSET. CONSTANTLY RUNNING WATER.**

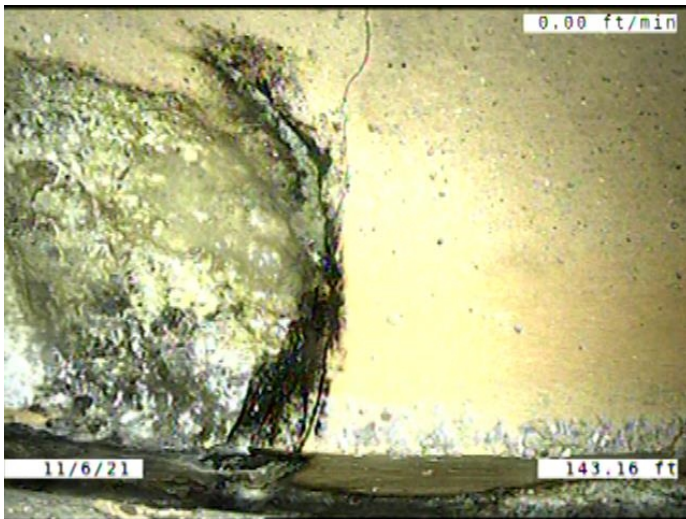
Code: **CL**
 Description: **Crack Longitudinal**

Distance (ft): **143.2**
 Structural Grade: **2**
 O&M Grade: **0**
 Clock Start/From: **3**
 Clock To:
 1st Value:
 2nd Value:
 Value Percent:
 Continuous Index:
 Within 8" of Joint: **YES**
 Remarks:

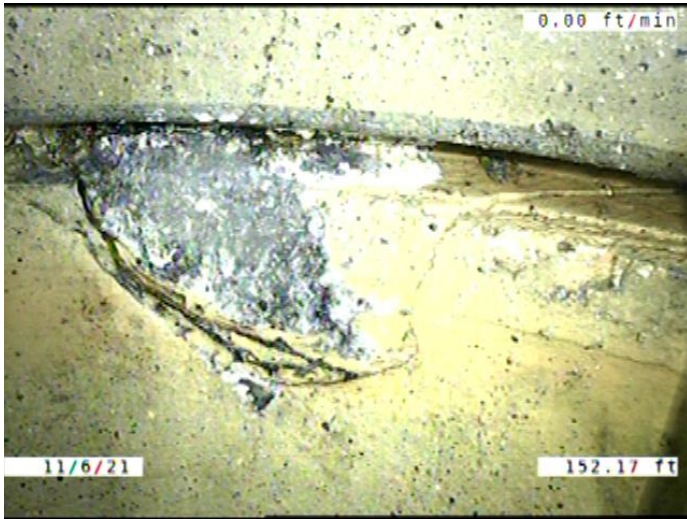
Code: **B**
Description: **Broken**

Distance (ft): **152.2**
Structural Grade: **4**
O&M Grade: **0**
Clock Start/From: **2**
Clock To: **3**
1st Value:
2nd Value:
Value Percent:
Continuous Index:
Within 8" of Joint: **YES**
Remarks:

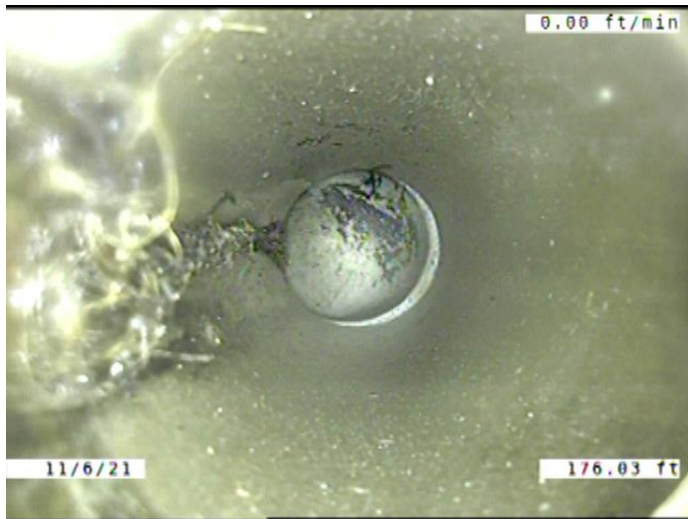
Code:	TBI
Description:	Tap Break-in Intruding
Distance (ft):	176.0
Structural Grade:	0
O&M Grade:	2
Clock Start/From:	11
Clock To:	
1st Value:	4.000
2nd Value:	1.000
Value Percent:	
Continuous Index:	
Within 8" of Joint:	YES
Remarks:	GROWING DOWN THE TAP INTO THE MAIN. CONSTANTLY RUNNING WAT

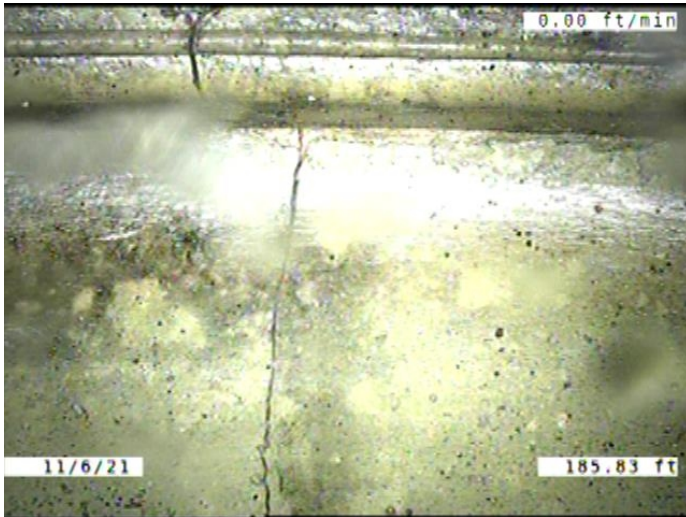
Code: **FL**
 Description: **Fracture Longitudinal**

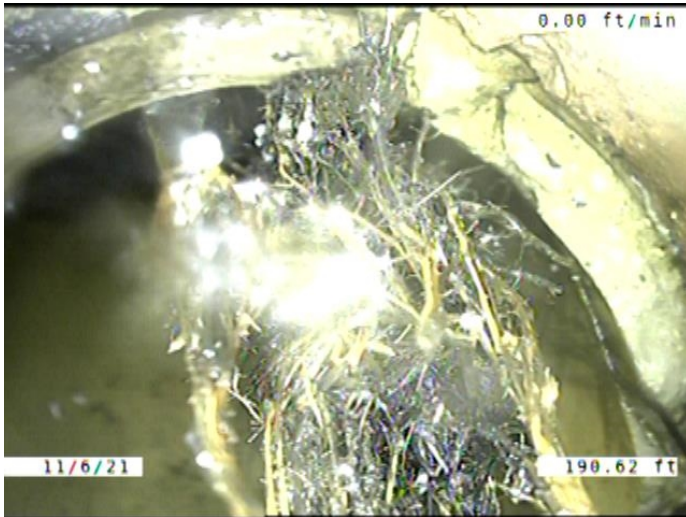
Code: **RML**
Description: **Roots Medium Lateral**

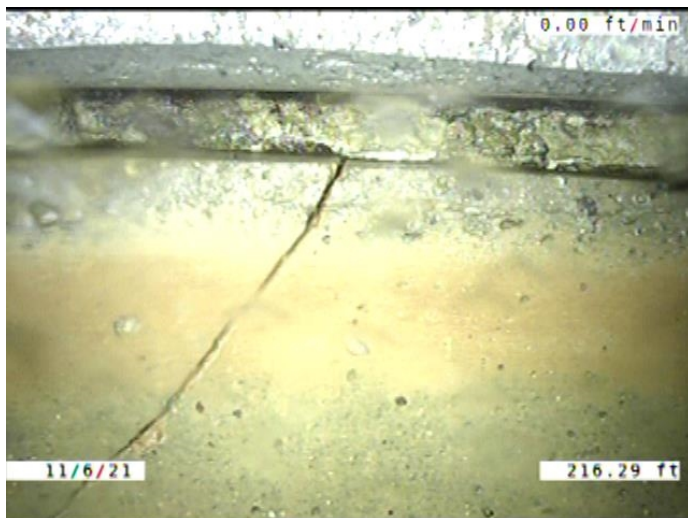
Code: **FS**
 Description: **Fracture Spiral**

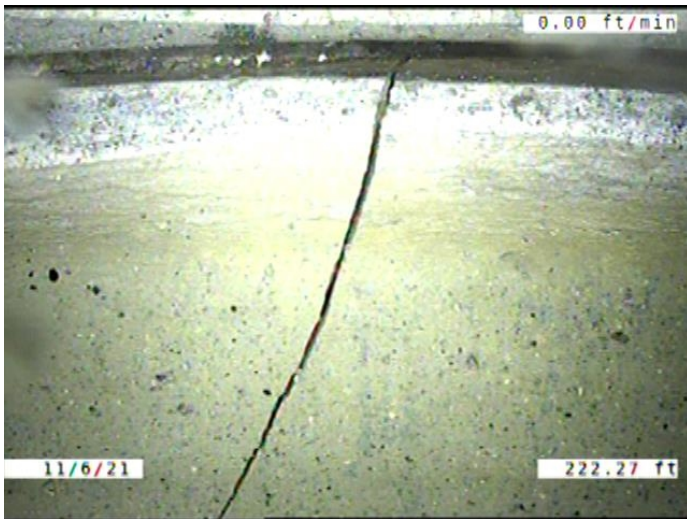
Code: **B**
 Description: **Broken**

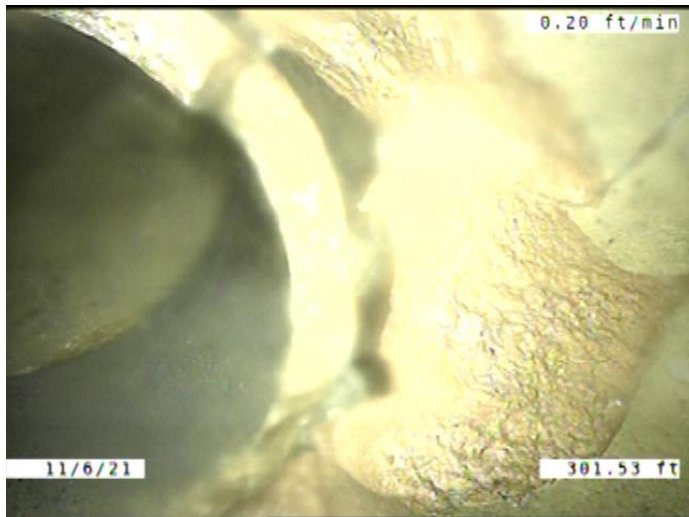
Code: **BSV**
 Description: **Broken Soil Visible**

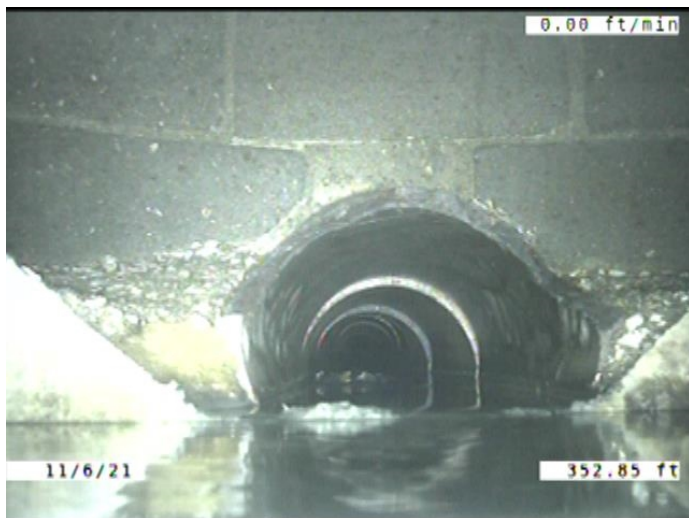
Code: **B**
 Description: **Broken**
