Profile/Photo Observation Report

Date:	04/22/2018	Weather:		Coding:	PACP 6.0
Pipe Length (ft):	307.4	Owner:	NA	Pre Clean:	No Pre-Cleaning
P.O.#:		Surveyor:	Mark Ruby	PSR:	P-404-005-004
Customer:		Clean Date:	01/01/1900	Shape:	C

Street:	W HOME AV	Flow Control:	Not Controlled
City:	Hobart, IN	Year Renewed:	
Location:	Light Highway	Tape/Media #:	
Purpose:	Routine Assessment	Dia/Height:	12"
Use:	Sanitary	Material:	VCP
Drain Area:	NA	Lining:	
Category:	NA		
Comment:	P_C at 66 ft nothing visible. Flow direction wrong		
Location Details:		Direction of Survey:	Downstream
US MH:	M-404-005	DS MH:	M-404-004
		Total Length Surveyed (ft):	67.5

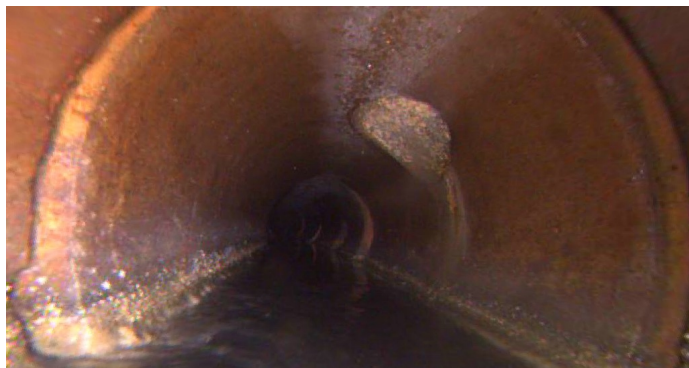
Code: **AMH**
Description: **Manhole**

Distance (ft): **.0**
Structural Grade: **0**
O&M Grade: **0**
Clock Start/From:
Clock To:
1st Value:
2nd Value:
Value Percent:
Continuous Index:
Within 8" of Joint: **NO**
Remarks: **M-404-005**

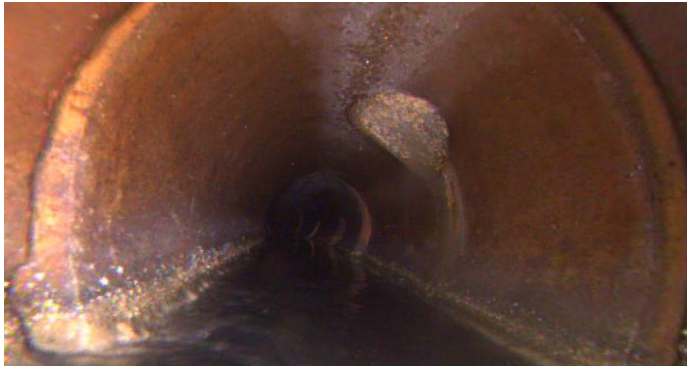
Code: **MWL**
Description: **Water Level**

Distance (ft): **.0**
Structural Grade: **0**
O&M Grade: **0**
Clock Start/From:
Clock To:
1st Value:
2nd Value:
Value Percent: **10.000**
Continuous Index:
Within 8" of Joint: **NO**
Remarks:

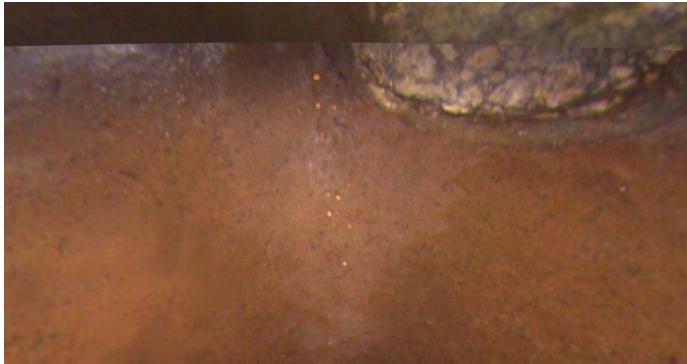
Code: **TFC**
Description: **Tap Factory Capped**

Distance (ft): **2.6**
Structural Grade: **0**
O&M Grade: **0**
Clock Start/From: **2**
Clock To:
1st Value: **4.000**
2nd Value:
Value Percent:
Continuous Index:
Within 8" of Joint:
Remarks:

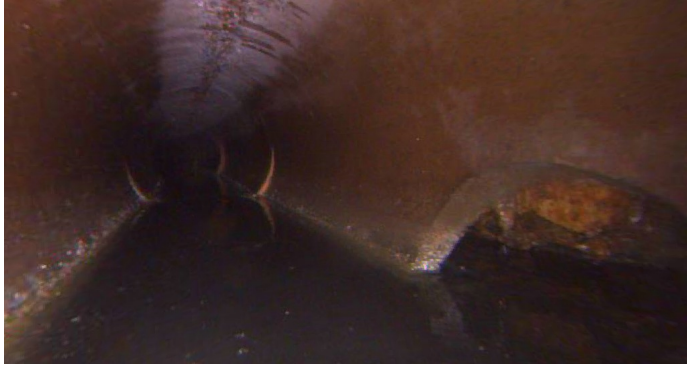
Code: **TFC**
Description: **Tap Factory Capped**

Distance (ft): **4.5**
Structural Grade: **0**
O&M Grade: **0**
Clock Start/From: **5**
Clock To:
1st Value: **4.000**
2nd Value:
Value Percent:
Continuous Index:
Within 8" of Joint:
Remarks:

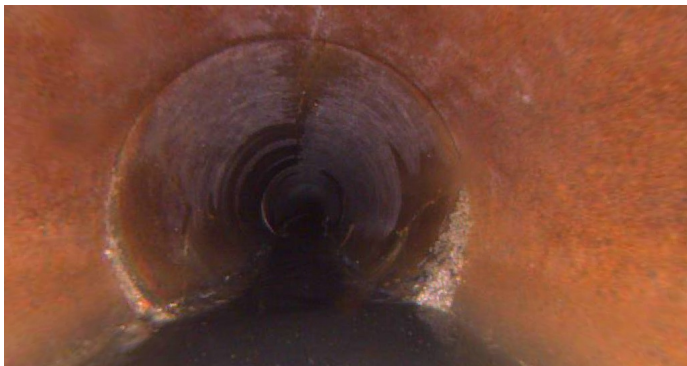
Code: **CL**
Description: **Crack Longitudinal**

Distance (ft): **26.9**
Structural Grade: **2**
O&M Grade: **0**
Clock Start/From: **12**
Clock To:
1st Value:
2nd Value:
Value Percent:
Continuous Index:
Within 8" of Joint: **NO**
Remarks:

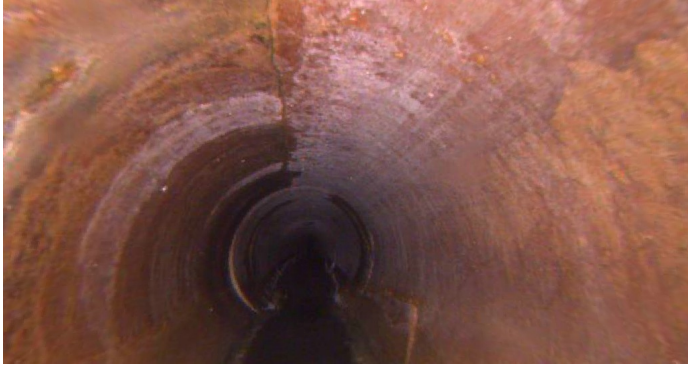
Code: **CM**
Description: **Crack Multiple**

Distance (ft): **28.5**
Structural Grade: **3**
O&M Grade: **0**
Clock Start/From: **7**
Clock To: **5**
1st Value:
2nd Value:
Value Percent:
Continuous Index:
Within 8" of Joint:
Remarks:

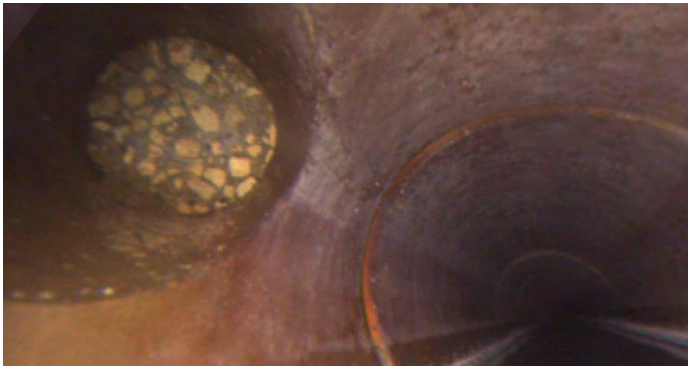
Code: **TFC**
Description: **Tap Factory Capped**

Distance (ft): **55.7**
Structural Grade: **0**
O&M Grade: **0**
Clock Start/From: **3**
Clock To:
1st Value: **4.000**
2nd Value:
Value Percent:
Continuous Index:
Within 8" of Joint:
Remarks:

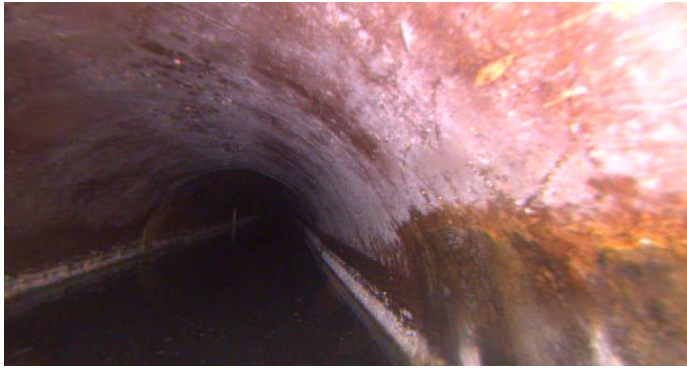
Code: **CL**
Description: **Crack Longitudinal**

Distance (ft): **61.6**
Structural Grade: **2**
O&M Grade: **0**
Clock Start/From: **4**
Clock To:
1st Value:
2nd Value:
Value Percent:
Continuous Index:
Within 8" of Joint:
Remarks:

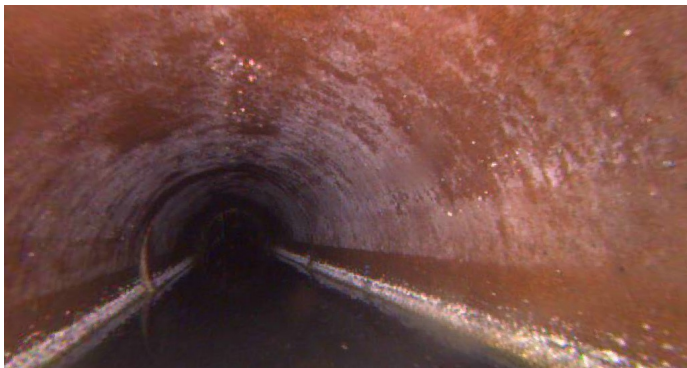
Code: **MSA**
Description: **Abandoned Survey**

Distance (ft): **67.5**
Structural Grade: **0**
O&M Grade: **0**
Clock Start/From:
Clock To:
1st Value:
2nd Value:
Value Percent:
Continuous Index:
Within 8" of Joint: **NO**
Remarks: **No blockage**
