## Profile/Photo Observation Report

Date:	<b>04/22/2018</b>	Weather:		Coding:	<b>PACP 6.0</b>
Pipe Length (ft):	<b>307.4</b>	Owner:	<b>NA</b>	Pre Clean:	<b>No Pre-Cleaning</b>
P.O.#:		Surveyor:	<b>Mark Ruby</b>	PSR:	<b>P-404-005-004</b>
Customer:		Clean Date:	<b>01/01/1900</b>	Shape:	<b>C</b>

Street:	<b>FOXCROFT STREET</b>	Flow Control:	<b>Not Controlled</b>
City:	<b>Hobart, IN</b>	Year Renewed:	
Location:	<b>Light Highway</b>	Tape/Media #:	
Purpose:	<b>Routine Assessment</b>	Dia/Height:	<b>12"</b>
Use:	<b>Sanitary</b>	Material:	<b>VCP</b>
Drain Area:	<b>NA</b>	Lining:	
Category:	<b>NA</b>		
Comment:	<b>P_C at 66 ft nothing visible. Flow direction wrong</b>		
Location Details:		Direction of Survey:	<b>Downstream</b>
US MH:	<b>M-404-005</b>	DS MH:	<b>M-404-004</b>
		Total Length Surveyed (ft):	<b>67.5</b>

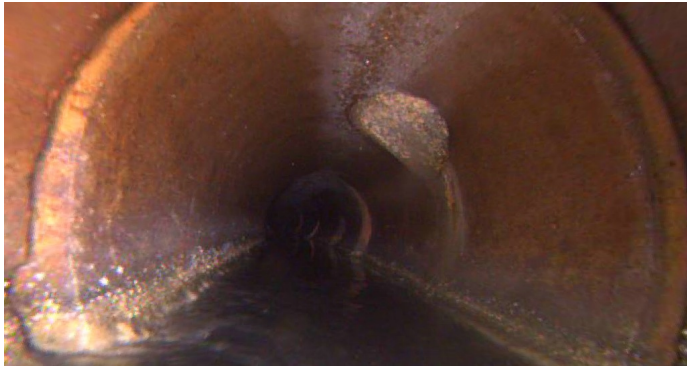
Code: **MWL**  
Description: **Water Level**

Distance (ft): **.0**  
Structural Grade: **0**  
O&M Grade: **0**  
Clock Start/From:  
Clock To:  
1st Value:  
2nd Value:  
Value Percent: **10.000**  
Continuous Index:  
Within 8" of Joint: **NO**  
Remarks:

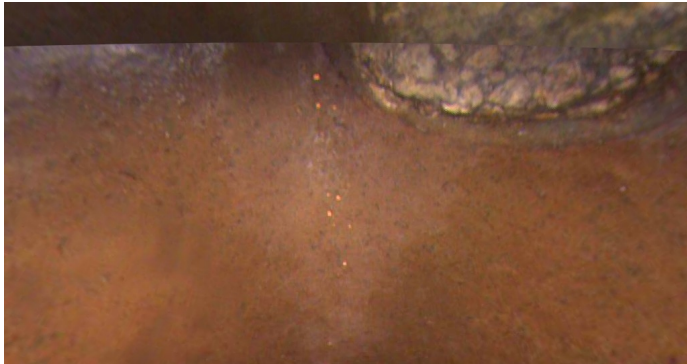
Code: **TFC**  
Description: **Tap Factory Capped**

Distance (ft): **2.6**  
Structural Grade: **0**  
O&M Grade: **0**  
Clock Start/From: **2**  
Clock To:  
1st Value: **4.000**  
2nd Value:  
Value Percent:  
Continuous Index:  
Within 8" of Joint:  
Remarks:

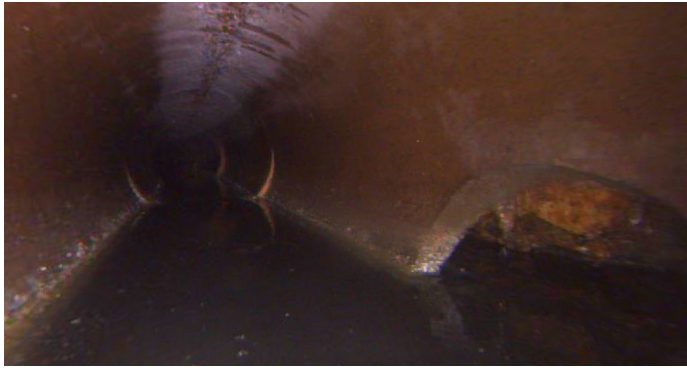
Code: **TFC**  
Description: **Tap Factory Capped**

Distance (ft): **4.5**  
Structural Grade: **0**  
O&M Grade: **0**  
Clock Start/From: **5**  
Clock To:  
1st Value: **4.000**  
2nd Value:  
Value Percent:  
Continuous Index:  
Within 8" of Joint:  
Remarks:

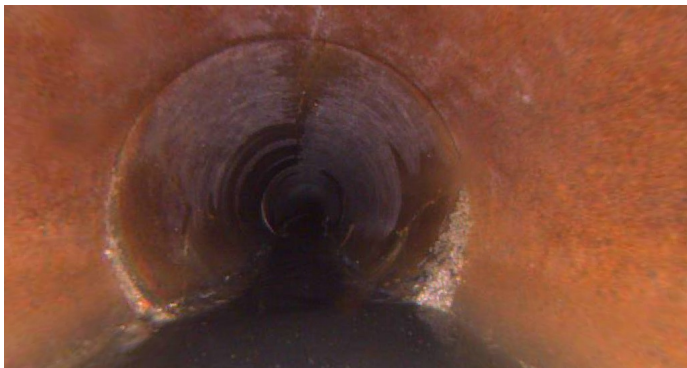
Code: **CL**  
Description: **Crack Longitudinal**

Distance (ft): **26.9**  
Structural Grade: **2**  
O&M Grade: **0**  
Clock Start/From: **12**  
Clock To:  
1st Value:  
2nd Value:  
Value Percent:  
Continuous Index:  
Within 8" of Joint: **NO**  
Remarks:

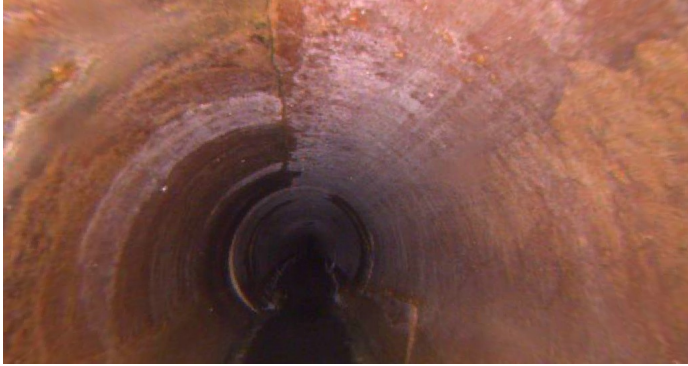
Code: **CM**  
Description: **Crack Multiple**

Distance (ft): **28.5**  
Structural Grade: **3**  
O&M Grade: **0**  
Clock Start/From: **7**  
Clock To: **5**  
1st Value:  
2nd Value:  
Value Percent:  
Continuous Index:  
Within 8" of Joint:  
Remarks:

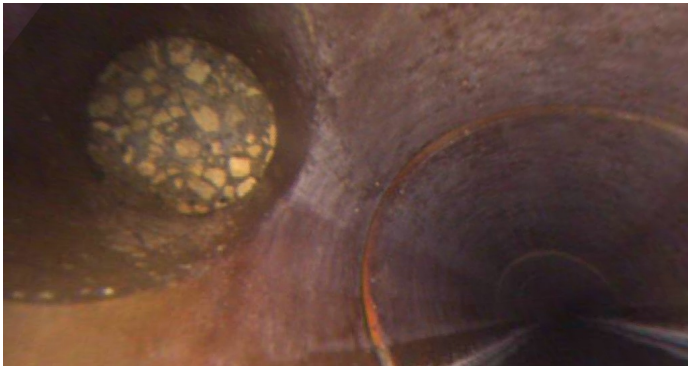
Code: **TFC**  
Description: **Tap Factory Capped**

Distance (ft): **55.7**  
Structural Grade: **0**  
O&M Grade: **0**  
Clock Start/From: **3**  
Clock To:  
1st Value: **4.000**  
2nd Value:  
Value Percent:  
Continuous Index:  
Within 8" of Joint:  
Remarks:

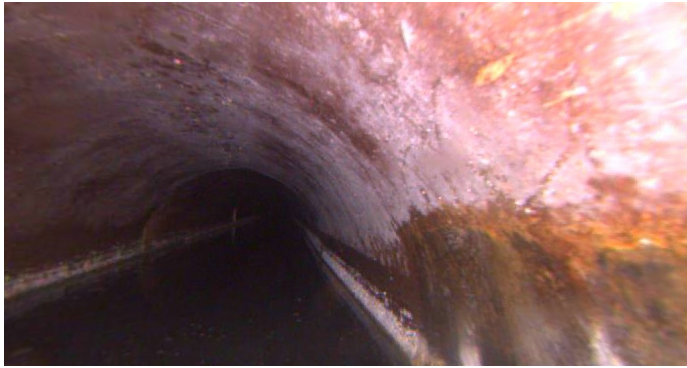
Code: **CL**  
Description: **Crack Longitudinal**

Distance (ft): **61.6**  
Structural Grade: **2**  
O&M Grade: **0**  
Clock Start/From: **4**  
Clock To:  
1st Value:  
2nd Value:  
Value Percent:  
Continuous Index:  
Within 8" of Joint:  
Remarks:

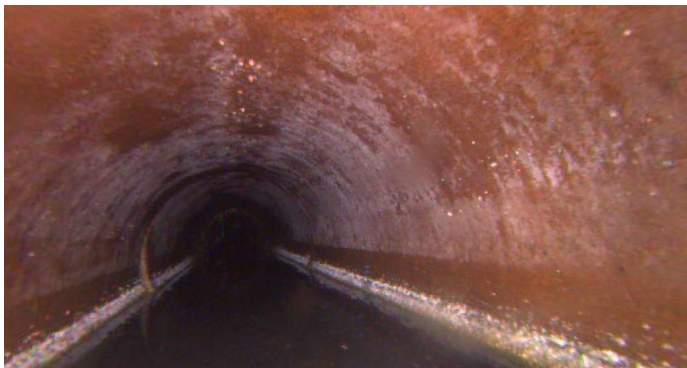
Code: **MSA**  
Description: **Abandoned Survey**

Distance (ft): **67.5**  
Structural Grade: **0**  
O&M Grade: **0**  
Clock Start/From:  
Clock To:  
1st Value:  
2nd Value:  
Value Percent:  
Continuous Index:  
Within 8" of Joint: **NO**  
Remarks: **No blockage**
