Profile/Photo Observation Report

Date:	11/06/2021	Weather:		Coding:	PACP 7.0
Pipe Length (ft):	303.8	Owner:	City of Hobart	Pre Clean:	Heavy Cleaning
P.O.#:	YES502259	Surveyor:	S. Bucklin	PSR:	P-404-005-004
Customer:	City of Hobart	Clean Date:	11/06/2021	Shape:	C

Street:	North Wabash Street	Flow Control:	Not Controlled
City:	Hobart, IN	Year Renewed:	
Location:	Alley	Tape/Media #:	
Purpose:	Routine Assessment	Dia/Height:	12"
Use:	Sanitary Sewage Pipe	Material:	VCP
Drain Area:		Lining:	None
Category:	NA		
Comment:			
Location Details:		Direction of Survey:	Downstream
US MH:	M-404-005	DS MH:	M-404-004
		Total Length Surveyed (ft):	303.8

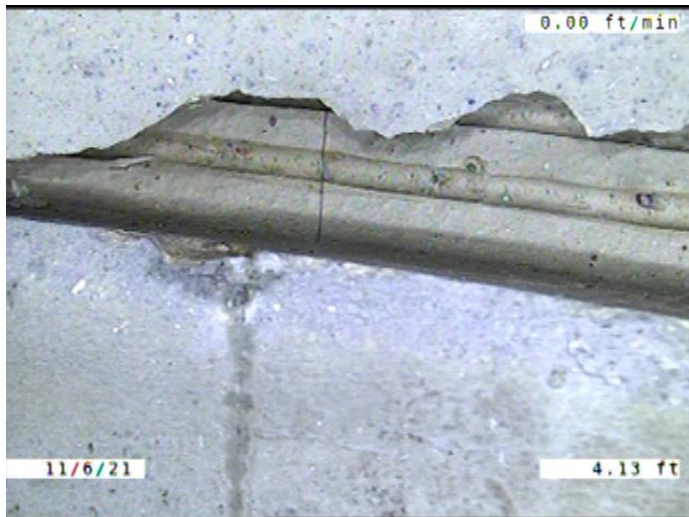
Code: **CL**
 Description: **Crack Longitudinal**

Distance (ft): **4.1**
 Structural Grade: **2**
 O&M Grade: **0**
 Clock Start/From: **2**
 Clock To:
 1st Value:
 2nd Value:
 Value Percent:
 Continuous Index:
 Within 8" of Joint: **YES**
 Remarks:

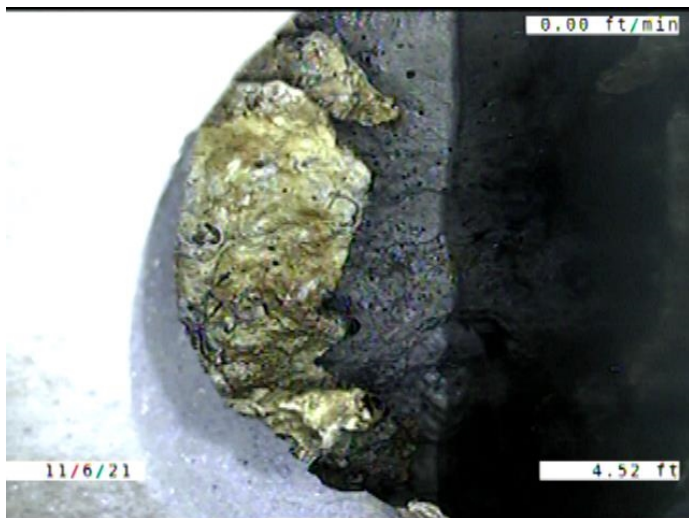
Code: **TFD**
 Description: **Tap Factory Defective**

Distance (ft): **4.5**
 Structural Grade: **0**
 O&M Grade: **3**
 Clock Start/From: **4**
 Clock To:
 1st Value: **4.000**
 2nd Value:
 Value Percent:
 Continuous Index:
 Within 8" of Joint: **YES**
 Remarks: **DAE, SOIL VISIBLE TOO**

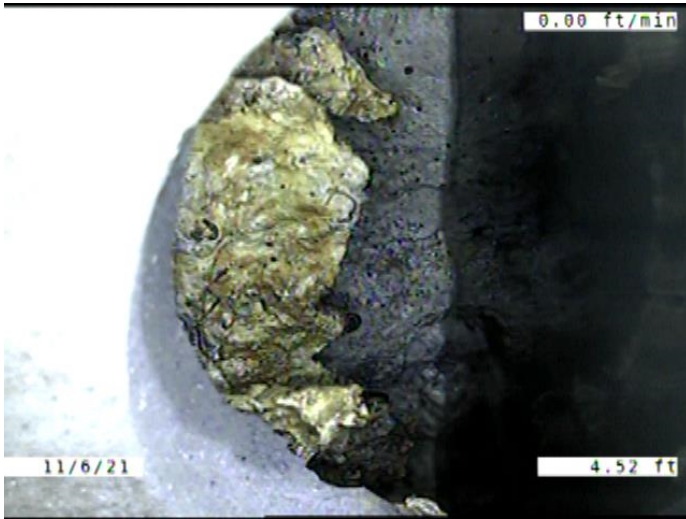
Code: **IDB**
Description: **Infiltration Dripper Barrel**

Distance (ft): **4.5**
Structural Grade: **0**
O&M Grade: **3**
Clock Start/From: **3**
Clock To: **4**
1st Value:
2nd Value:
Value Percent:
Continuous Index:
Within 8" of Joint: **YES**
Remarks:

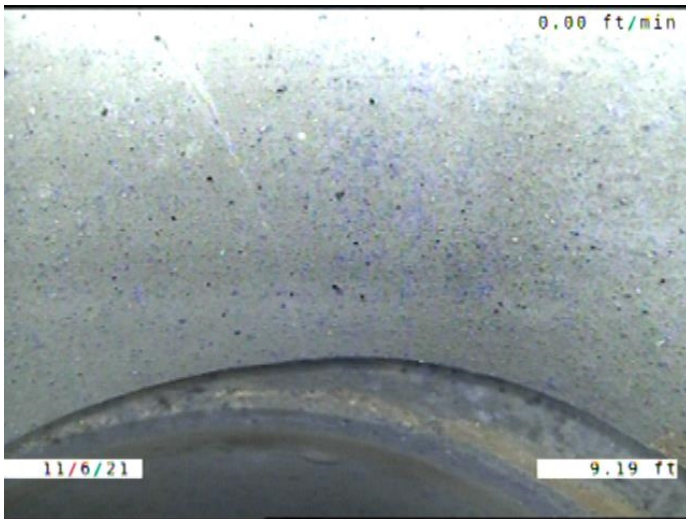
Code: **CS**
Description: **Crack Spiral**

Distance (ft): **9.2**
Structural Grade: **2**
O&M Grade: **0**
Clock Start/From: **11**
Clock To: **1**
1st Value:
2nd Value:
Value Percent:
Continuous Index:
Within 8" of Joint: **YES**
Remarks:

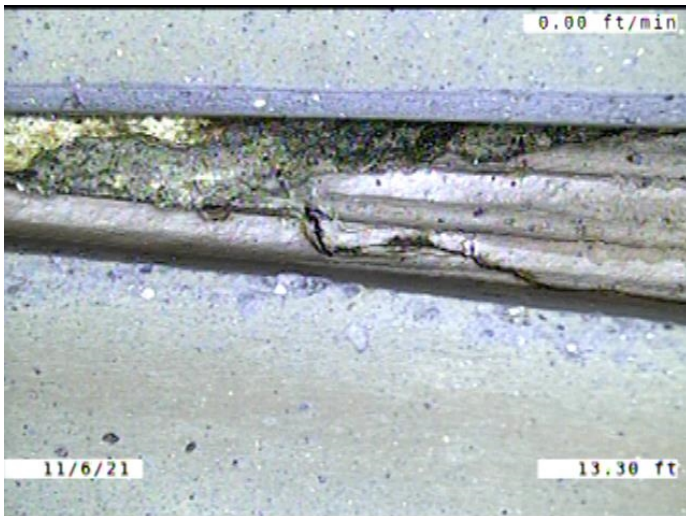
Code: **CM**
Description: **Crack Multiple**

Distance (ft): **13.3**
Structural Grade: **3**
O&M Grade: **0**
Clock Start/From: **1**
Clock To: **3**
1st Value:
2nd Value:
Value Percent:
Continuous Index:
Within 8" of Joint: **YES**
Remarks:

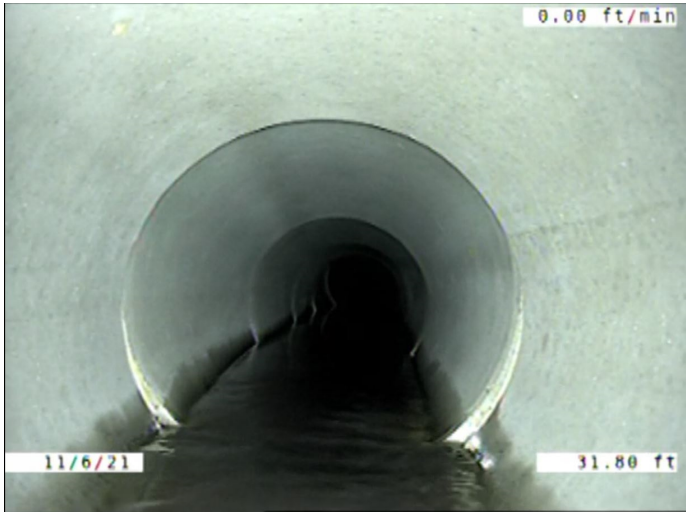
Code: **FM**
Description: **Fracture Multiple**

Distance (ft): **31.8**
Structural Grade: **4**
O&M Grade: **0**
Clock Start/From: **12**
Clock To: **12**
1st Value:
2nd Value:
Value Percent:
Continuous Index: **F01**
Within 8" of Joint: **YES**
Remarks:

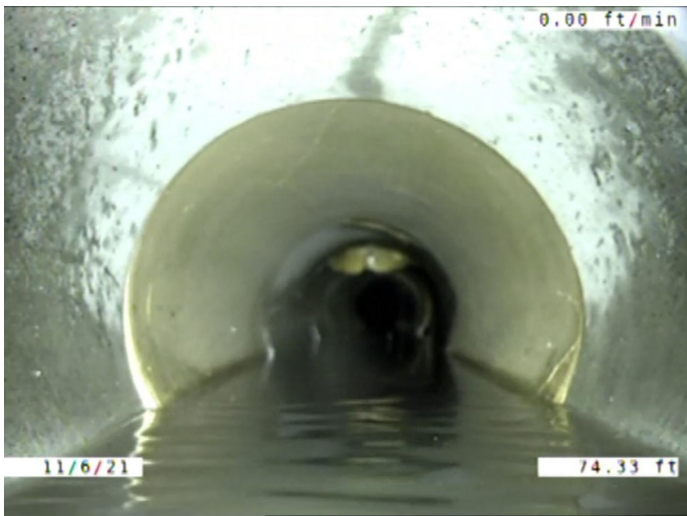
Code:	CM
Description:	Crack Multiple
Distance (ft):	74.3
Structural Grade:	3
O&M Grade:	0
Clock Start/From:	8
Clock To:	4
1st Value:	
2nd Value:	
Value Percent:	
Continuous Index:	S07
Within 8" of Joint:	YES
Remarks:	Wandering

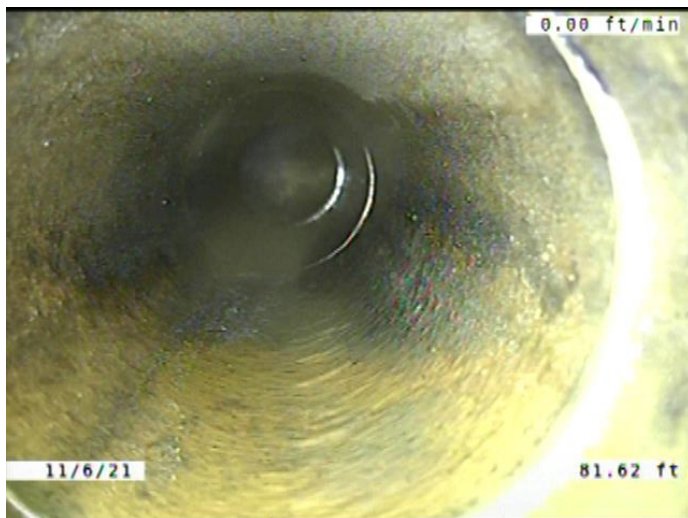
Code: **TBI**
Description: **Tap Break-in Intruding**

Distance (ft): **81.6**
Structural Grade: **0**
O&M Grade: **2**
Clock Start/From: **12**
Clock To:
1st Value: **4.000**
2nd Value: **1.000**
Value Percent:
Continuous Index:
Within 8" of Joint: **YES**
Remarks: **CONSTANTLY RUNNING WATER.**

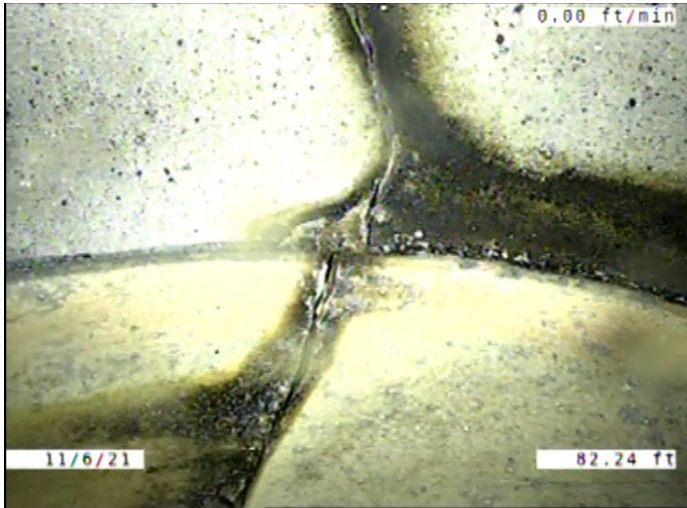
Code: **FM**
 Description: **Fracture Multiple**

Distance (ft): **82.2**
 Structural Grade: **4**
 O&M Grade: **0**
 Clock Start/From: **11**
 Clock To: **12**
 1st Value:
 2nd Value:
 Value Percent:
 Continuous Index:
 Within 8" of Joint: **YES**
 Remarks:

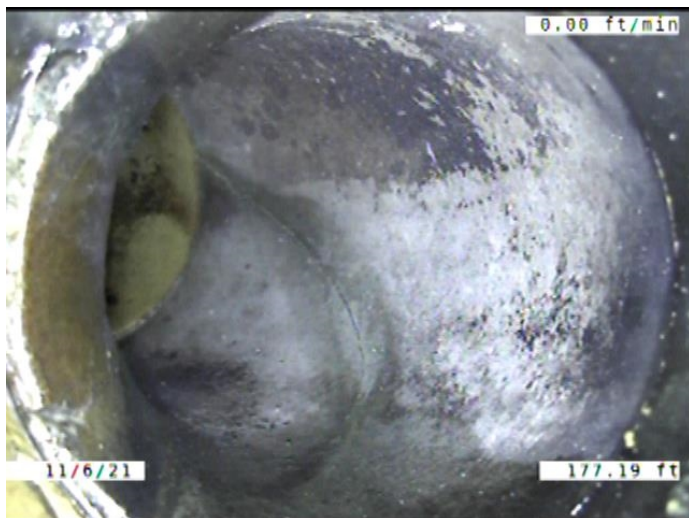
Code: **TBI**
Description: **Tap Break-in Intruding**

Distance (ft): **177.2**
Structural Grade: **0**
O&M Grade: **2**
Clock Start/From: **12**
Clock To:
1st Value: **4.000**
2nd Value: **1.000**
Value Percent:
Continuous Index:
Within 8" of Joint: **YES**
Remarks: **CONSTANTLY RUNNING WATER.**

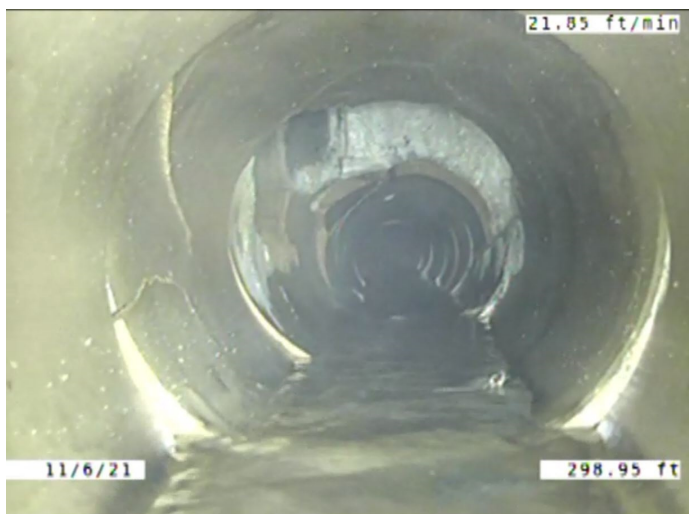
Code: **B**
Description: **Broken**
