# Profile/Photo Observation Report

Date:	11/06/2021	Weather:		Coding:	PACP 7.0
Pipe Length (ft):	303.8	Owner:	City of Hobart	Pre Clean:	Heavy Cleaning
P.O.#:	YES502259	Surveyor:	S. Bucklin	PSR:	P-404-005-004
Customer:	City of Hobart	Clean Date:	11/06/2021	Shape:	C

Street:	North Wabash Street	Flow Control:	Not Controlled
City:	Hobart, IN	Year Renewed:	
Location:	Alley	Tape/Media #:	
Purpose:	Routine Assessment	Dia/Height:	12"
Use:	Sanitary Sewage Pipe	Material:	VCP
Drain Area:		Lining:	None
Category:	NA		
Comment:			
Location Details:		Direction of Survey:	Downstream
US MH:	M-404-005	DS MH:	M-404-004
		Total Length Surveyed (ft):	303.8

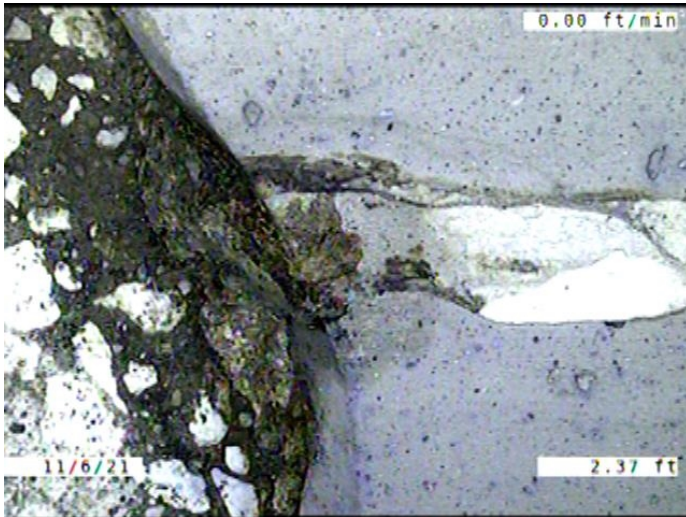
Code: **DAE**  
 Description: **Deposits Attached Encrustation**

Distance (ft): **2.4**  
 Structural Grade: **0**  
 O&M Grade: **2**  
 Clock Start/From: **2**  
 Clock To: **3**  
 1st Value:  
 2nd Value:  
 Value Percent: **5.000**  
 Continuous Index:  
 Within 8" of Joint: **YES**  
 Remarks:

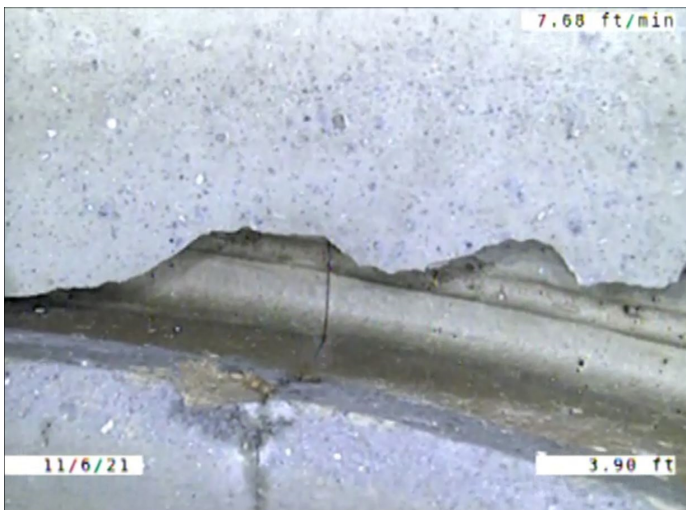
Code: **SMW**  
 Description: **Surface Damage Missing Wall**

Distance (ft): **3.9**  
 Structural Grade: **5**  
 O&M Grade: **0**  
 Clock Start/From: **2**  
 Clock To: **4**  
 1st Value:  
 2nd Value:  
 Value Percent:  
 Continuous Index:  
 Within 8" of Joint: **YES**  
 Remarks:

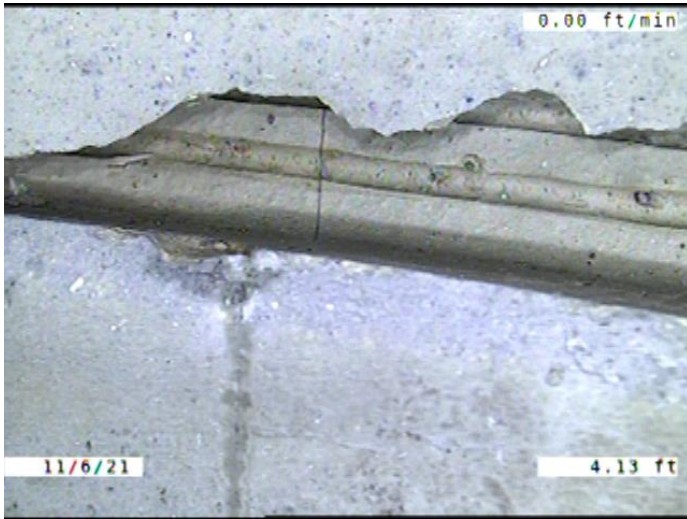
Code: **CL**  
Description: **Crack Longitudinal**

Distance (ft): **4.1**  
Structural Grade: **2**  
O&M Grade: **0**  
Clock Start/From: **2**  
Clock To:  
1st Value:  
2nd Value:  
Value Percent:  
Continuous Index:  
Within 8" of Joint: **YES**  
Remarks:

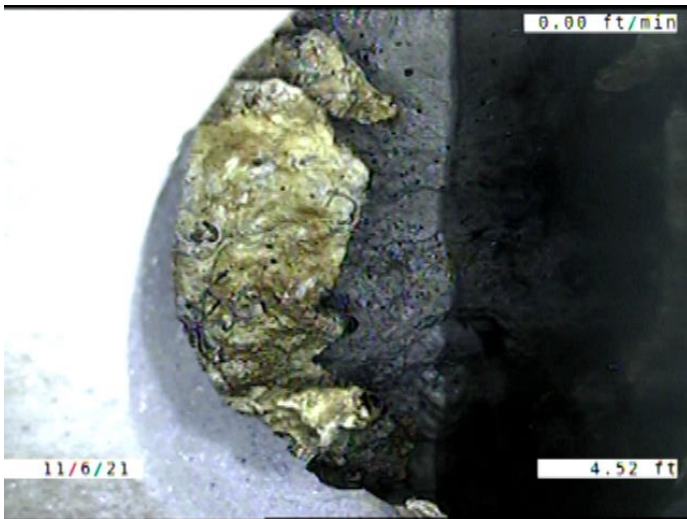
Code: **TFD**  
Description: **Tap Factory Defective**

Distance (ft): **4.5**  
Structural Grade: **0**  
O&M Grade: **3**  
Clock Start/From: **4**  
Clock To:  
1st Value: **4.000**  
2nd Value:  
Value Percent:  
Continuous Index:  
Within 8" of Joint: **YES**  
Remarks: **DAE, SOIL VISIBLE TOO**

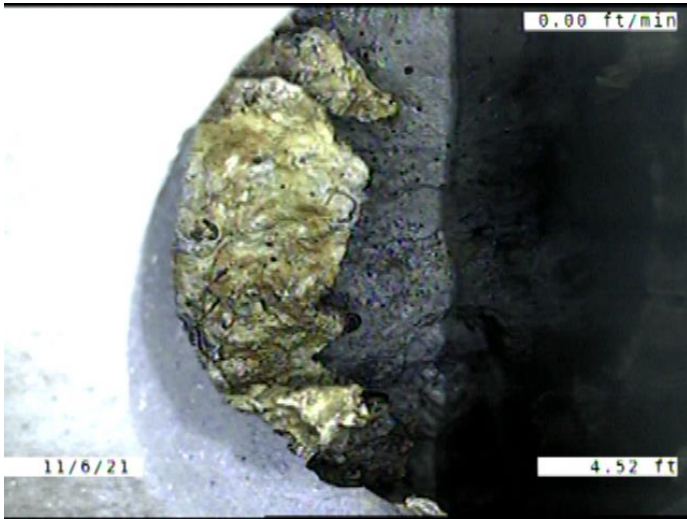
Code: **IDB**  
Description: **Infiltration Dripper Barrel**

Distance (ft): **4.5**  
Structural Grade: **0**  
O&M Grade: **3**  
Clock Start/From: **3**  
Clock To: **4**  
1st Value:  
2nd Value:  
Value Percent:  
Continuous Index:  
Within 8" of Joint: **YES**  
Remarks:

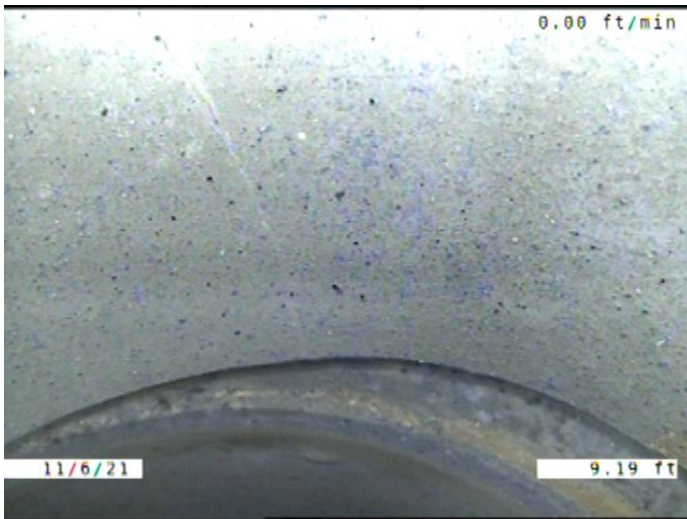
Code: **CS**  
Description: **Crack Spiral**

Distance (ft): **9.2**  
Structural Grade: **2**  
O&M Grade: **0**  
Clock Start/From: **11**  
Clock To: **1**  
1st Value:  
2nd Value:  
Value Percent:  
Continuous Index:  
Within 8" of Joint: **YES**  
Remarks:

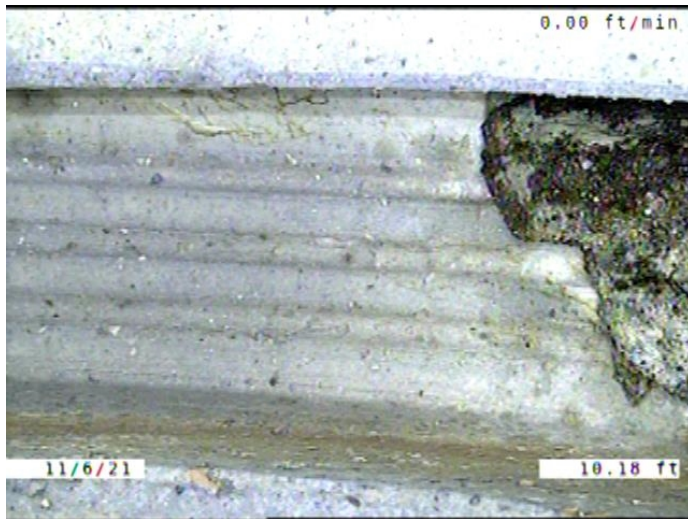
Code: **JAL**  
 Description: **Joint Angular Large**

Distance (ft): **10.2**  
 Structural Grade: **4**  
 O&M Grade: **0**  
 Clock Start/From:  
 Clock To:  
 1st Value:  
 2nd Value:  
 Value Percent:  
 Continuous Index:  
 Within 8" of Joint: **NO**  
 Remarks:

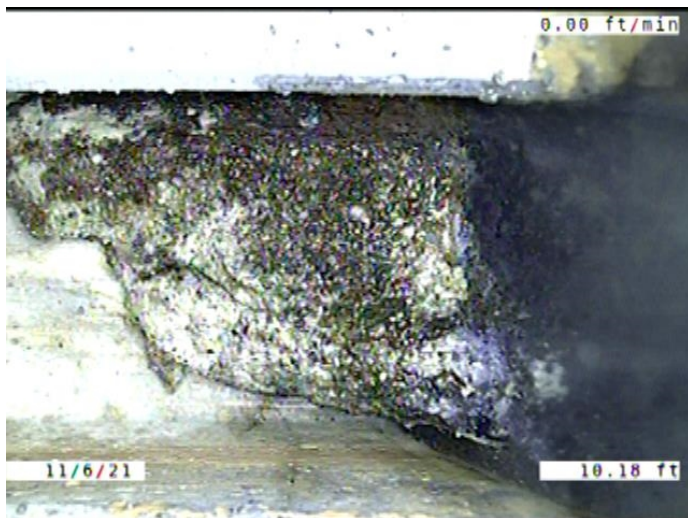
Code: **DAE**  
 Description: **Deposits Attached Encrustation**

Distance (ft): **10.2**  
 Structural Grade: **0**  
 O&M Grade: **2**  
 Clock Start/From: **3**  
 Clock To: **4**  
 1st Value:  
 2nd Value:  
 Value Percent: **5.000**  
 Continuous Index:  
 Within 8" of Joint: **YES**  
 Remarks:

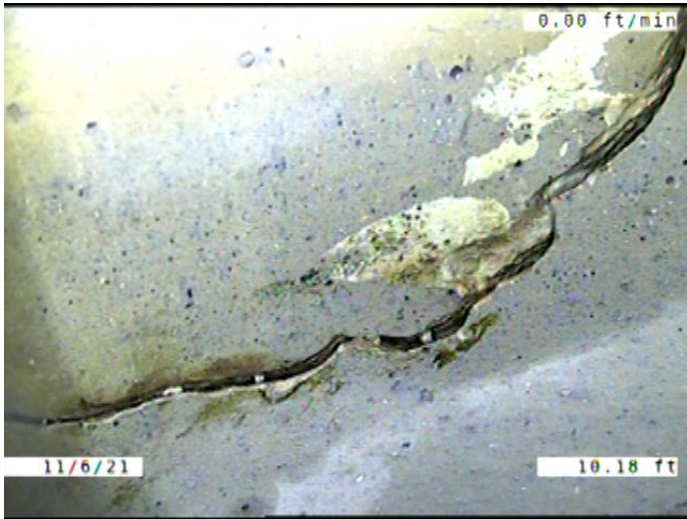
Code: **B**  
 Description: **Broken**

Distance (ft): **10.2**  
 Structural Grade: **4**  
 O&M Grade: **0**  
 Clock Start/From: **8**  
 Clock To: **10**  
 1st Value:  
 2nd Value:  
 Value Percent:  
 Continuous Index:  
 Within 8" of Joint: **YES**  
 Remarks:

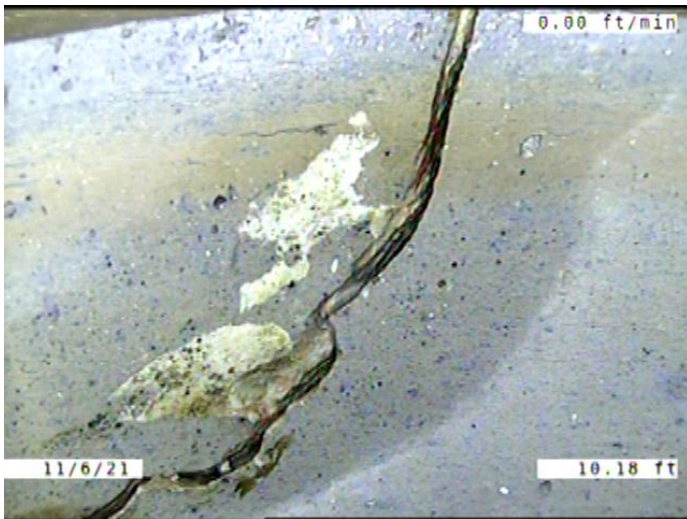
Code: **DAE**  
 Description: **Deposits Attached Encrustation**

Distance (ft): **10.2**  
 Structural Grade: **0**  
 O&M Grade: **2**  
 Clock Start/From: **8**  
 Clock To: **9**  
 1st Value:  
 2nd Value:  
 Value Percent: **5.000**  
 Continuous Index:  
 Within 8" of Joint: **YES**  
 Remarks:

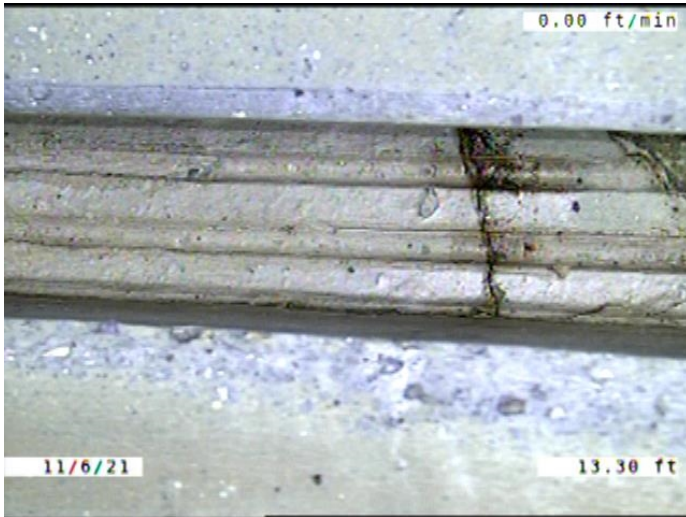
Code: **JAM**  
Description: **Joint Angular Medium**

Distance (ft): **13.3**  
Structural Grade: **3**  
O&M Grade: **0**  
Clock Start/From:  
Clock To:  
1st Value:  
2nd Value:  
Value Percent:  
Continuous Index:  
Within 8" of Joint: **NO**  
Remarks:

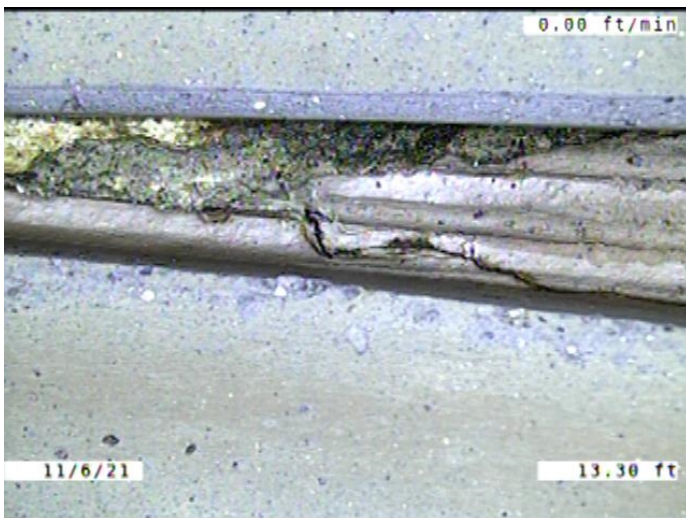
Code: **CM**  
Description: **Crack Multiple**

Distance (ft): **13.3**  
Structural Grade: **3**  
O&M Grade: **0**  
Clock Start/From: **1**  
Clock To: **3**  
1st Value:  
2nd Value:  
Value Percent:  
Continuous Index:  
Within 8" of Joint: **YES**  
Remarks:

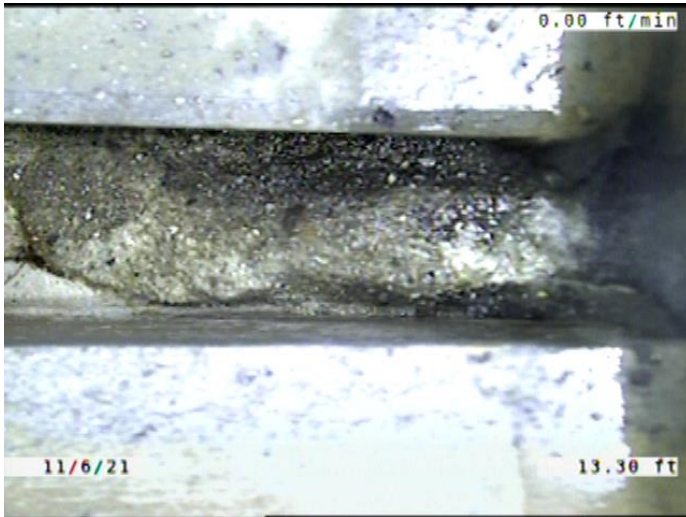
Code: **DAE**  
 Description: **Deposits Attached Encrustation**

Distance (ft): **13.3**  
 Structural Grade: **0**  
 O&M Grade: **2**  
 Clock Start/From: **12**  
 Clock To: **4**  
 1st Value:  
 2nd Value:  
 Value Percent: **5.000**  
 Continuous Index:  
 Within 8" of Joint: **YES**  
 Remarks:

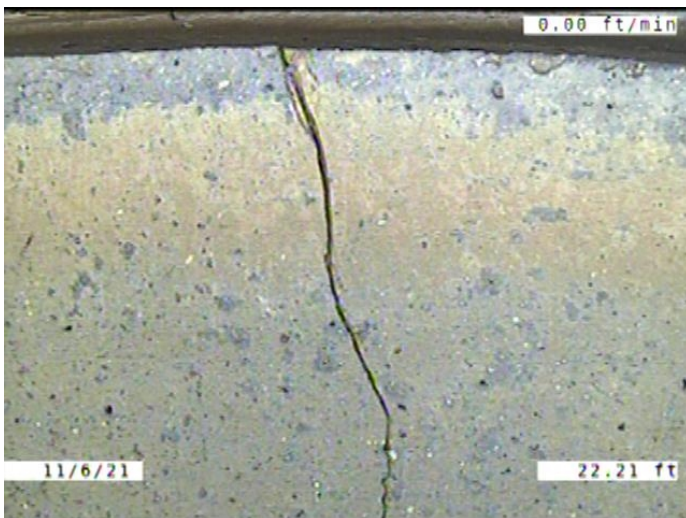
Code: **FS**  
 Description: **Fracture Spiral**

Distance (ft): **22.2**  
 Structural Grade: **3**  
 O&M Grade: **0**  
 Clock Start/From: **10**  
 Clock To: **1**  
 1st Value:  
 2nd Value:  
 Value Percent:  
 Continuous Index:  
 Within 8" of Joint: **YES**  
 Remarks:

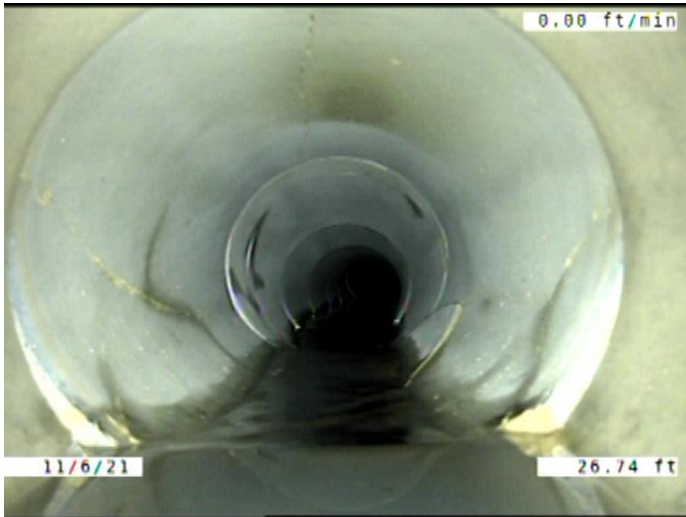
Code: **FM**  
 Description: **Fracture Multiple**

Distance (ft): **26.7**  
 Structural Grade: **4**  
 O&M Grade: **0**  
 Clock Start/From: **12**  
 Clock To: **12**  
 1st Value:  
 2nd Value:  
 Value Percent:  
 Continuous Index: **S01**  
 Within 8" of Joint: **YES**  
 Remarks:

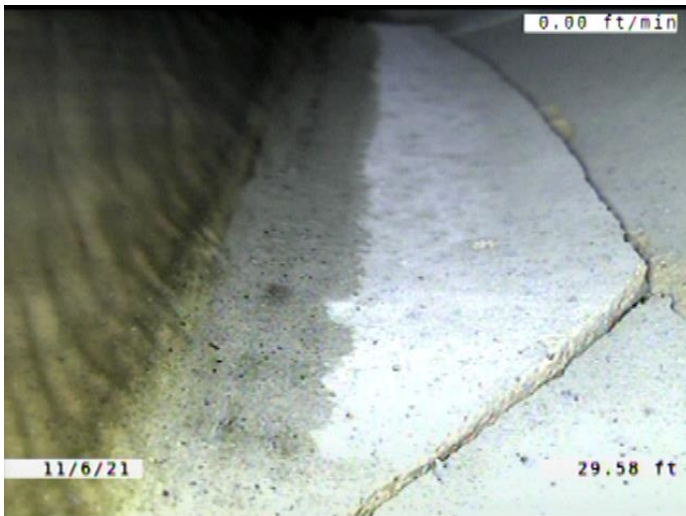
Code: **B**  
 Description: **Broken**

Distance (ft): **29.6**  
 Structural Grade: **4**  
 O&M Grade: **0**  
 Clock Start/From: **3**  
 Clock To: **5**  
 1st Value:  
 2nd Value:  
 Value Percent:  
 Continuous Index:  
 Within 8" of Joint: **NO**  
 Remarks:

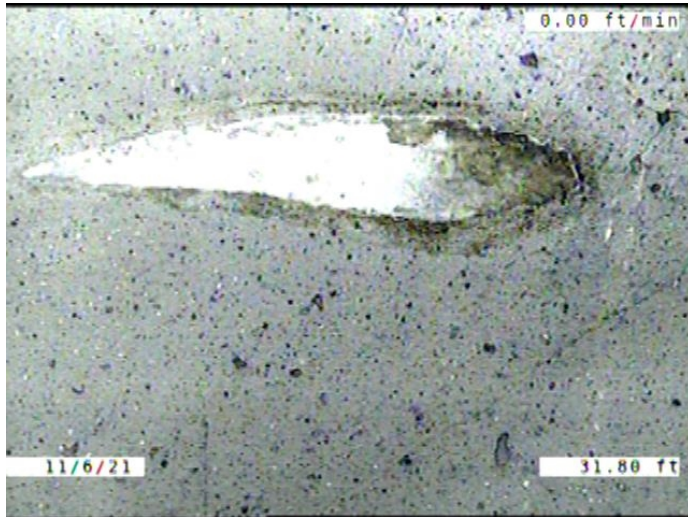
Code: **DAE**  
Description: **Deposits Attached Encrustation**

Distance (ft): **31.8**  
Structural Grade: **0**  
O&M Grade: **2**  
Clock Start/From: **10**  
Clock To:  
1st Value:  
2nd Value:  
Value Percent: **5.000**  
Continuous Index:  
Within 8" of Joint: **NO**  
Remarks:

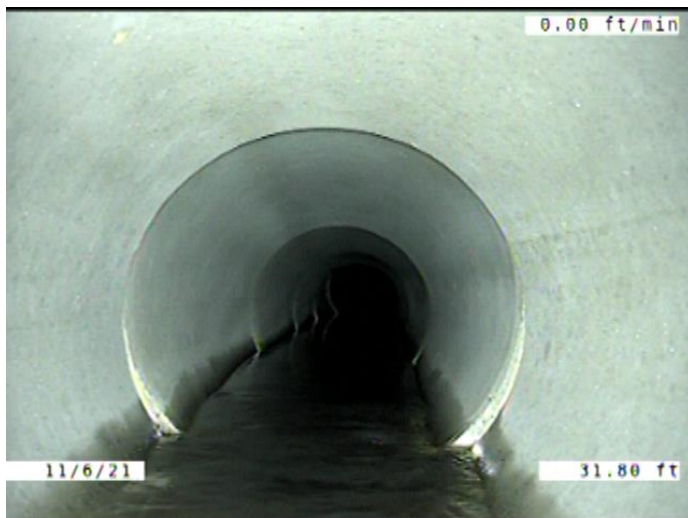
Code: **MWLS**  
Description: **Miscellaneous Water Level Sag**

Distance (ft): **31.8**  
Structural Grade: **2**  
O&M Grade: **0**  
Clock Start/From:  
Clock To:  
1st Value:  
2nd Value:  
Value Percent: **10.000**  
Continuous Index: **S02**  
Within 8" of Joint: **NO**  
Remarks:

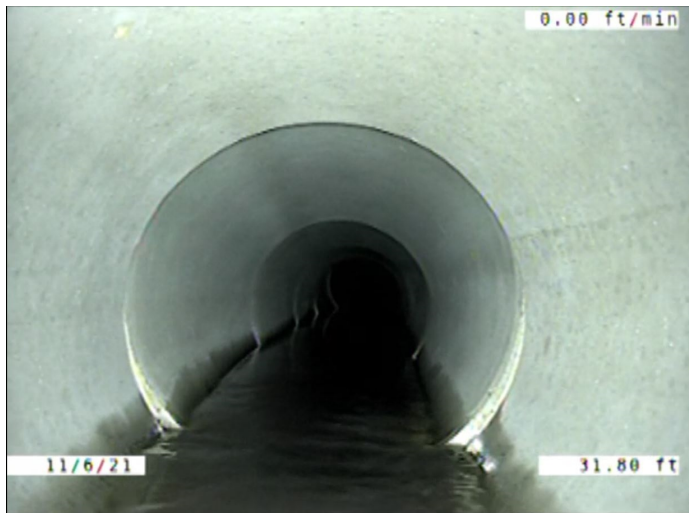
Code: **FM**  
Description: **Fracture Multiple**

Distance (ft): **31.8**  
Structural Grade: **4**  
O&M Grade: **0**  
Clock Start/From: **12**  
Clock To: **12**  
1st Value:  
2nd Value:  
Value Percent:  
Continuous Index: **F01**  
Within 8" of Joint: **YES**  
Remarks:

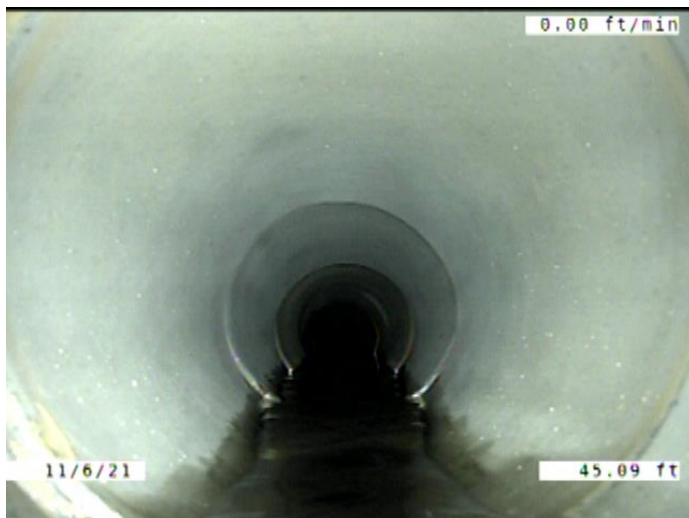
Code: **MWLS**  
Description: **Miscellaneous Water Level Sag**

Distance (ft): **45.1**  
Structural Grade: **2**  
O&M Grade: **0**  
Clock Start/From:  
Clock To:  
1st Value:  
2nd Value:  
Value Percent: **10.000**  
Continuous Index: **F02**  
Within 8" of Joint: **NO**  
Remarks:

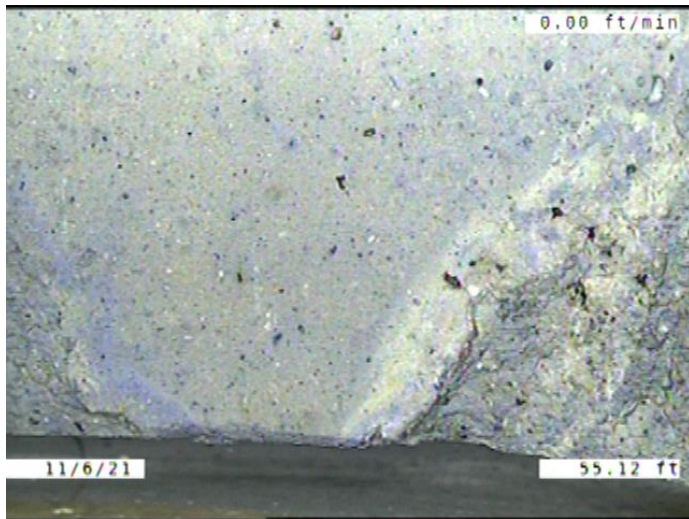
Code: **SSS**  
 Description: **Surface Damage Surface Spalling**

Distance (ft): **55.1**  
 Structural Grade: **2**  
 O&M Grade: **0**  
 Clock Start/From: **1**  
 Clock To: **3**  
 1st Value:  
 2nd Value:  
 Value Percent:  
 Continuous Index:  
 Within 8" of Joint: **YES**  
 Remarks:

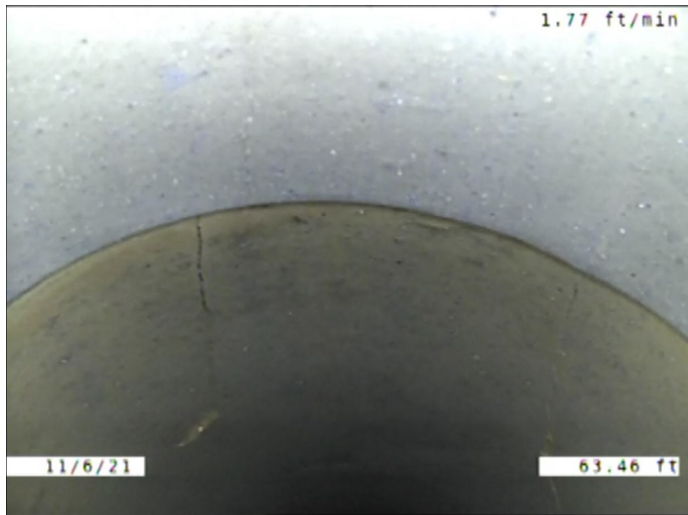
Code: **CM**  
Description: **Crack Multiple**

Distance (ft): **63.5**  
Structural Grade: **3**  
O&M Grade: **0**  
Clock Start/From: **11**  
Clock To: **2**  
1st Value:  
2nd Value:  
Value Percent:  
Continuous Index:  
Within 8" of Joint: **NO**  
Remarks:

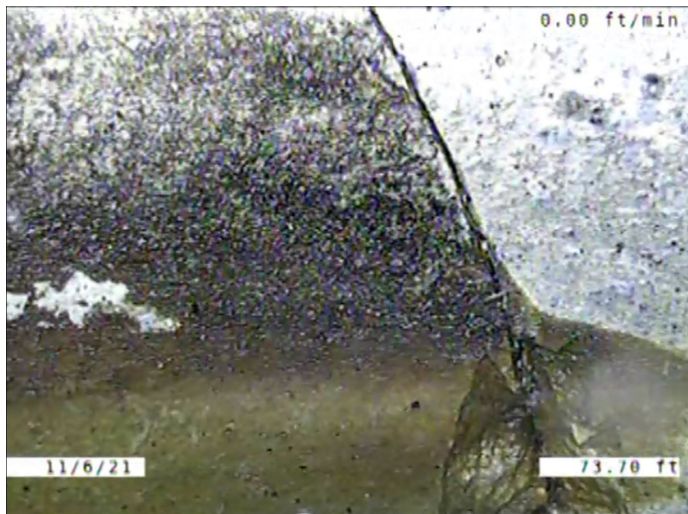
Code: **FL**  
Description: **Fracture Longitudinal**

Distance (ft): **73.7**  
Structural Grade: **3**  
O&M Grade: **0**  
Clock Start/From: **12**  
Clock To:  
1st Value:  
2nd Value:  
Value Percent:  
Continuous Index:  
Within 8" of Joint: **NO**  
Remarks:

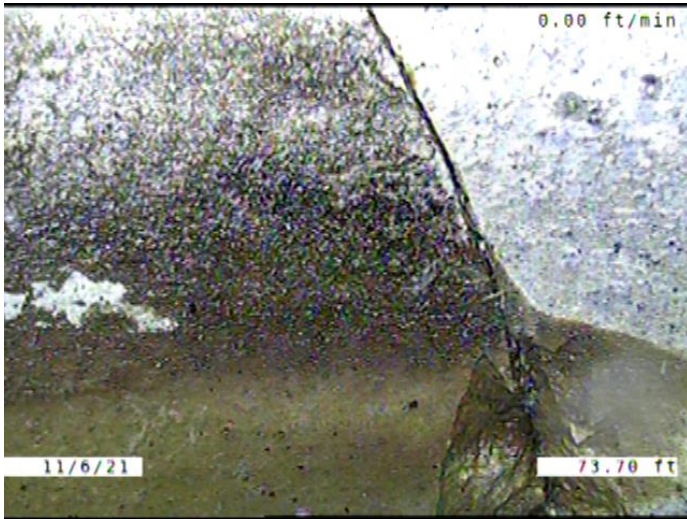
Code: **ISB**  
 Description: **Infiltration Stain Barrel**

Distance (ft): **73.7**  
 Structural Grade: **0**  
 O&M Grade: **1**  
 Clock Start/From: **8**  
 Clock To: **4**  
 1st Value:  
 2nd Value:  
 Value Percent:  
 Continuous Index:  
 Within 8" of Joint: **YES**  
 Remarks:

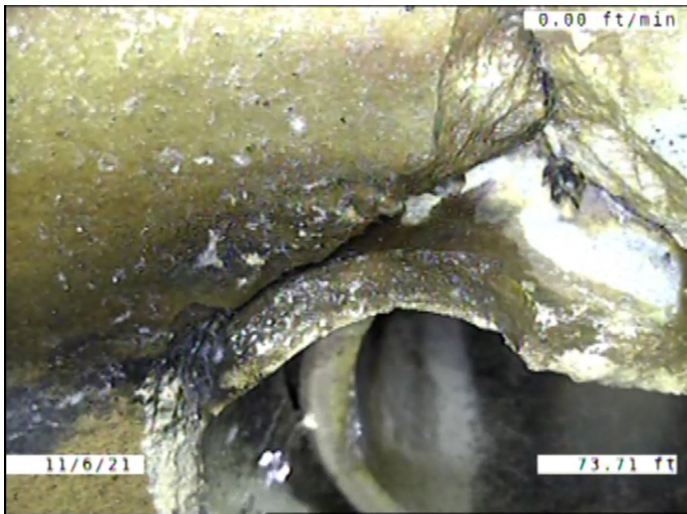
Code: **SSS**  
 Description: **Surface Damage Surface Spalling**

Distance (ft): **73.7**  
 Structural Grade: **2**  
 O&M Grade: **0**  
 Clock Start/From: **12**  
 Clock To:  
 1st Value:  
 2nd Value:  
 Value Percent:  
 Continuous Index:  
 Within 8" of Joint: **NO**  
 Remarks:

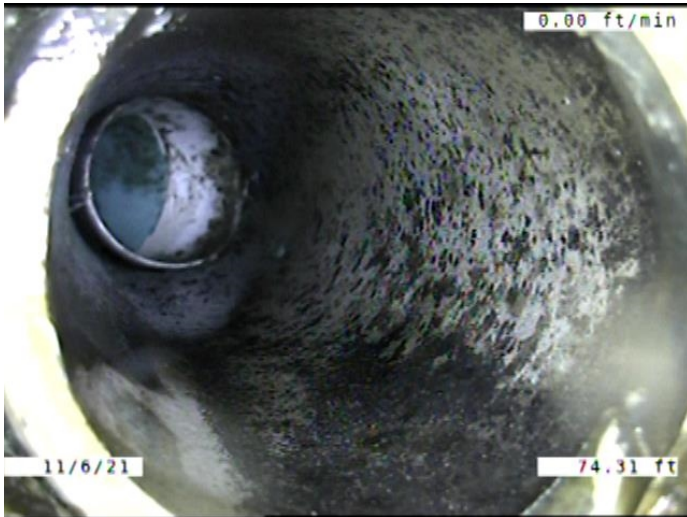
Code:	<b>TBI</b>
Description:	<b>Tap Break-in Intruding</b>
Distance (ft):	<b>74.3</b>
Structural Grade:	<b>0</b>
O&M Grade:	<b>2</b>
Clock Start/From:	<b>12</b>
Clock To:	
1st Value:	<b>4.000</b>
2nd Value:	<b>1.000</b>
Value Percent:	
Continuous Index:	
Within 8" of Joint:	<b>YES</b>
Remarks:	<b>CONSTANTLY RUNNING WATER</b>

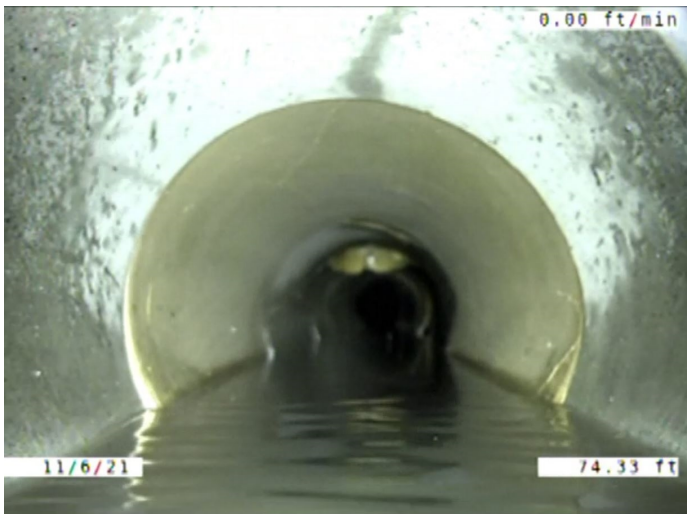
Code:	<b>CM</b>
Description:	<b>Crack Multiple</b>
Distance (ft):	<b>74.3</b>
Structural Grade:	<b>3</b>
O&M Grade:	<b>0</b>
Clock Start/From:	<b>8</b>
Clock To:	<b>4</b>
1st Value:	
2nd Value:	
Value Percent:	
Continuous Index:	<b>S07</b>
Within 8" of Joint:	<b>YES</b>
Remarks:	<b>Wandering</b>

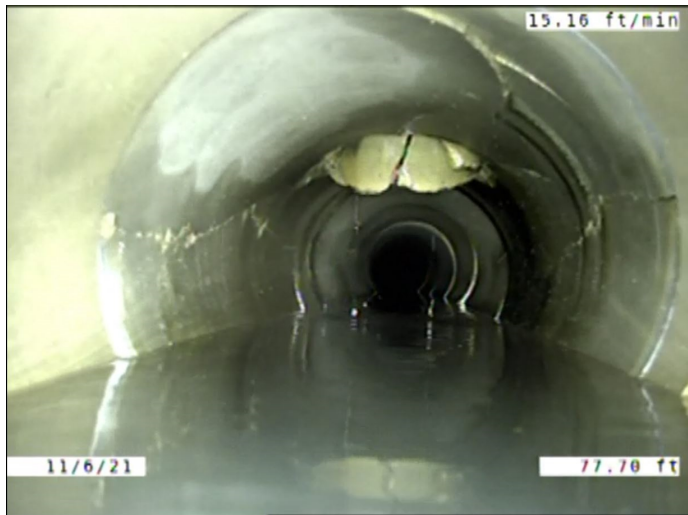
Code: **B**  
Description: **Broken**

Distance (ft): **77.7**  
Structural Grade: **4**  
O&M Grade: **0**  
Clock Start/From: **11**  
Clock To: **1**  
1st Value:  
2nd Value:  
Value Percent:  
Continuous Index:  
Within 8" of Joint: **YES**  
Remarks:

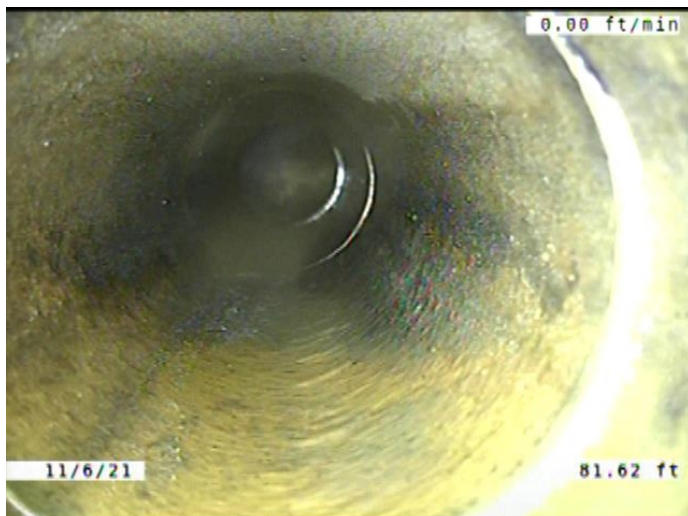
Code: **TBI**  
Description: **Tap Break-in Intruding**

Distance (ft): **81.6**  
Structural Grade: **0**  
O&M Grade: **2**  
Clock Start/From: **12**  
Clock To:  
1st Value: **4.000**  
2nd Value: **1.000**  
Value Percent:  
Continuous Index:  
Within 8" of Joint: **YES**  
Remarks: **CONSTANTLY RUNNING WATER.**

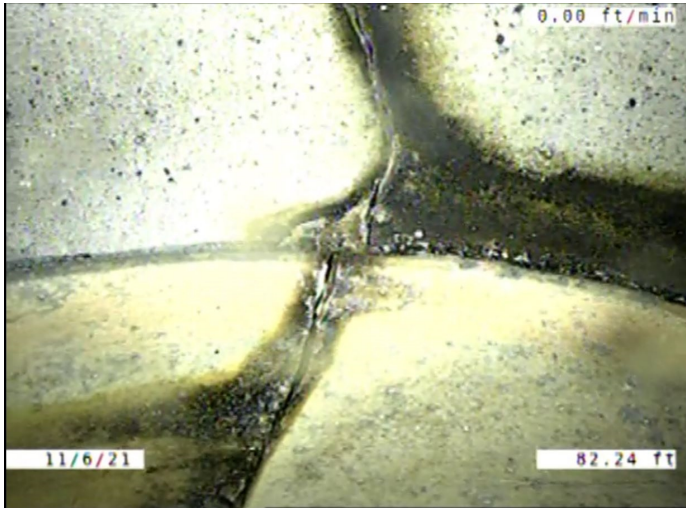
Code: **FM**  
 Description: **Fracture Multiple**

Distance (ft): **82.2**  
 Structural Grade: **4**  
 O&M Grade: **0**  
 Clock Start/From: **11**  
 Clock To: **12**  
 1st Value:  
 2nd Value:  
 Value Percent:  
 Continuous Index:  
 Within 8" of Joint: **YES**  
 Remarks:

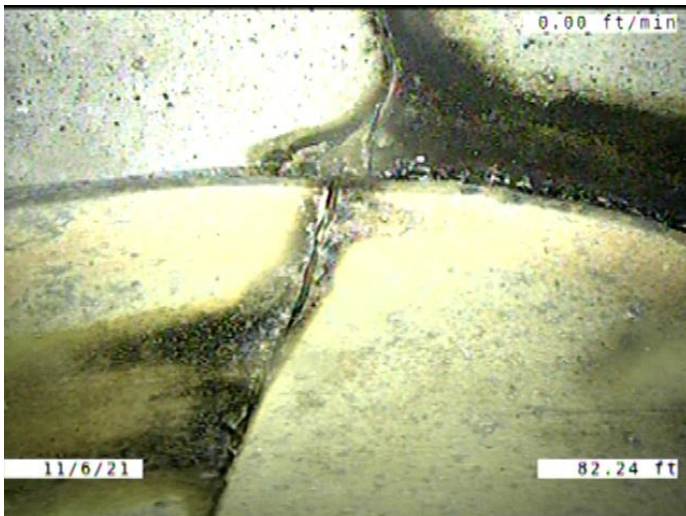
Code: **ISB**  
 Description: **Infiltration Stain Barrel**

Distance (ft): **82.2**  
 Structural Grade: **0**  
 O&M Grade: **1**  
 Clock Start/From: **8**  
 Clock To: **4**  
 1st Value:  
 2nd Value:  
 Value Percent:  
 Continuous Index:  
 Within 8" of Joint: **YES**  
 Remarks:

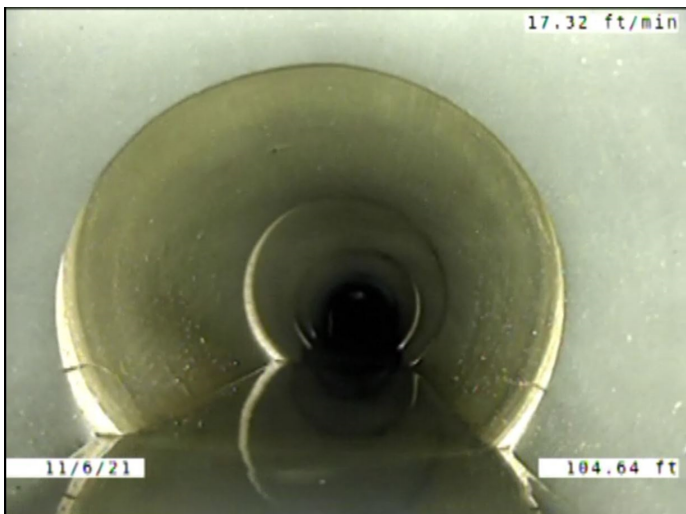
Code: **FS**  
 Description: **Fracture Spiral**

Distance (ft): **104.6**  
 Structural Grade: **3**  
 O&M Grade: **0**  
 Clock Start/From: **7**  
 Clock To: **8**  
 1st Value:  
 2nd Value:  
 Value Percent:  
 Continuous Index:  
 Within 8" of Joint: **YES**  
 Remarks:

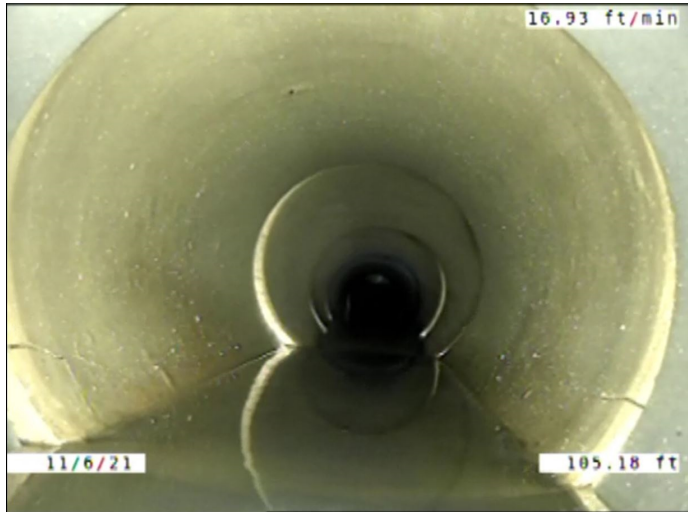
Code: **FL**  
Description: **Fracture Longitudinal**

Distance (ft): **105.2**  
Structural Grade: **3**  
O&M Grade: **0**  
Clock Start/From: **4**  
Clock To:  
1st Value:  
2nd Value:  
Value Percent:  
Continuous Index:  
Within 8" of Joint: **YES**  
Remarks:

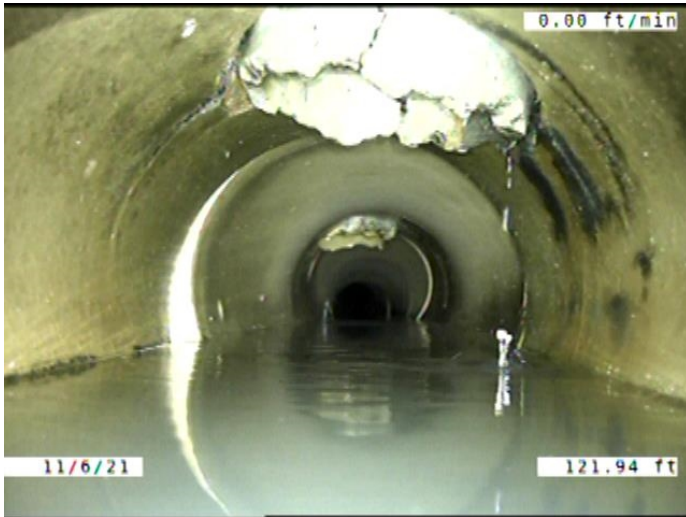
Code: **MWLS**  
 Description: **Miscellaneous Water Level Sag**

Distance (ft): **121.9**  
 Structural Grade: **2**  
 O&M Grade: **0**  
 Clock Start/From:  
 Clock To:  
 1st Value:  
 2nd Value:  
 Value Percent: **15.000**  
 Continuous Index: **S03**  
 Within 8" of Joint: **NO**  
 Remarks:

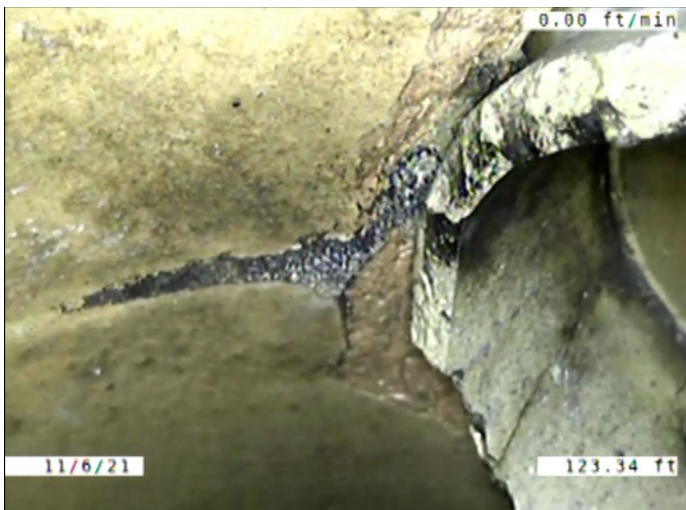
Code: **SSS**  
 Description: **Surface Damage Surface Spalling**

Distance (ft): **123.3**  
 Structural Grade: **2**  
 O&M Grade: **0**  
 Clock Start/From: **12**  
 Clock To: **2**  
 1st Value:  
 2nd Value:  
 Value Percent:  
 Continuous Index:  
 Within 8" of Joint: **NO**  
 Remarks:

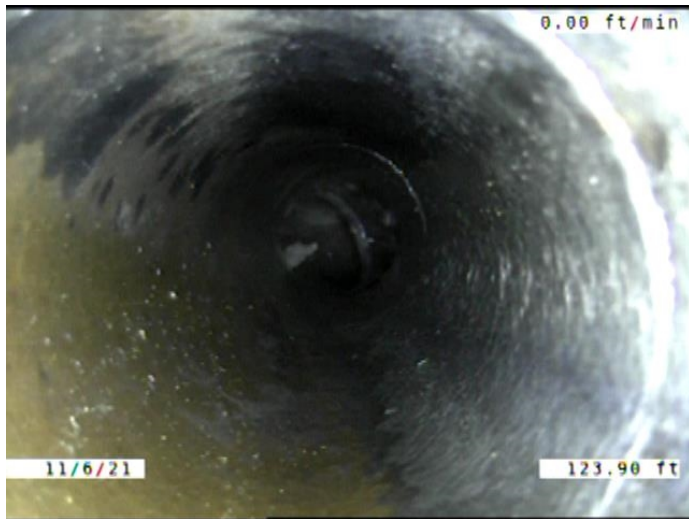
Code: **TBI**  
 Description: **Tap Break-in Intruding**

Distance (ft): **123.9**  
 Structural Grade: **0**  
 O&M Grade: **2**  
 Clock Start/From: **12**  
 Clock To:  
 1st Value: **4.000**  
 2nd Value: **1.000**  
 Value Percent:  
 Continuous Index:  
 Within 8" of Joint: **YES**  
 Remarks: **LARGE OFFSET**

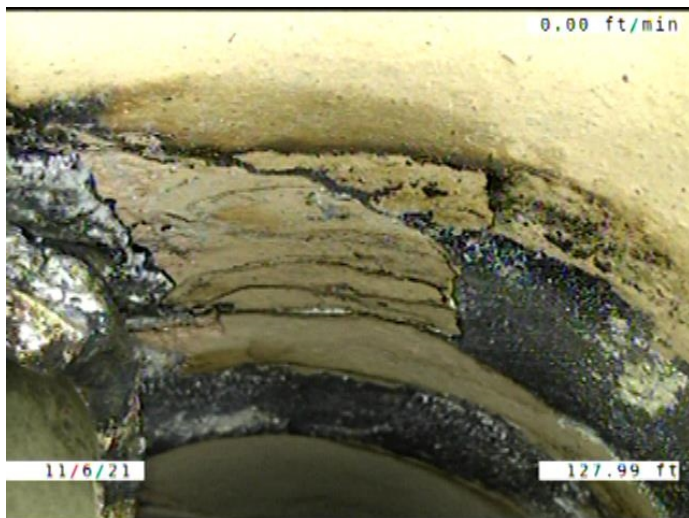
Code: **DAE**  
 Description: **Deposits Attached Encrustation**

Distance (ft): **128.0**  
 Structural Grade: **0**  
 O&M Grade: **2**  
 Clock Start/From: **9**  
 Clock To: **3**  
 1st Value:  
 2nd Value:  
 Value Percent: **5.000**  
 Continuous Index:  
 Within 8" of Joint: **YES**  
 Remarks:

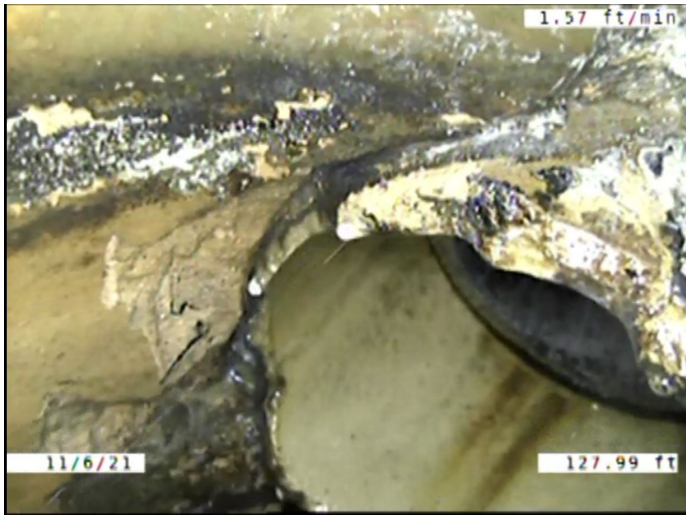
Code:	<b>SSS</b>
Description:	<b>Surface Damage Surface Spalling</b>
Distance (ft):	<b>128.0</b>
Structural Grade:	<b>2</b>
O&M Grade:	<b>0</b>
Clock Start/From:	<b>10</b>
Clock To:	
1st Value:	
2nd Value:	
Value Percent:	
Continuous Index:	
Within 8" of Joint:	<b>NO</b>
Remarks:

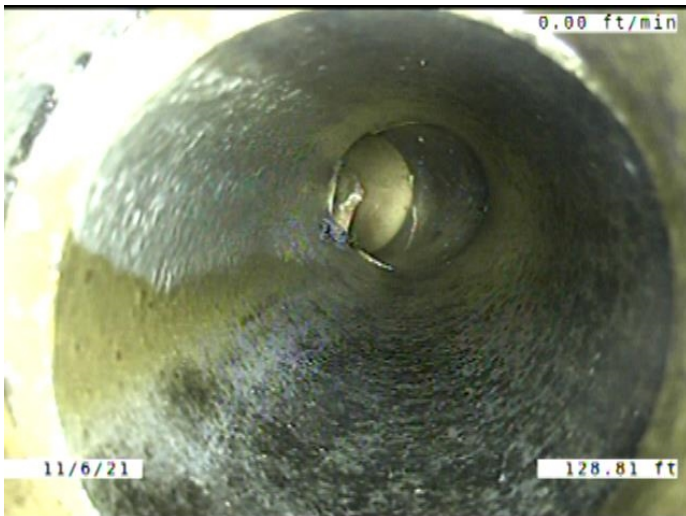
Code:	<b>TBI</b>
Description:	<b>Tap Break-in Intruding</b>
Distance (ft):	<b>128.8</b>
Structural Grade:	<b>0</b>
O&M Grade:	<b>2</b>
Clock Start/From:	<b>12</b>
Clock To:	
1st Value:	<b>4.000</b>
2nd Value:	<b>1.000</b>
Value Percent:	
Continuous Index:	
Within 8" of Joint:	<b>YES</b>
Remarks:	<b>BROKEN. CONSTANTLY RUNNING WATER.</b>

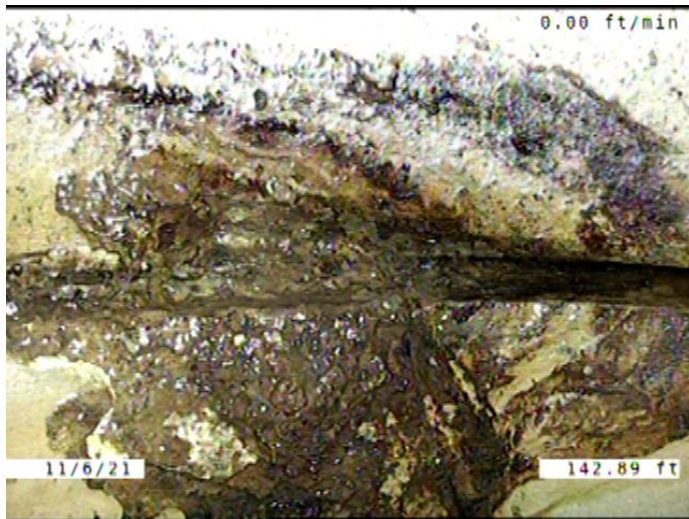
Code: **DAE**  
 Description: **Deposits Attached Encrustation**

Distance (ft): **142.9**  
 Structural Grade: **0**  
 O&M Grade: **2**  
 Clock Start/From: **9**  
 Clock To: **11**  
 1st Value:  
 2nd Value:  
 Value Percent: **5.000**  
 Continuous Index:  
 Within 8" of Joint: **YES**  
 Remarks:

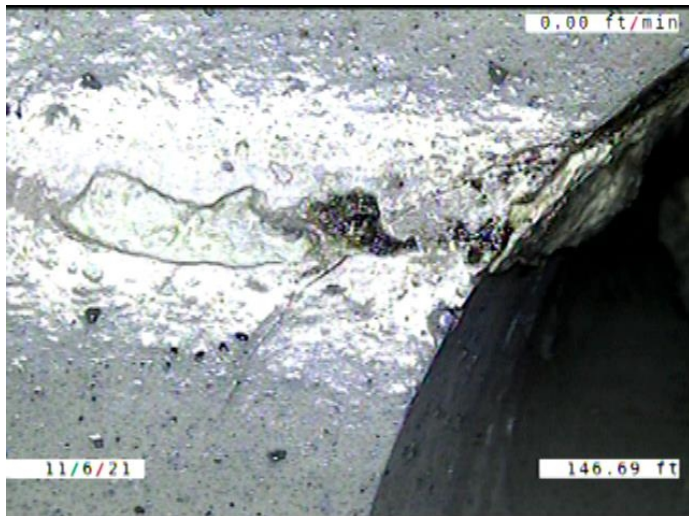
Code: **DAE**  
 Description: **Deposits Attached Encrustation**

Distance (ft): **146.7**  
 Structural Grade: **0**  
 O&M Grade: **2**  
 Clock Start/From: **10**  
 Clock To: **11**  
 1st Value:  
 2nd Value:  
 Value Percent: **5.000**  
 Continuous Index:  
 Within 8" of Joint: **YES**  
 Remarks:

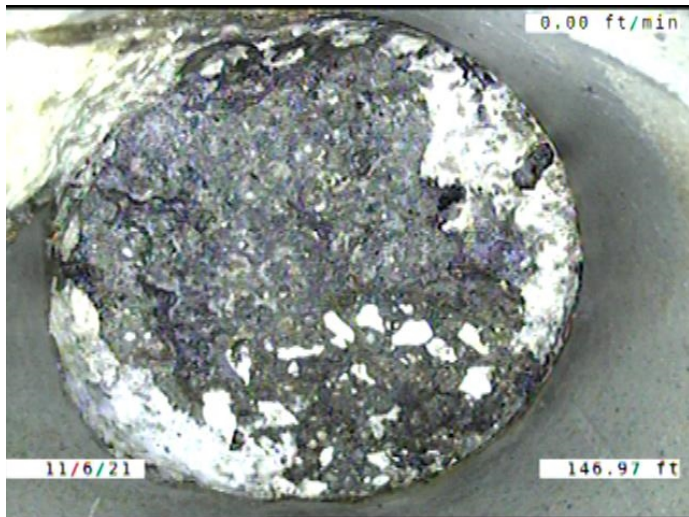
Code: **TFC**  
 Description: **Tap Factory Capped**

Distance (ft): **147.0**  
 Structural Grade: **0**  
 O&M Grade: **0**  
 Clock Start/From: **11**  
 Clock To:  
 1st Value: **4.000**  
 2nd Value:  
 Value Percent:  
 Continuous Index:  
 Within 8" of Joint: **YES**  
 Remarks: **ENCRUSTATION AROUND THE CAP**

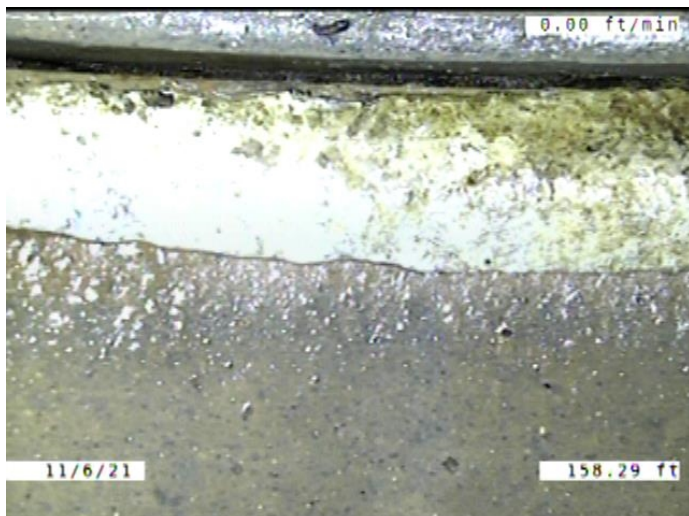
Code: **DAE**  
 Description: **Deposits Attached Encrustation**

Distance (ft): **158.3**  
 Structural Grade: **0**  
 O&M Grade: **2**  
 Clock Start/From: **10**  
 Clock To: **12**  
 1st Value:  
 2nd Value:  
 Value Percent: **5.000**  
 Continuous Index:  
 Within 8" of Joint: **YES**  
 Remarks:

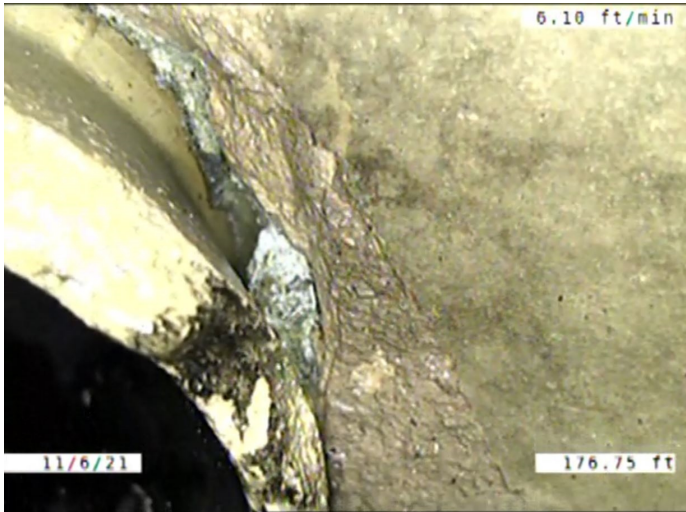
Code:	<b>SSS</b>
Description:	<b>Surface Damage Surface Spalling</b>
Distance (ft):	<b>176.8</b>
Structural Grade:	<b>2</b>
O&M Grade:	<b>0</b>
Clock Start/From:	<b>11</b>
Clock To:	
1st Value:	
2nd Value:	
Value Percent:	
Continuous Index:	
Within 8" of Joint:	<b>NO</b>
Remarks:

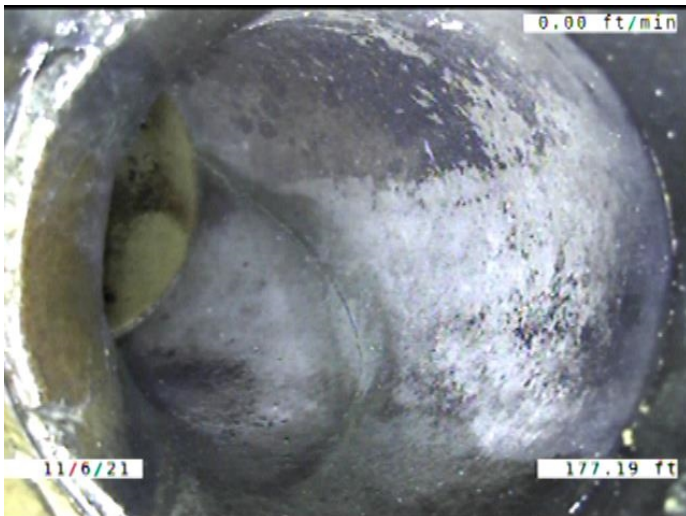
Code:	<b>TBI</b>
Description:	<b>Tap Break-in Intruding</b>
Distance (ft):	<b>177.2</b>
Structural Grade:	<b>0</b>
O&M Grade:	<b>2</b>
Clock Start/From:	<b>12</b>
Clock To:	
1st Value:	<b>4.000</b>
2nd Value:	<b>1.000</b>
Value Percent:	
Continuous Index:	
Within 8" of Joint:	<b>YES</b>
Remarks:	<b>CONSTANTLY RUNNING WATER.</b>

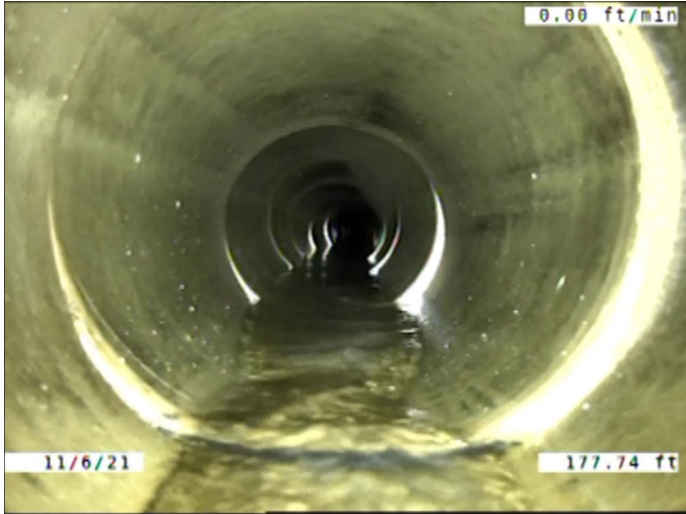
Code: **CM**  
Description: **Crack Multiple**

Distance (ft): **177.7**  
Structural Grade: **3**  
O&M Grade: **0**  
Clock Start/From: **8**  
Clock To: **4**  
1st Value:  
2nd Value:  
Value Percent:  
Continuous Index: **F07**  
Within 8" of Joint: **YES**  
Remarks: **Wandering**

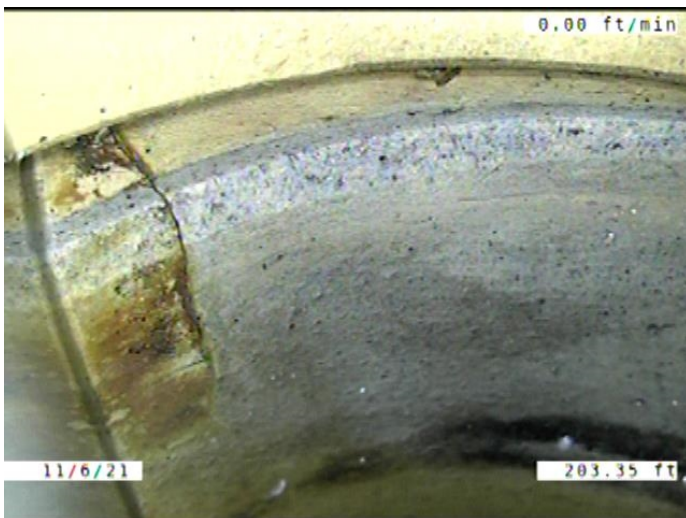
Code: **ISB**  
 Description: **Infiltration Stain Barrel**

Distance (ft): **203.4**  
 Structural Grade: **0**  
 O&M Grade: **1**  
 Clock Start/From: **9**  
 Clock To:  
 1st Value:  
 2nd Value:  
 Value Percent:  
 Continuous Index:  
 Within 8" of Joint: **YES**  
 Remarks:

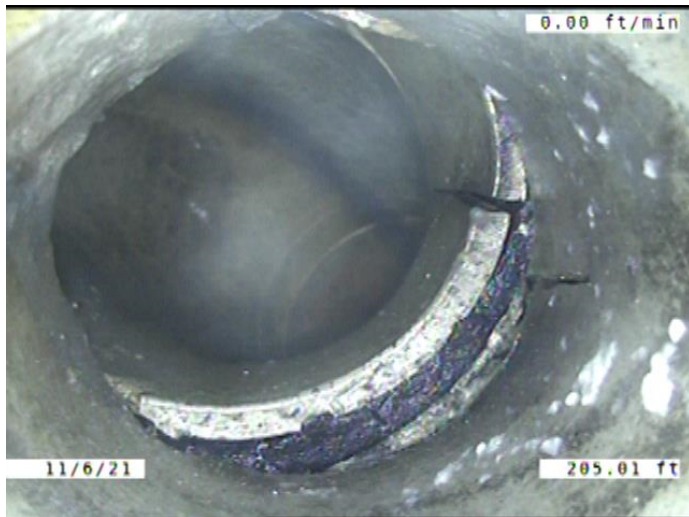
Code: **TFD**  
 Description: **Tap Factory Defective**

Distance (ft): **205.0**  
 Structural Grade: **0**  
 O&M Grade: **3**  
 Clock Start/From: **11**  
 Clock To:  
 1st Value: **4.000**  
 2nd Value:  
 Value Percent:  
 Continuous Index:  
 Within 8" of Joint: **YES**  
 Remarks: **BROKEN. LARGE OFFSET. SOIL VISIBLE**

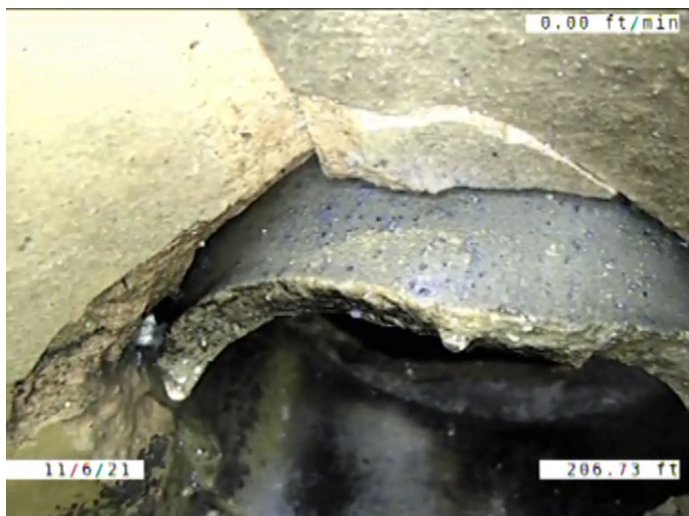
Code: **B**  
 Description: **Broken**

Distance (ft): **206.7**  
 Structural Grade: **4**  
 O&M Grade: **0**  
 Clock Start/From: **10**  
 Clock To: **12**  
 1st Value:  
 2nd Value:  
 Value Percent:  
 Continuous Index:  
 Within 8" of Joint: **NO**  
 Remarks:

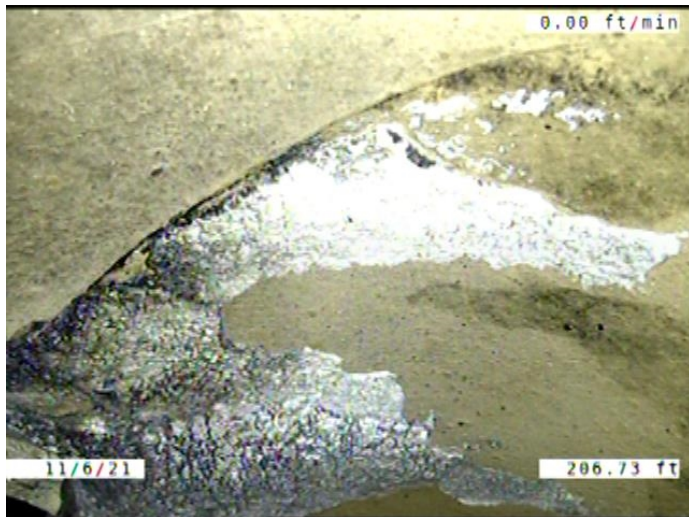
Code: **DAE**  
 Description: **Deposits Attached Encrustation**

Distance (ft): **206.7**  
 Structural Grade: **0**  
 O&M Grade: **2**  
 Clock Start/From: **10**  
 Clock To: **3**  
 1st Value:  
 2nd Value:  
 Value Percent: **5.000**  
 Continuous Index:  
 Within 8" of Joint: **YES**  
 Remarks:

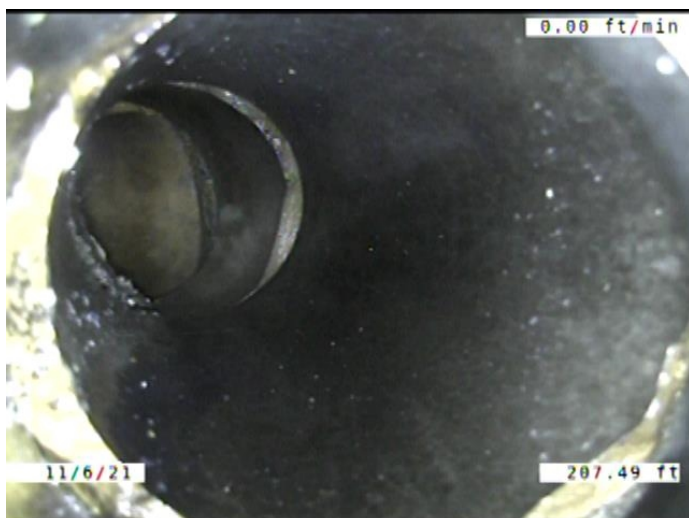
Code: **TBI**  
 Description: **Tap Break-in Intruding**

Distance (ft): **207.5**  
 Structural Grade: **0**  
 O&M Grade: **2**  
 Clock Start/From: **12**  
 Clock To:  
 1st Value: **4.000**  
 2nd Value: **1.000**  
 Value Percent:  
 Continuous Index:  
 Within 8" of Joint: **YES**  
 Remarks: **CONSTANTLY RUNNING WATER.**

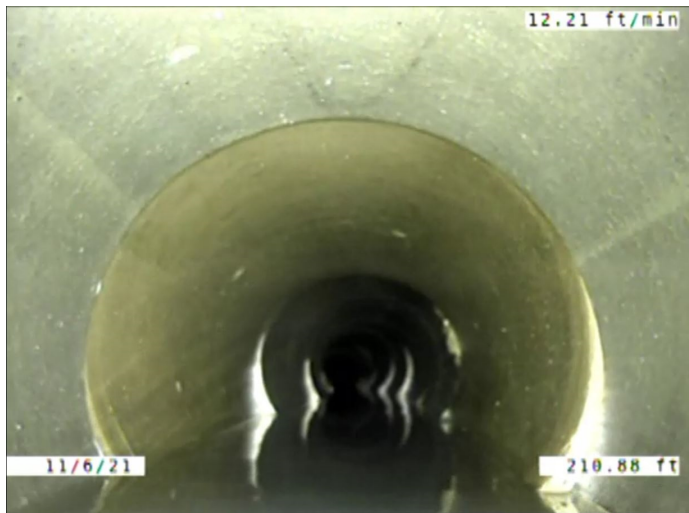
Code: **CS**  
 Description: **Crack Spiral**
