# Profile/Photo Observation Report

Date:	11/06/2021	Weather:		Coding:	PACP 7.0
Pipe Length (ft):	303.8	Owner:	City of Hobart	Pre Clean:	Heavy Cleaning
P.O.#:	YES502259	Surveyor:	S. Bucklin	PSR:	P-404-005-004
Customer:	City of Hobart	Clean Date:	11/06/2021	Shape:	C

Street:	North Wabash Street	Flow Control:	Not Controlled
City:	Hobart, IN	Year Renewed:	
Location:	Alley	Tape/Media #:	
Purpose:	Routine Assessment	Dia/Height:	12"
Use:	Sanitary Sewage Pipe	Material:	VCP
Drain Area:		Lining:	None
Category:	NA		
Comment:			
Location Details:		Direction of Survey:	Downstream
US MH:	M-404-005	DS MH:	M-404-004
		Total Length Surveyed (ft):	303.8

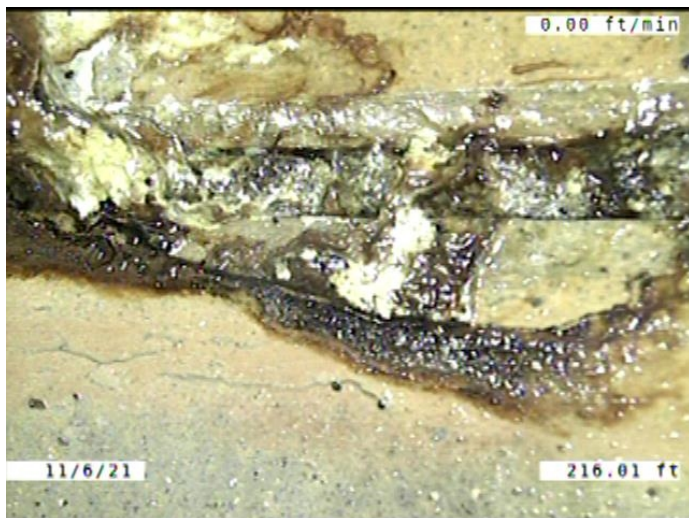
Code: **DAE**  
 Description: **Deposits Attached Encrustation**

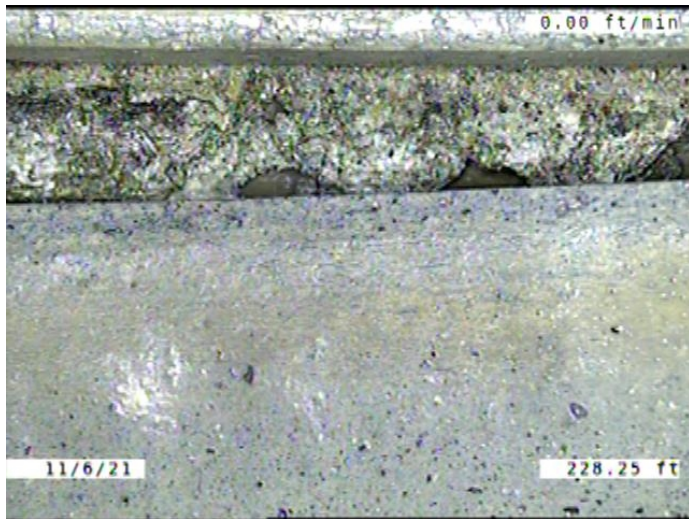
Code: **DAE**  
 Description: **Deposits Attached Encrustation**

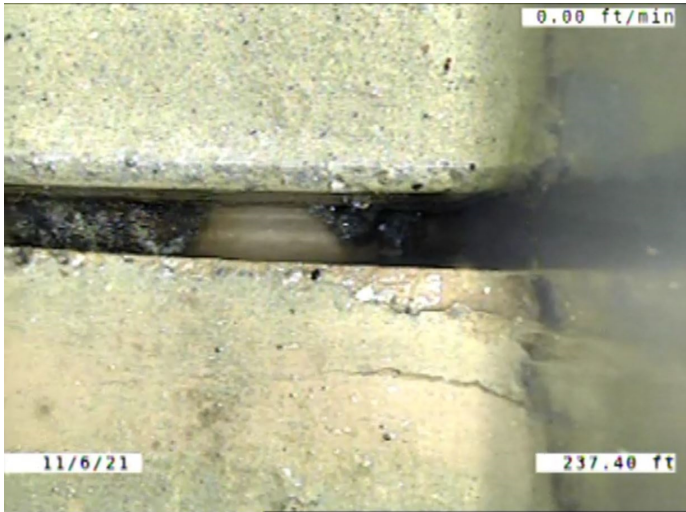
Code: **CC**  
Description: **Crack Circumferential**

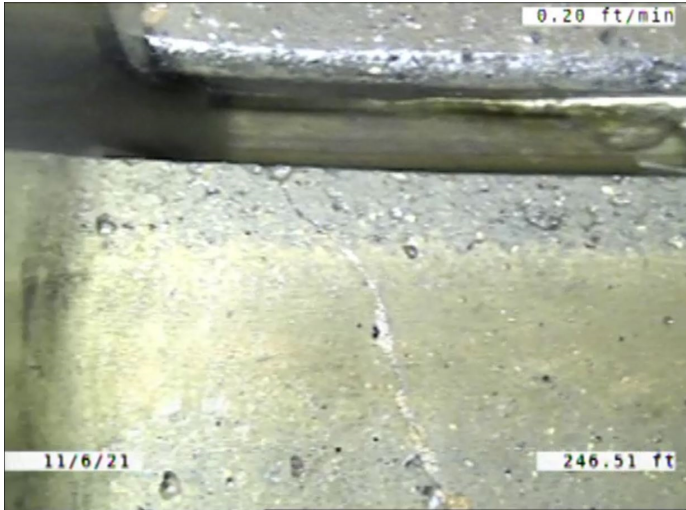
Code: **CL**  
Description: **Crack Longitudinal**

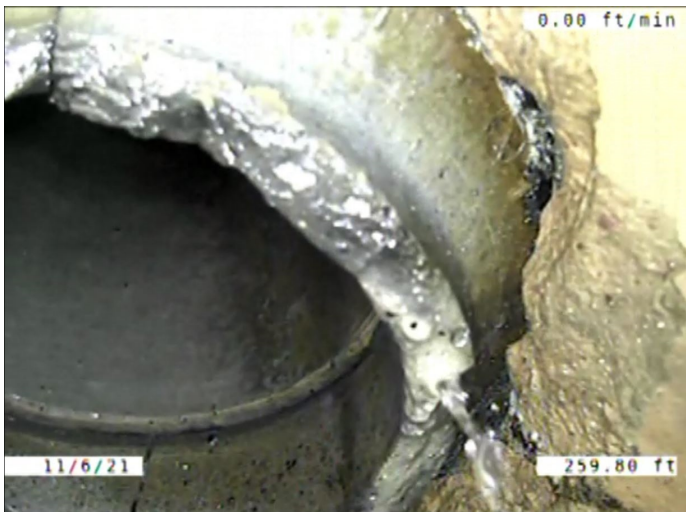
Code: **SSS**  
 Description: **Surface Damage Surface Spalling**

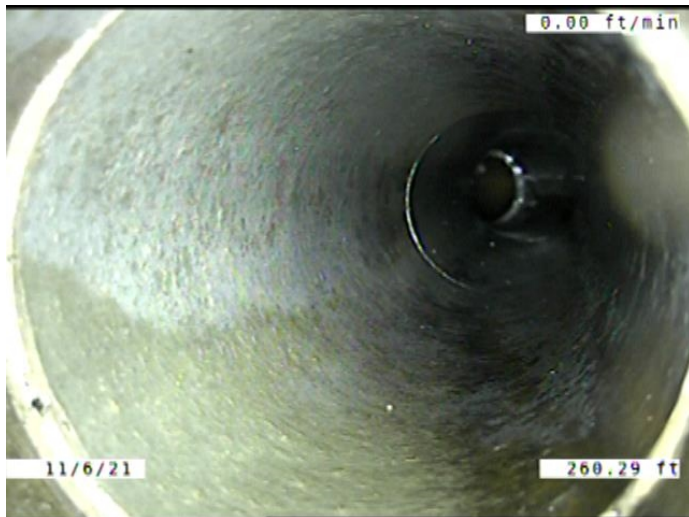
Code: **TBI**  
 Description: **Tap Break-in Intruding**

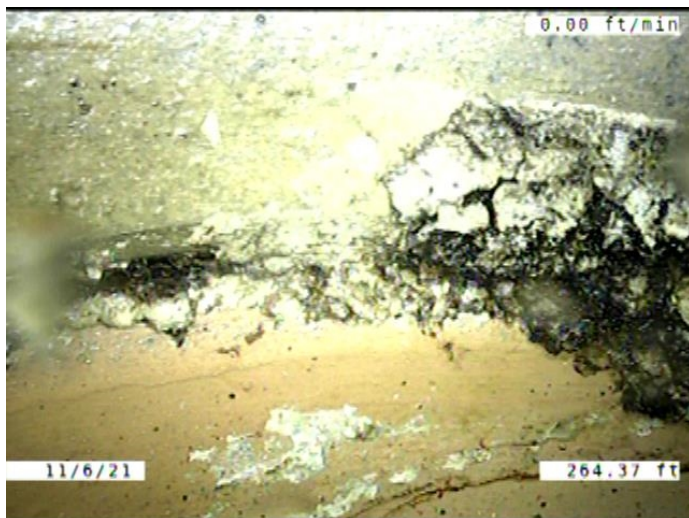
Code: **DAE**  
 Description: **Deposits Attached Encrustation**

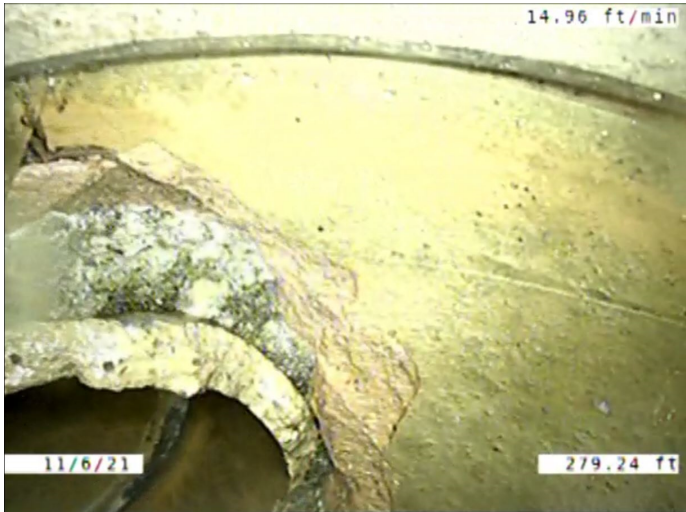
Code: **CM**  
Description: **Crack Multiple**

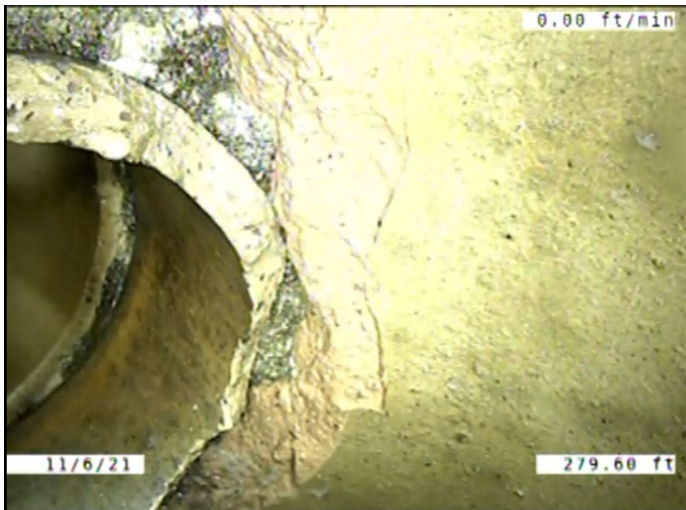
Code: **SSS**  
Description: **Surface Damage Surface Spalling**

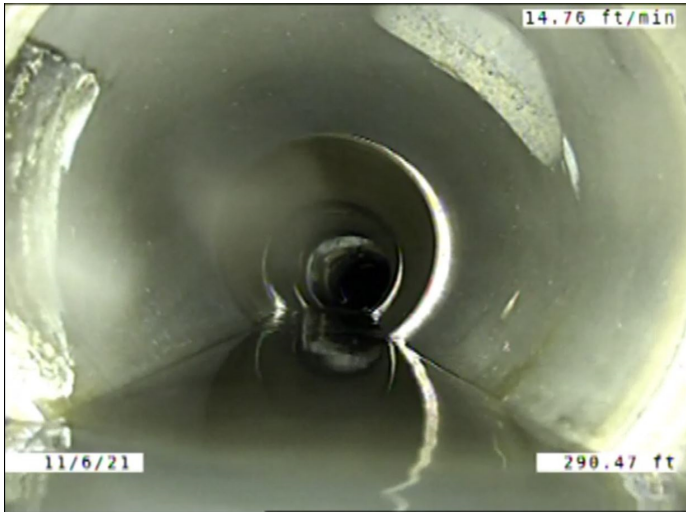
Code: **CL**  
Description: **Crack Longitudinal**

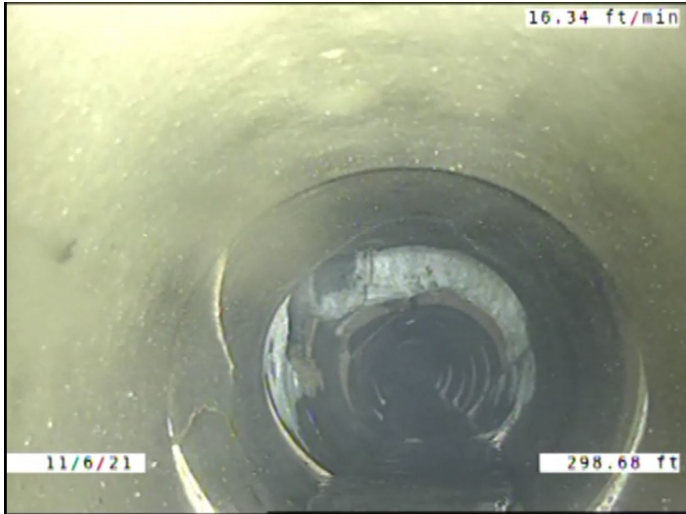
Code: **CM**  
Description: **Crack Multiple**

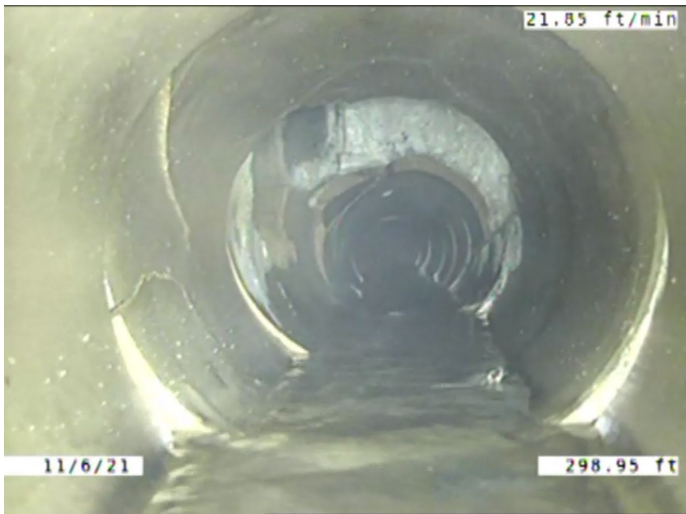
Code: **B**  
Description: **Broken**
