Profile/Photo Observation Report

Date:	11/06/2021	Weather:		Coding:	PACP 7.0
Pipe Length (ft):	658.6	Owner:	City of Hobart	Pre Clean:	Heavy Cleaning
P.O.#:	YES502259	Surveyor:	S. Bucklin	PSR:	P-404-006-005
Customer:	City of Hobart	Clean Date:	10/23/2021	Shape:	C

Street:	North Wabash Street	Flow Control:	Not Controlled
City:	Hobart, IN	Year Renewed:	
Location:	Alley	Tape/Media #:	
Purpose:	Routine Assessment	Dia/Height:	12"
Use:	Sanitary Sewage Pipe	Material:	VCP
Drain Area:		Lining:	None
Category:	NA		
Comment:			
Location Details:		Direction of Survey:	Upstream
US MH:	M-404-006	DS MH:	M-404-005
		Total Length Surveyed (ft):	658.6

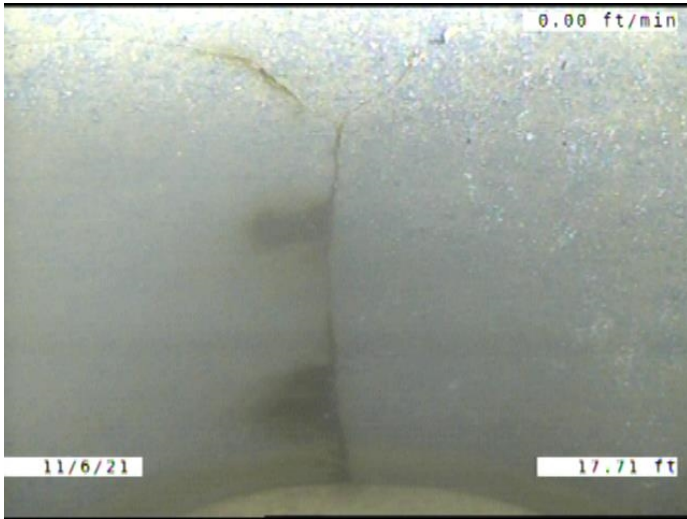
Code: **CM**
Description: **Crack Multiple**

Distance (ft): **17.7**
Structural Grade: **3**
O&M Grade: **0**
Clock Start/From: **10**
Clock To: **2**
1st Value:
2nd Value:
Value Percent:
Continuous Index:
Within 8" of Joint: **YES**
Remarks:

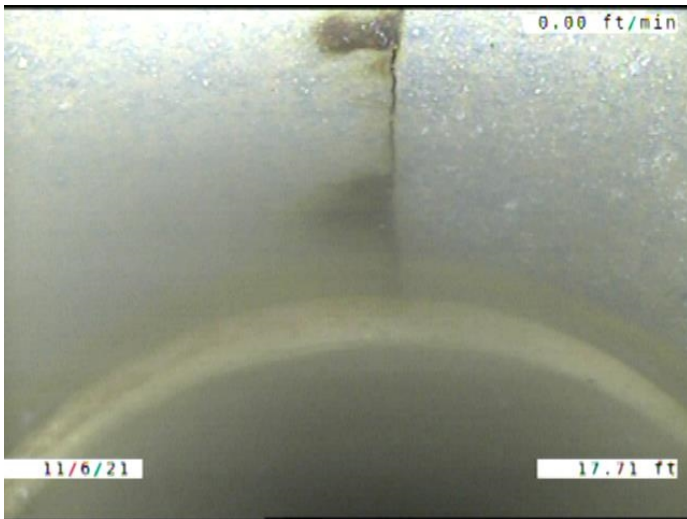
Code: **ISB**
Description: **Infiltration Stain Barrel**

Distance (ft): **17.7**
Structural Grade: **0**
O&M Grade: **1**
Clock Start/From: **11**
Clock To: **12**
1st Value:
2nd Value:
Value Percent:
Continuous Index:
Within 8" of Joint: **YES**
Remarks:

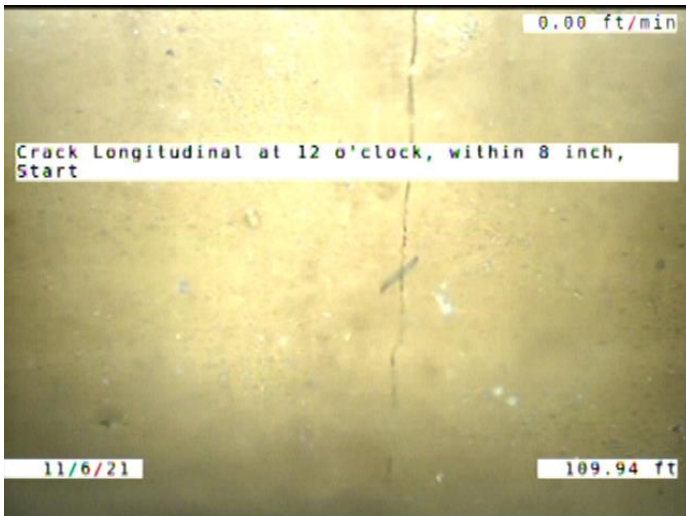
Code: **CL**
 Description: **Crack Longitudinal**

Distance (ft): **109.9**
 Structural Grade: **2**
 O&M Grade: **0**
 Clock Start/From: **12**
 Clock To:
 1st Value:
 2nd Value:
 Value Percent:
 Continuous Index: **S03**
 Within 8" of Joint: **YES**
 Remarks:

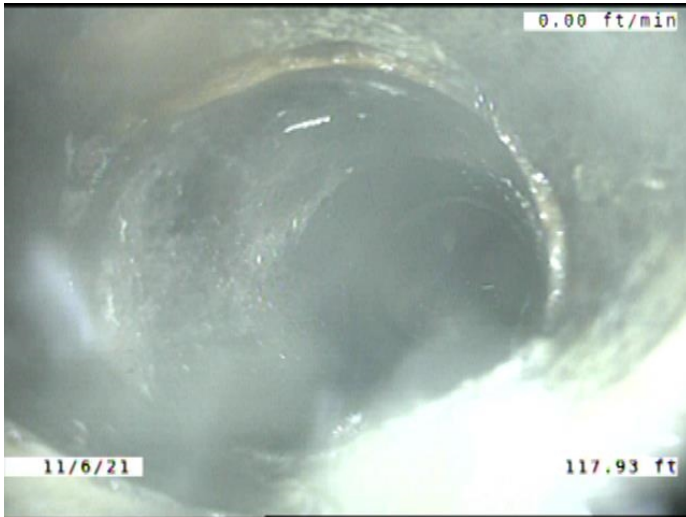
Code: **TFD**
Description: **Tap Factory Defective**

Distance (ft): **117.9**
Structural Grade: **0**
O&M Grade: **3**
Clock Start/From: **1**
Clock To:
1st Value: **4.000**
2nd Value:
Value Percent:
Continuous Index:
Within 8" of Joint: **YES**
Remarks: **Defective**

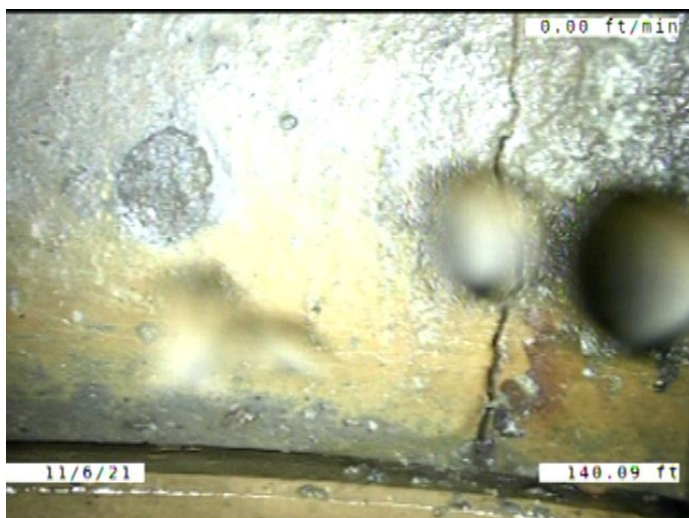
Code: **B**
Description: **Broken**

Distance (ft): **144.6**
Structural Grade: **4**
O&M Grade: **0**
Clock Start/From: **12**
Clock To:
1st Value:
2nd Value:
Value Percent:
Continuous Index:
Within 8" of Joint: **YES**
Remarks:

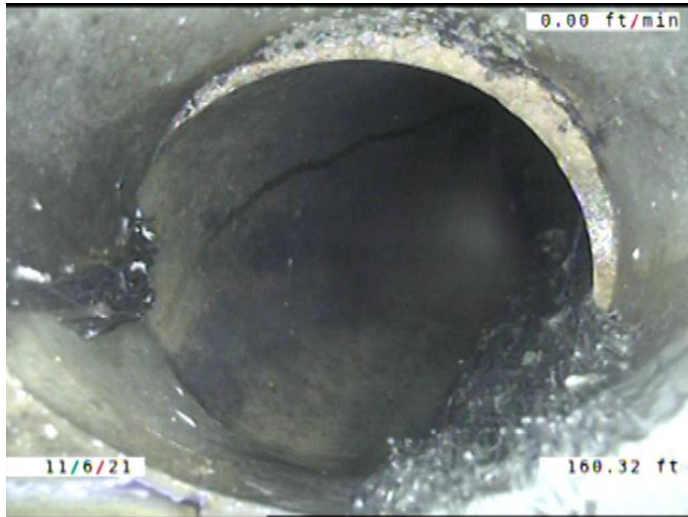
Code:	TFD
Description:	Tap Factory Defective
Distance (ft):	160.3
Structural Grade:	0
O&M Grade:	3
Clock Start/From:	12
Clock To:	
1st Value:	4.000
2nd Value:	
Value Percent:	
Continuous Index:	
Within 8" of Joint:	YES
Remarks:	BROKEN. CONSTANTLY RUNNING WATER. ROOTS GROWING INTO THE

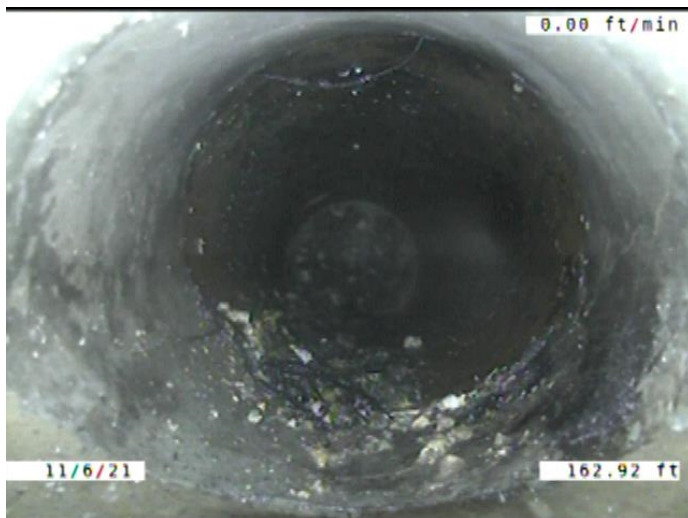
Code:	TFD
Description:	Tap Factory Defective
Distance (ft):	162.9
Structural Grade:	0
O&M Grade:	3
Clock Start/From:	11
Clock To:	
1st Value:	4.000
2nd Value:	
Value Percent:	
Continuous Index:	
Within 8" of Joint:	YES
Remarks:	CAPPED. BROKEN. ROOTS GROWING IN THE TAP

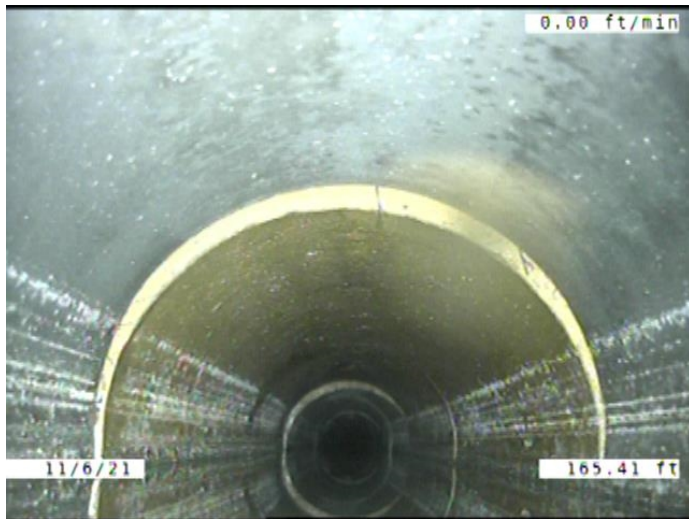
Code: **FM**
 Description: **Fracture Multiple**

Distance (ft): **165.4**
 Structural Grade: **4**
 O&M Grade: **0**
 Clock Start/From: **9**
 Clock To: **3**
 1st Value:
 2nd Value:
 Value Percent:
 Continuous Index: **F04**
 Within 8" of Joint: **YES**
 Remarks:

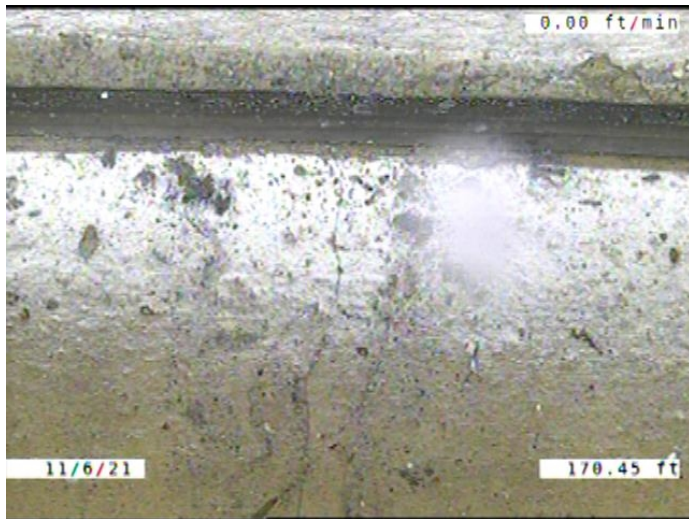
Code: **CL**
 Description: **Crack Longitudinal**

Distance (ft): **170.4**
 Structural Grade: **2**
 O&M Grade: **0**
 Clock Start/From: **12**
 Clock To:
 1st Value:
 2nd Value:
 Value Percent:
 Continuous Index:
 Within 8" of Joint: **YES**
 Remarks:

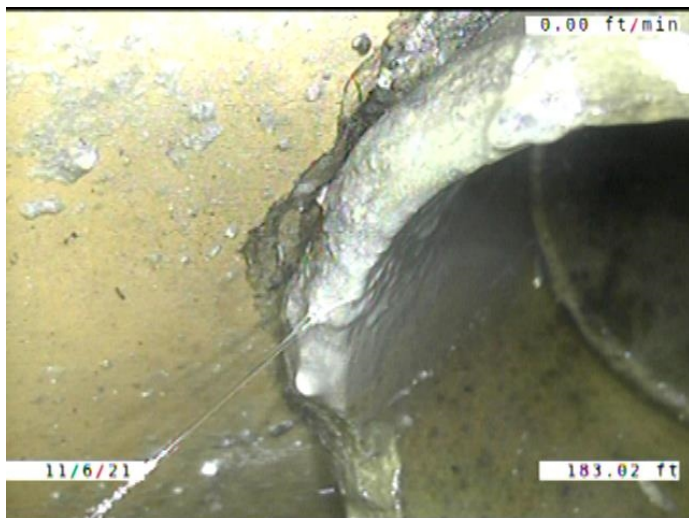
Code: **SSS**
 Description: **Surface Damage Surface Spalling**

Distance (ft): **183.0**
 Structural Grade: **2**
 O&M Grade: **0**
 Clock Start/From: **9**
 Clock To: **3**
 1st Value:
 2nd Value:
 Value Percent:
 Continuous Index:
 Within 8" of Joint: **YES**
 Remarks:

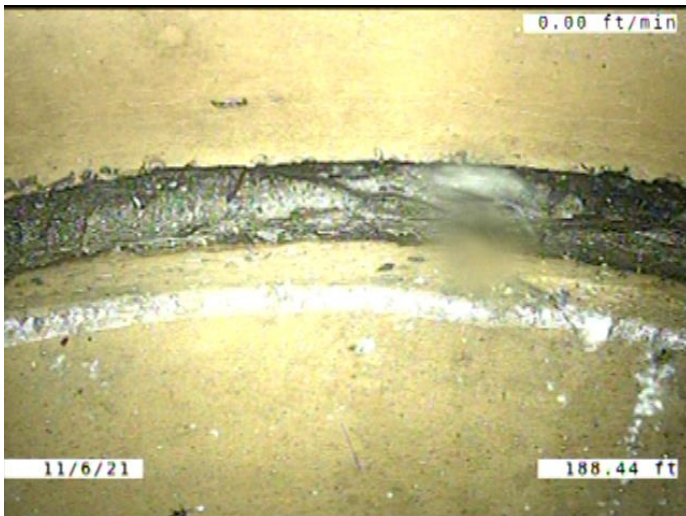
Code: **RFJ**
Description: **Roots Fine Joint**

Distance (ft): **188.4**
Structural Grade: **0**
O&M Grade: **1**
Clock Start/From: **9**
Clock To: **2**
1st Value:
2nd Value:
Value Percent:
Continuous Index:
Within 8" of Joint: **YES**
Remarks:

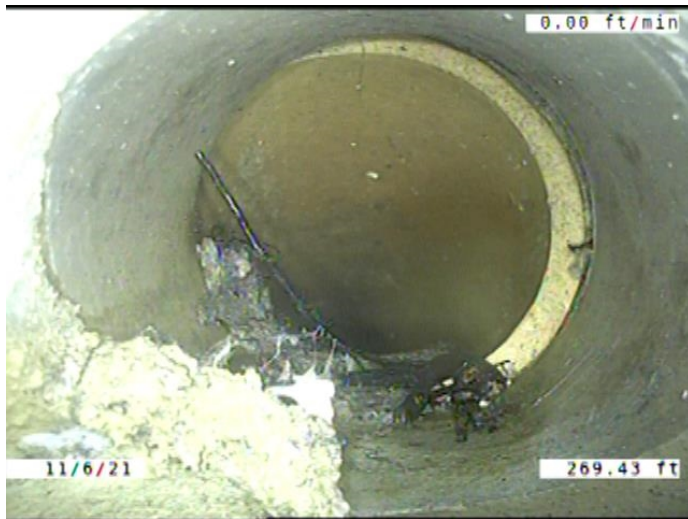
Code:	TFD
Description:	Tap Factory Defective
Distance (ft):	269.4
Structural Grade:	0
O&M Grade:	3
Clock Start/From:	11
Clock To:	
1st Value:	4.000
2nd Value:	
Value Percent:	
Continuous Index:	
Within 8" of Joint:	YES
Remarks:	OFFSET. ROOTS GROWING FROM THE JOINT. ENCUSTATION COMING

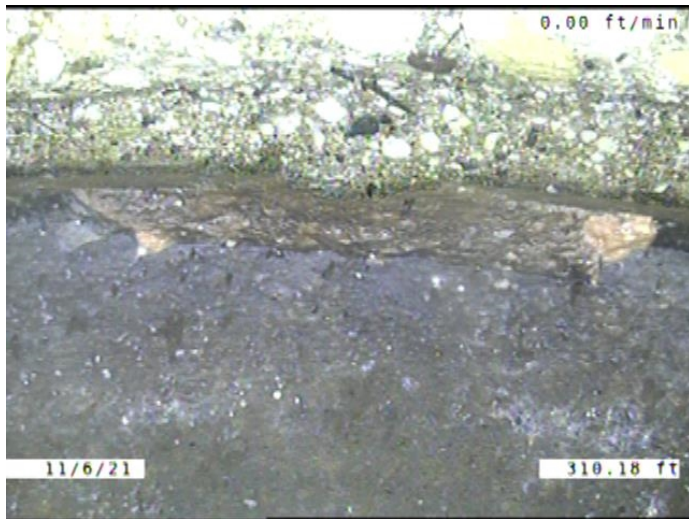
Code:	SZ
Description:	Surface Damage Other
Distance (ft):	310.2
Structural Grade:	0
O&M Grade:	0
Clock Start/From:	12
Clock To:	
1st Value:	
2nd Value:	
Value Percent:	
Continuous Index:	
Within 8" of Joint:	YES
Remarks:	A PIECE CHIPPED AWAY FROM THE JOINT

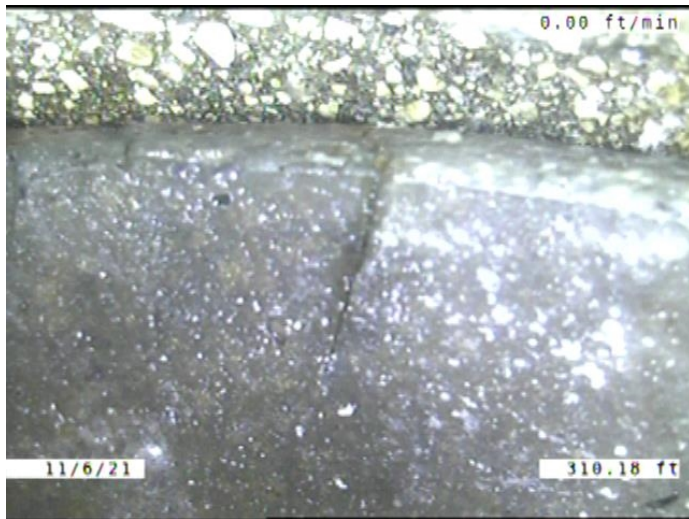
Code:	CL
Description:	Crack Longitudinal
Distance (ft):	310.2
Structural Grade:	2
O&M Grade:	0
Clock Start/From:	3
Clock To:	
1st Value:	
2nd Value:	
Value Percent:	
Continuous Index:	
Within 8" of Joint:	YES
Remarks:

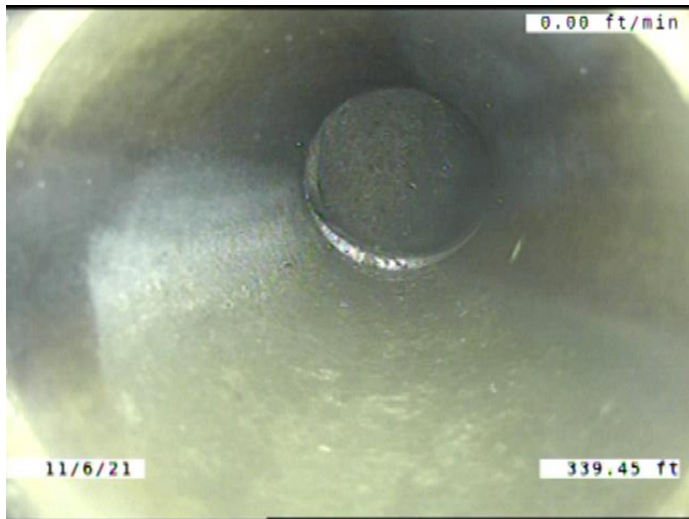
Code:	TBD
Description:	Tap Break-in/Hammer Defective
Distance (ft):	339.4
Structural Grade:	0
O&M Grade:	3
Clock Start/From:	12
Clock To:	
1st Value:	4.000
2nd Value:	
Value Percent:	
Continuous Index:	
Within 8" of Joint:	YES
Remarks:	Defective

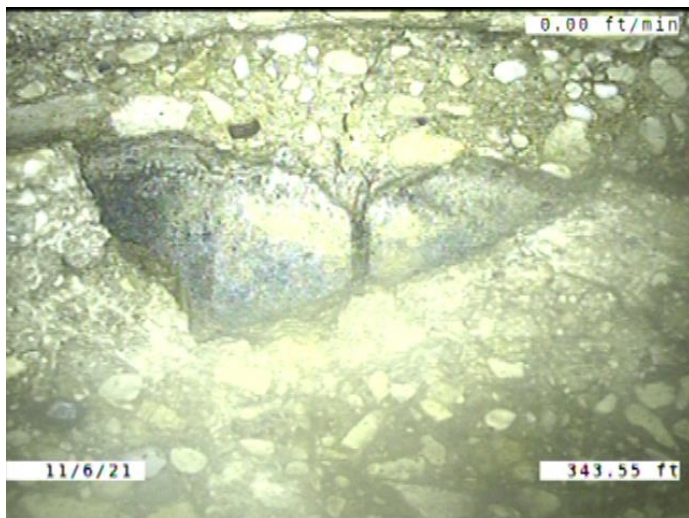
Code:	SMW
Description:	Surface Damage Missing Wall
Distance (ft):	343.5
Structural Grade:	5
O&M Grade:	0
Clock Start/From:	12
Clock To:	1
1st Value:	
2nd Value:	
Value Percent:	
Continuous Index:	
Within 8" of Joint:	YES
Remarks:	INSIDE OF THE JOINT

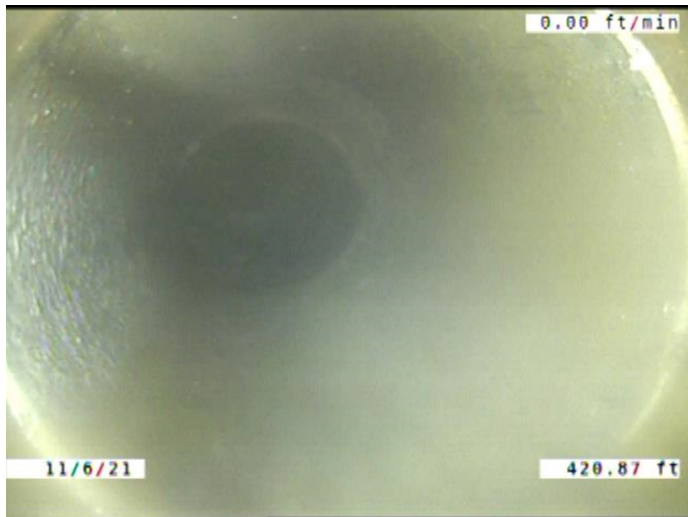
Code: **TBI**
 Description: **Tap Break-in Intruding**

Distance (ft): **420.9**
 Structural Grade: **0**
 O&M Grade: **2**
 Clock Start/From: **11**
 Clock To:
 1st Value: **4.000**
 2nd Value: **3.000**
 Value Percent:
 Continuous Index:
 Within 8" of Joint: **YES**
 Remarks: **BROKEN. CONSTANTLY DRIPPING WATER.**

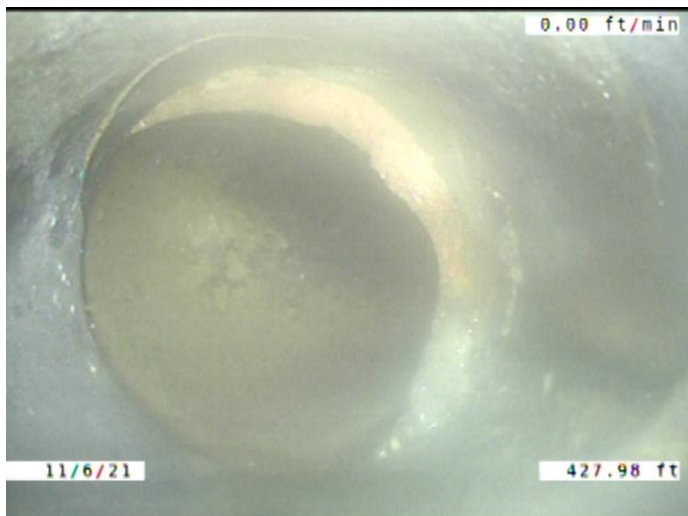
Code: **TFD**
 Description: **Tap Factory Defective**

Distance (ft): **428.0**
 Structural Grade: **0**
 O&M Grade: **3**
 Clock Start/From: **1**
 Clock To:
 1st Value: **4.000**
 2nd Value:
 Value Percent:
 Continuous Index:
 Within 8" of Joint: **YES**
 Remarks: **CONSTANTLY RUNNING WATER. BROKEN. OFFSET**

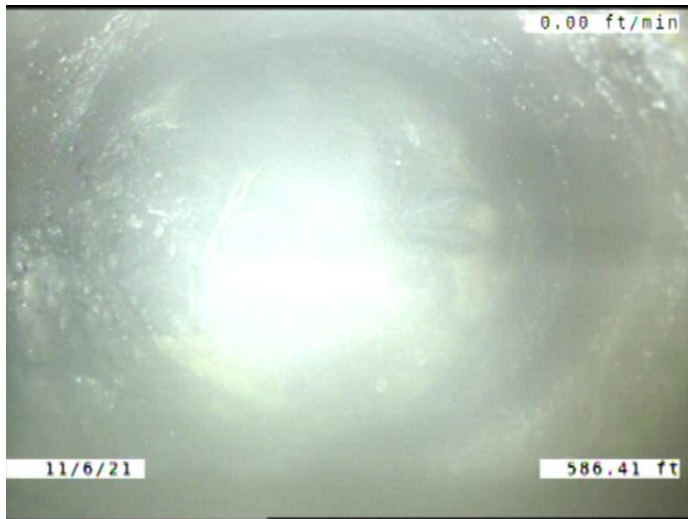
Code: **TFD**
Description: **Tap Factory Defective**

Distance (ft): **586.4**
Structural Grade: **0**
O&M Grade: **3**
Clock Start/From: **11**
Clock To:
1st Value: **4.000**
2nd Value:
Value Percent:
Continuous Index:
Within 8" of Joint: **YES**
Remarks: **ROOT AND SOIL VISIBLE. CAP
BROKEN OR MISSING**

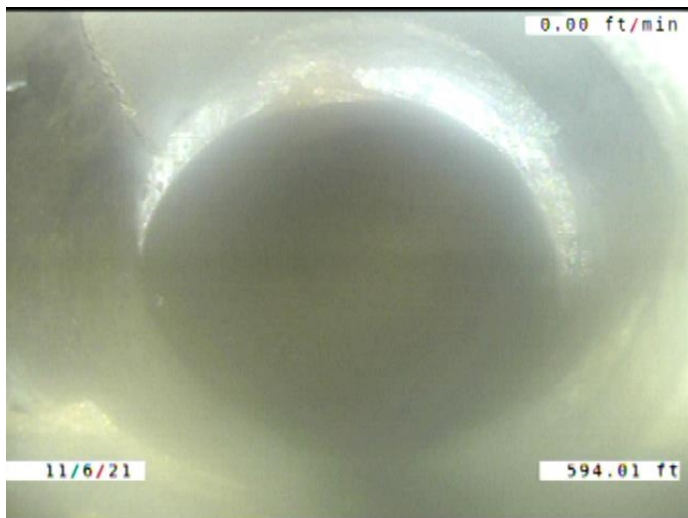
Code: **TFD**
 Description: **Tap Factory Defective**

Distance (ft): **594.0**
 Structural Grade: **0**
 O&M Grade: **3**
 Clock Start/From: **2**
 Clock To:
 1st Value: **4.000**
 2nd Value:
 Value Percent:
 Continuous Index:
 Within 8" of Joint: **YES**
 Remarks: **BROKEN. LARGE OFFSET. SOIL VISIBLE**
