RedZone
ROBOTICS

Street:	North Wabash Street		Flow Control:	Not Controlled	
City:	Hobart, IN		Year Renewed:		
Location:	Alley		Tape/Media #:		
Purpose:	Routine Assessment		Dia/Height:	12"	
Use:	Sanitary Sewage Pipe		Material:	VCP	
Drain Area:			Lining:	None	
Category:	NA				
Comment:					
Location Details:			Direction of Survey:	Upstream	
US MH:	M-404-006	DS MH:	M-404-005	Total Length Surveyed (ft):	658.6

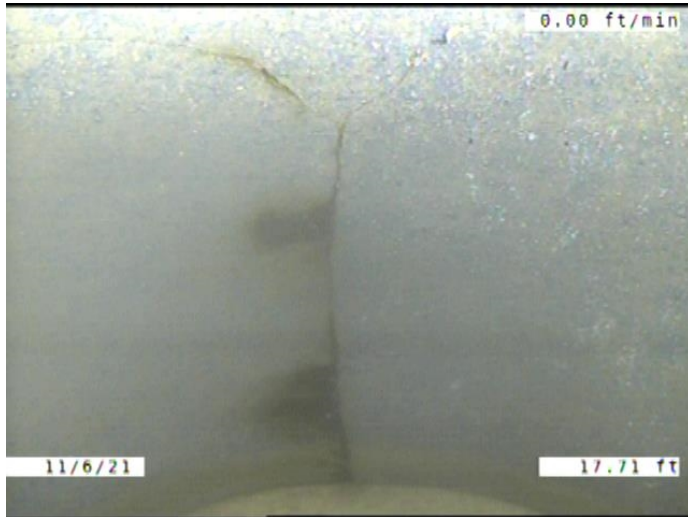
Code: **CM**
 Description: **Crack Multiple**

Distance (ft): **17.7**
 Structural Grade: **3**
 O&M Grade: **0**
 Clock Start/From: **10**
 Clock To: **2**
 1st Value:
 2nd Value:
 Value Percent:
 Continuous Index:
 Within 8" of Joint: **YES**
 Remarks:

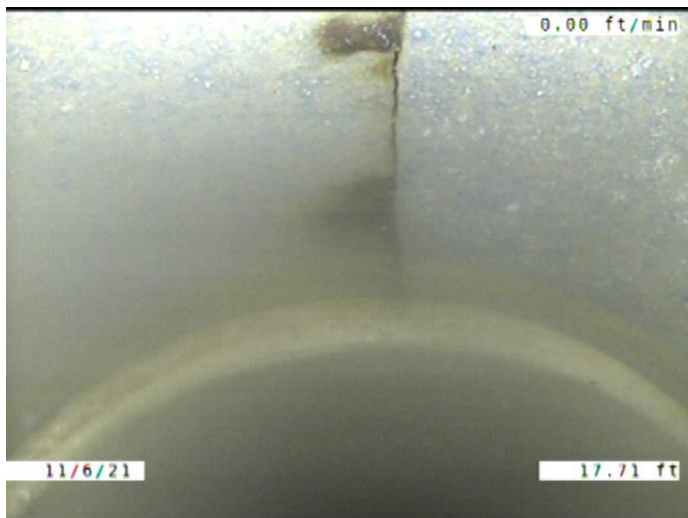
Code: **ISB**
 Description: **Infiltration Stain Barrel**

Distance (ft): **17.7**
 Structural Grade: **0**
 O&M Grade: **1**
 Clock Start/From: **11**
 Clock To: **12**
 1st Value:
 2nd Value:
 Value Percent:
 Continuous Index:
 Within 8" of Joint: **YES**
 Remarks:

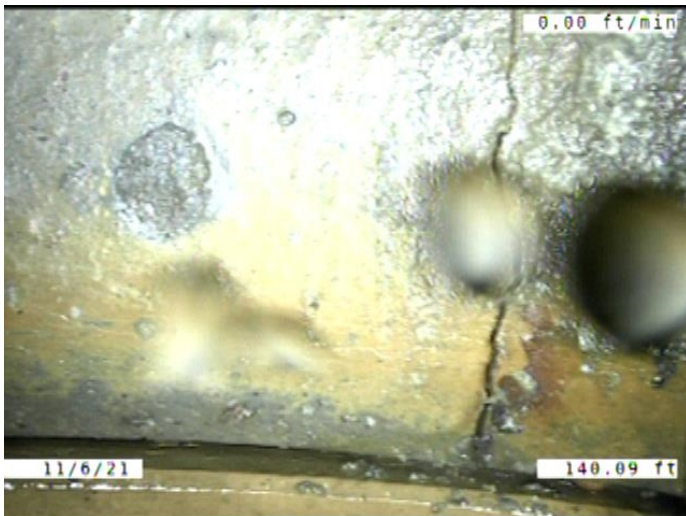
Code:	FM
Description:	Fracture Multiple
Distance (ft):	140.1
Structural Grade:	4
O&M Grade:	0
Clock Start/From:	9
Clock To:	3
1st Value:	
2nd Value:	
Value Percent:	
Continuous Index:	S04
Within 8" of Joint:	YES
Remarks:

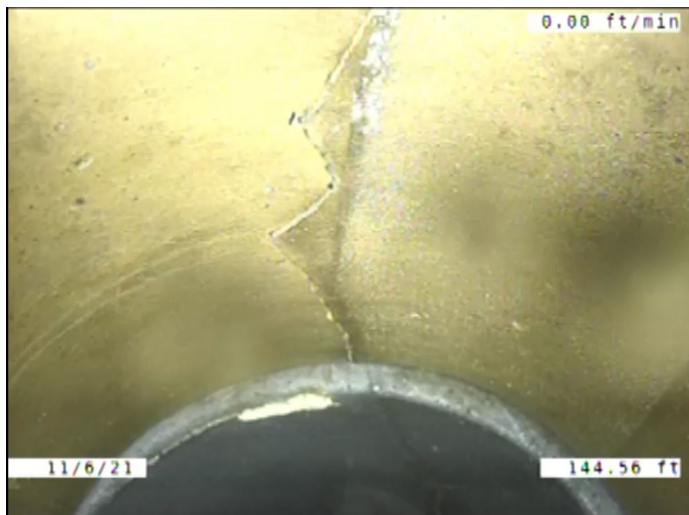
Code: **B**
 Description: **Broken**

Distance (ft): **144.6**
 Structural Grade: **4**
 O&M Grade: **0**
 Clock Start/From: **12**
 Clock To:
 1st Value:
 2nd Value:
 Value Percent:
 Continuous Index:
 Within 8" of Joint: **YES**
 Remarks:

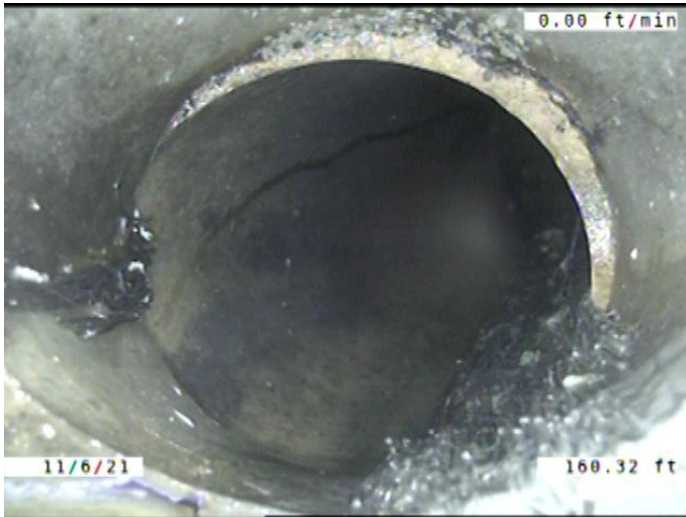
Code: **TFD**
Description: **Tap Factory Defective**

Distance (ft): **160.3**
Structural Grade: **0**
O&M Grade: **3**
Clock Start/From: **12**
Clock To:
1st Value: **4.000**
2nd Value:
Value Percent:
Continuous Index:
Within 8" of Joint: **YES**
Remarks: **BROKEN. CONSTANTLY RUNNING WATER. ROOTS GROWING INTO THE**

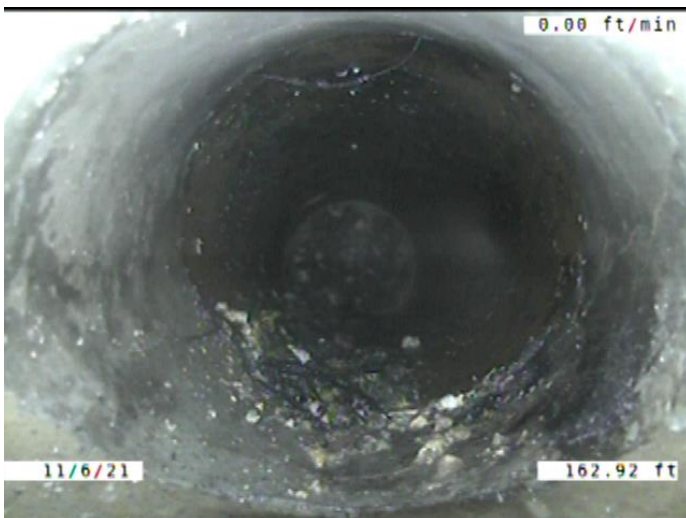
Code: **TFD**
Description: **Tap Factory Defective**

Distance (ft): **162.9**
Structural Grade: **0**
O&M Grade: **3**
Clock Start/From: **11**
Clock To:
1st Value: **4.000**
2nd Value:
Value Percent:
Continuous Index:
Within 8" of Joint: **YES**
Remarks: **CAPPED. BROKEN. ROOTS GROWING IN THE TAP**

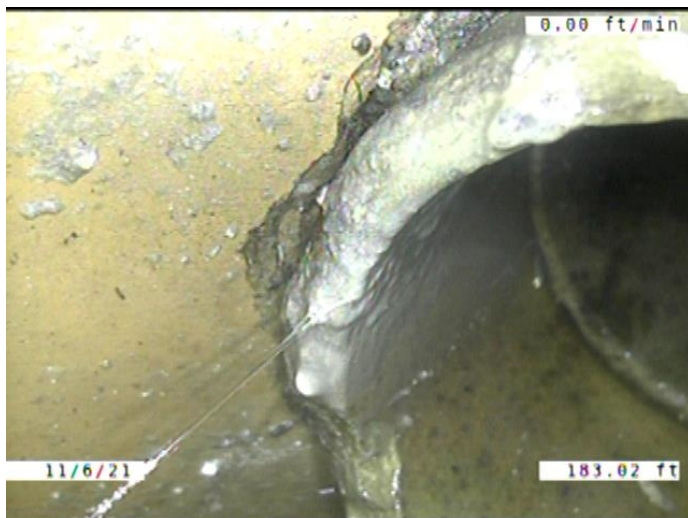
Code: **SSS**
 Description: **Surface Damage Surface Spalling**

Distance (ft): **183.0**
 Structural Grade: **2**
 O&M Grade: **0**
 Clock Start/From: **9**
 Clock To: **3**
 1st Value:
 2nd Value:
 Value Percent:
 Continuous Index:
 Within 8" of Joint: **YES**
 Remarks:

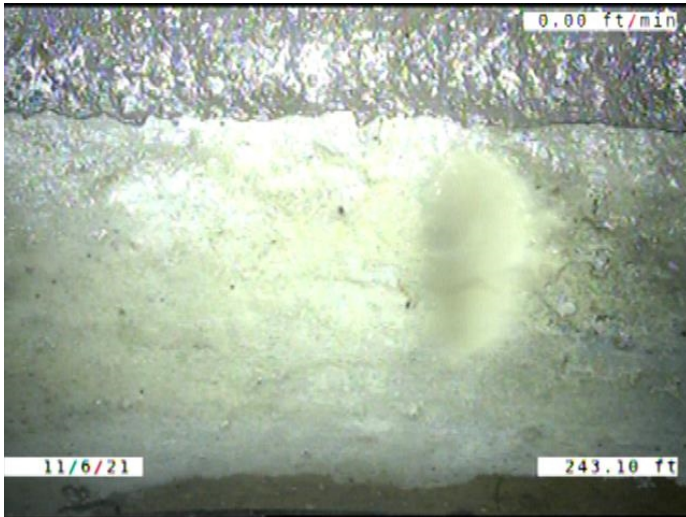
Code: **FM**
Description: **Fracture Multiple**

Distance (ft): **243.1**
Structural Grade: **4**
O&M Grade: **0**
Clock Start/From: **8**
Clock To: **4**
1st Value:
2nd Value:
Value Percent:
Continuous Index:
Within 8" of Joint: **YES**
Remarks:

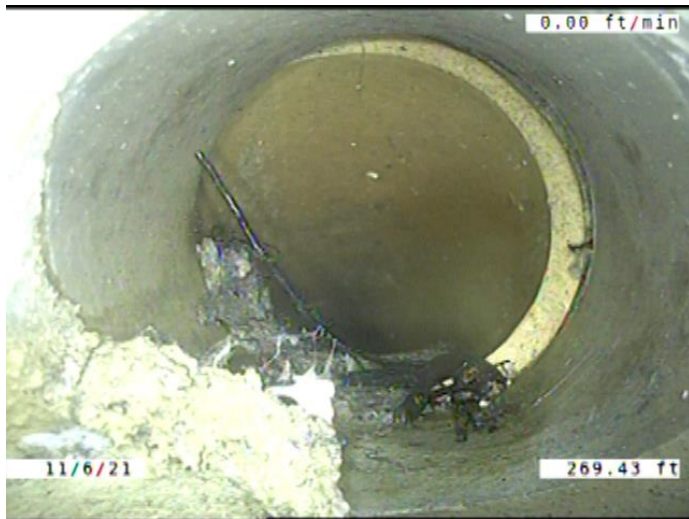
Code:	TFD
Description:	Tap Factory Defective
Distance (ft):	269.4
Structural Grade:	0
O&M Grade:	3
Clock Start/From:	11
Clock To:	
1st Value:	4.000
2nd Value:	
Value Percent:	
Continuous Index:	
Within 8" of Joint:	YES
Remarks:	OFFSET. ROOTS GROWING FROM THE JOINT. ENCUSTATION COMING

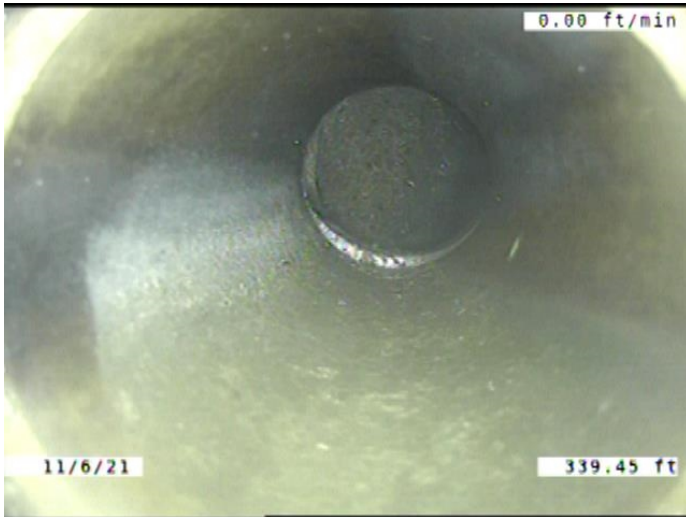
Code: **TBD**
 Description: **Tap Break-in/Hammer Defective**

Distance (ft): **339.4**
 Structural Grade: **0**
 O&M Grade: **3**
 Clock Start/From: **12**
 Clock To:
 1st Value: **4.000**
 2nd Value:
 Value Percent:
 Continuous Index:
 Within 8" of Joint: **YES**
 Remarks: **Defective**

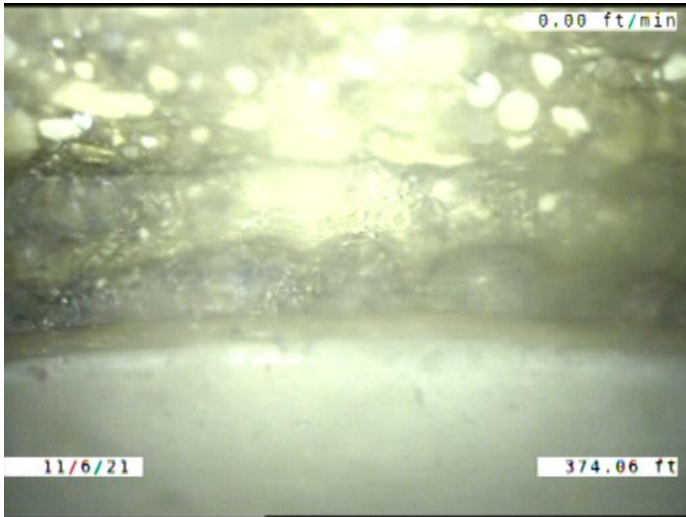
Code:	FM
Description:	Fracture Multiple
Distance (ft):	374.1
Structural Grade:	4
O&M Grade:	0
Clock Start/From:	8
Clock To:	4
1st Value:	
2nd Value:	
Value Percent:	
Continuous Index:	
Within 8" of Joint:	YES
Remarks:

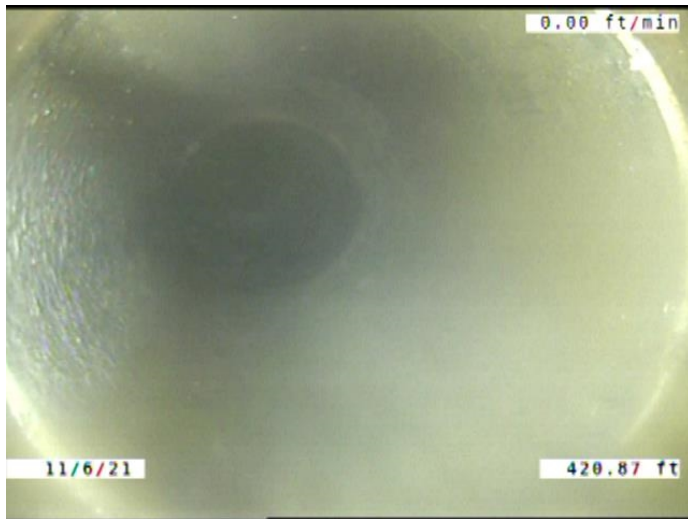
Code: **TBI**
 Description: **Tap Break-in Intruding**

Distance (ft): **420.9**
 Structural Grade: **0**
 O&M Grade: **2**
 Clock Start/From: **11**
 Clock To:
 1st Value: **4.000**
 2nd Value: **3.000**
 Value Percent:
 Continuous Index:
 Within 8" of Joint: **YES**
 Remarks: **BROKEN. CONSTANTLY DRIPPING WATER.**

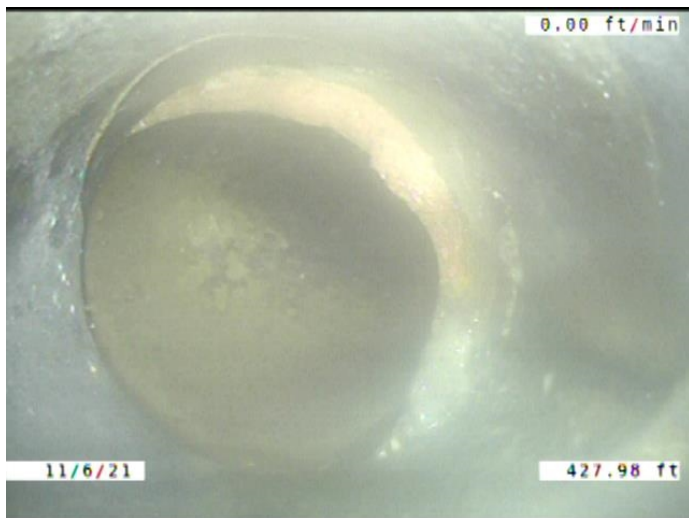
Code: **TFD**
 Description: **Tap Factory Defective**

Distance (ft): **428.0**
 Structural Grade: **0**
 O&M Grade: **3**
 Clock Start/From: **1**
 Clock To:
 1st Value: **4.000**
 2nd Value:
 Value Percent:
 Continuous Index:
 Within 8" of Joint: **YES**
 Remarks: **CONSTANTLY RUNNING WATER. BROKEN. OFFSET**
