Profile/Photo Observation Report

Location Details:		Direction of Survey:	Upstream
US MH:	M-404-007	DS MH:	M-404-006
		Total Length Surveyed (ft):	20.3

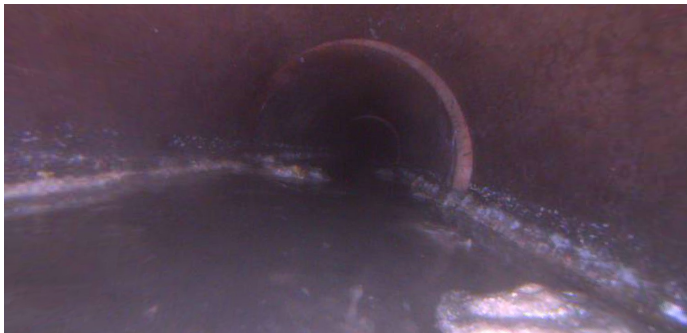
Code: **AMH**
Description: **Manhole**

Distance (ft): **.0**
Structural Grade: **0**
O&M Grade: **0**
Clock Start/From:
Clock To:
1st Value:
2nd Value:
Value Percent:
Continuous Index:
Within 8" of Joint: **NO**
Remarks: **M-404-007**

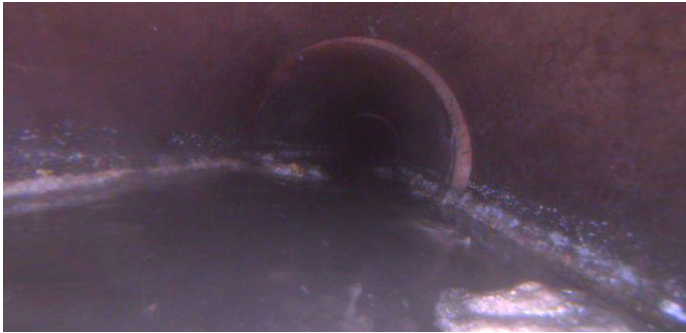
Code:	MWL
Description:	Water Level

Distance (ft):	.0
Structural Grade:	0
O&M Grade:	0
Clock Start/From:	
Clock To:	
1st Value:	
2nd Value:	
Value Percent:	30.000
Continuous Index:	
Within 8" of Joint:	NO
Remarks:

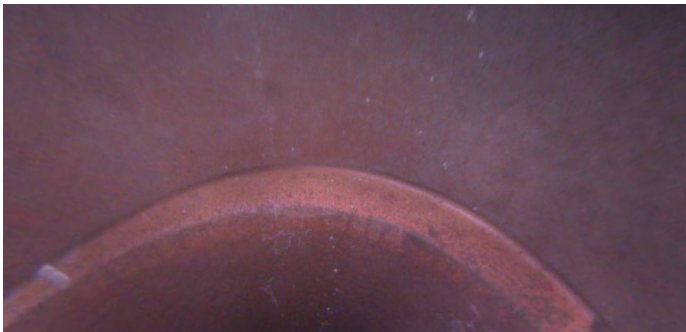
Code:	CL
Description:	Crack Longitudinal

Distance (ft):	4.9
Structural Grade:	2
O&M Grade:	0
Clock Start/From:	12
Clock To:	
1st Value:	
2nd Value:	
Value Percent:	
Continuous Index:	
Within 8" of Joint:	YES
Remarks:

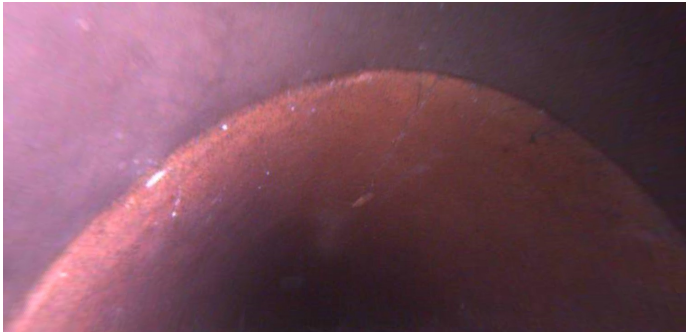
Code: **FL**
Description: **Fracture Longitudinal**

Distance (ft): **8.1**
Structural Grade: **3**
O&M Grade: **0**
Clock Start/From: **12**
Clock To:
1st Value:
2nd Value:
Value Percent:
Continuous Index:
Within 8" of Joint: **YES**
Remarks:

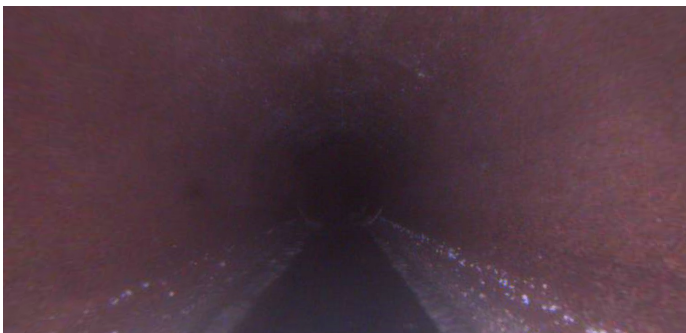
Code: **MSA**
Description: **Abandoned Survey**

Distance (ft): **20.3**
Structural Grade: **0**
O&M Grade: **0**
Clock Start/From:
Clock To:
1st Value:
2nd Value:
Value Percent:
Continuous Index:
Within 8" of Joint: **NO**
Remarks: **UNKNOWN**
