Profile/Photo Observation Report

Date:	10/24/2021	Weather:		Coding:	PACP 7.0
Pipe Length (ft):	167.3	Owner:	City of Hobart	Pre Clean:	Heavy Cleaning
P.O.#:	YES502259	Surveyor:	S. Bucklin	PSR:	P-404-008-007
Customer:	City of Hobart	Clean Date:	10/22/2021	Shape:	C

Street:	North Wabash Street	Flow Control:	Not Controlled
City:	Hobart, IN	Year Renewed:	
Location:	Alley	Tape/Media #:	
Purpose:	Routine Assessment	Dia/Height:	10"
Use:	Sanitary Sewage Pipe	Material:	VCP
Drain Area:		Lining:	None
Category:	NA		
Comment:			
Location Details:		Direction of Survey:	Downstream
US MH:	M-404-008	DS MH:	M-404-007
		Total Length Surveyed (ft):	167.3

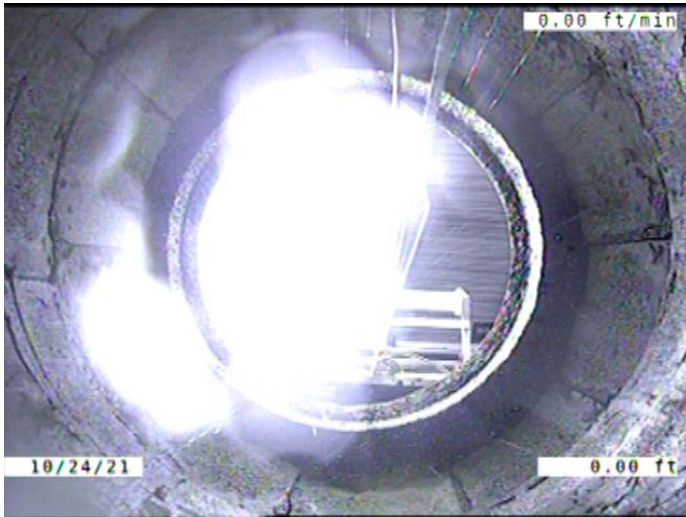
Code: **AMH**
Description: **Manhole**

Distance (ft): **.0**
Structural Grade: **0**
O&M Grade: **0**
Clock Start/From:
Clock To:
1st Value:
2nd Value:
Value Percent:
Continuous Index:
Within 8" of Joint: **NO**
Remarks: **M-404-008**

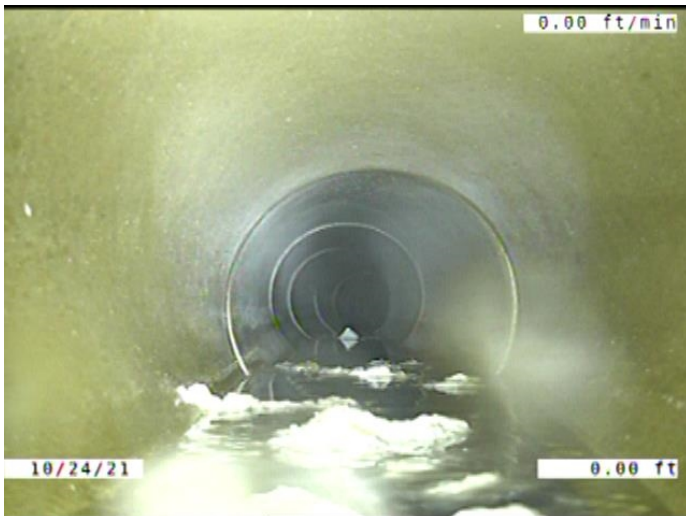
Code: **MWL**
Description: **Miscellaneous Water Level**

Distance (ft): **.0**
Structural Grade: **0**
O&M Grade: **0**
Clock Start/From:
Clock To:
1st Value:
2nd Value:
Value Percent: **5.000**
Continuous Index:
Within 8" of Joint: **NO**
Remarks:

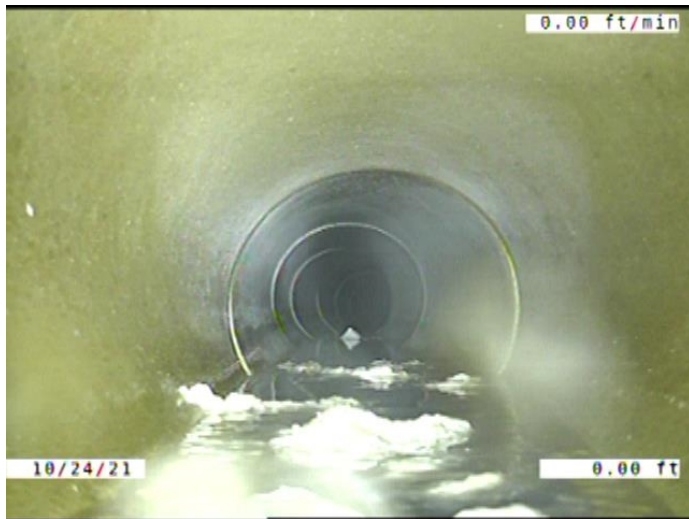
Code: **DSF**
 Description: **Deposits Settled Fine**

Distance (ft): **.0**
 Structural Grade: **0**
 O&M Grade: **2**
 Clock Start/From: **5**
 Clock To: **7**
 1st Value:
 2nd Value:
 Value Percent: **5.000**
 Continuous Index: **S01**
 Within 8" of Joint: **YES**
 Remarks:

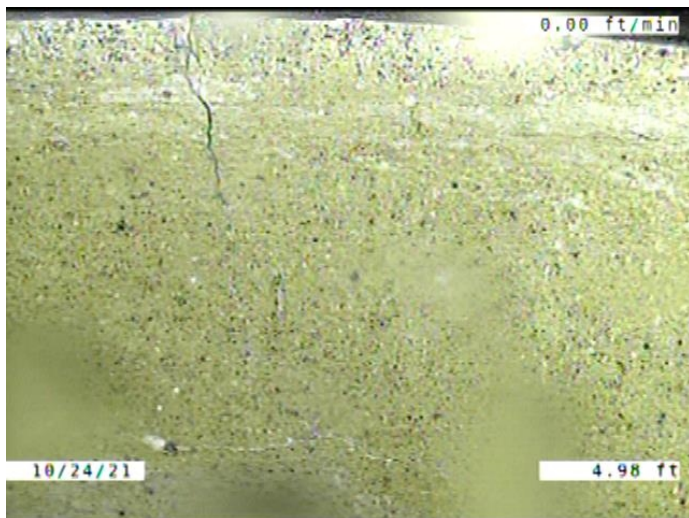
Code: **CM**
 Description: **Crack Multiple**

Distance (ft): **5.0**
 Structural Grade: **3**
 O&M Grade: **0**
 Clock Start/From: **1**
 Clock To: **4**
 1st Value:
 2nd Value:
 Value Percent:
 Continuous Index:
 Within 8" of Joint: **YES**
 Remarks:

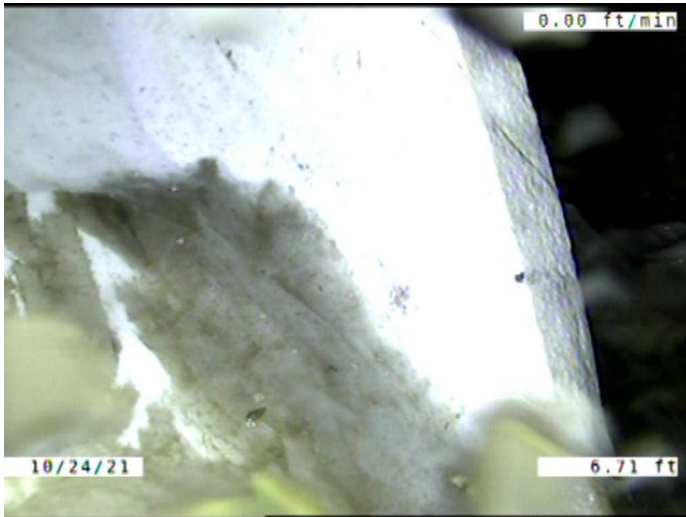
Code:	OBM
Description:	Obstruction Pipe Material in Invert
Distance (ft):	6.7
Structural Grade:	0
O&M Grade:	2
Clock Start/From:	5
Clock To:	7
1st Value:	
2nd Value:	
Value Percent:	5.000
Continuous Index:	
Within 8" of Joint:	YES
Remarks:

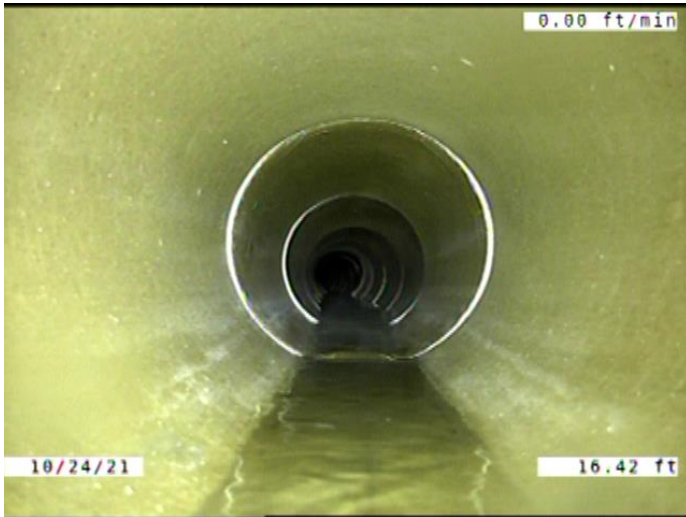
Code: **DSF**
Description: **Deposits Settled Fine**

Distance (ft): **16.4**
Structural Grade: **0**
O&M Grade: **2**
Clock Start/From: **5**
Clock To: **7**
1st Value:
2nd Value:
Value Percent: **5.000**
Continuous Index: **F01**
Within 8" of Joint: **YES**
Remarks:

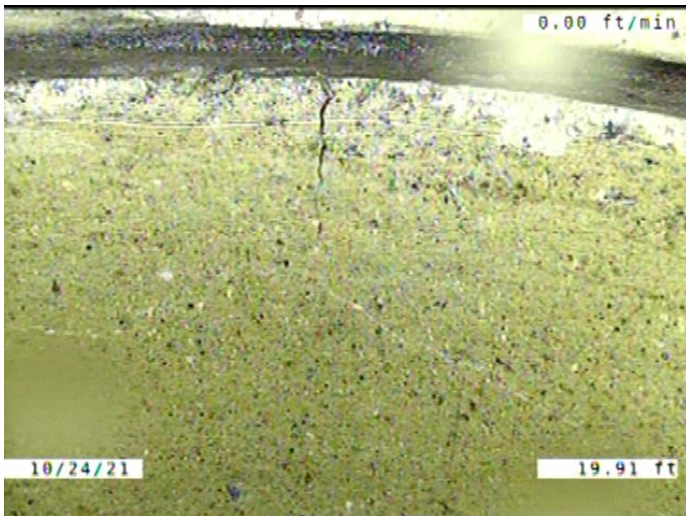
Code: **CM**
Description: **Crack Multiple**

Distance (ft): **19.9**
Structural Grade: **3**
O&M Grade: **0**
Clock Start/From: **10**
Clock To: **2**
1st Value:
2nd Value:
Value Percent:
Continuous Index:
Within 8" of Joint: **YES**
Remarks:

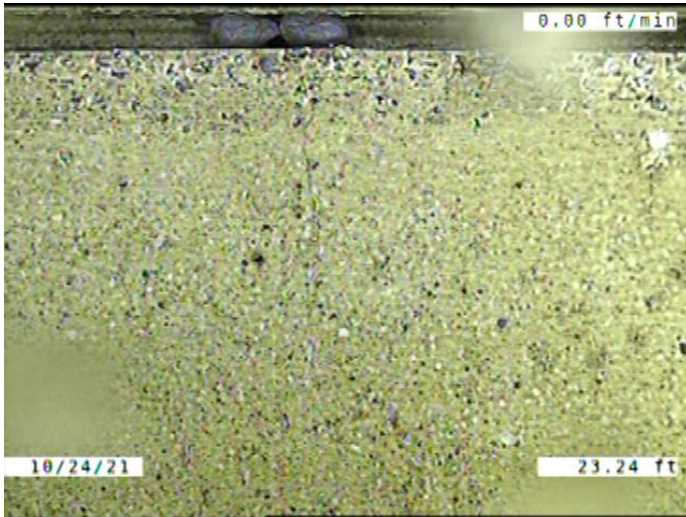
Code: **CL**
Description: **Crack Longitudinal**

Distance (ft): **23.2**
Structural Grade: **2**
O&M Grade: **0**
Clock Start/From: **2**
Clock To:
1st Value:
2nd Value:
Value Percent:
Continuous Index:
Within 8" of Joint: **YES**
Remarks:

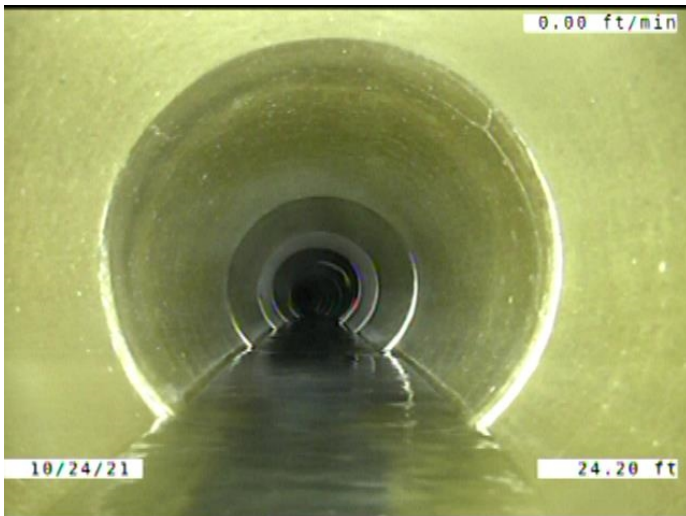
Code: **MWLS**
Description: **Miscellaneous Water Level Sag**

Distance (ft): **24.2**
Structural Grade: **2**
O&M Grade: **0**
Clock Start/From:
Clock To:
1st Value:
2nd Value:
Value Percent: **10.000**
Continuous Index: **S02**
Within 8" of Joint: **NO**
Remarks:

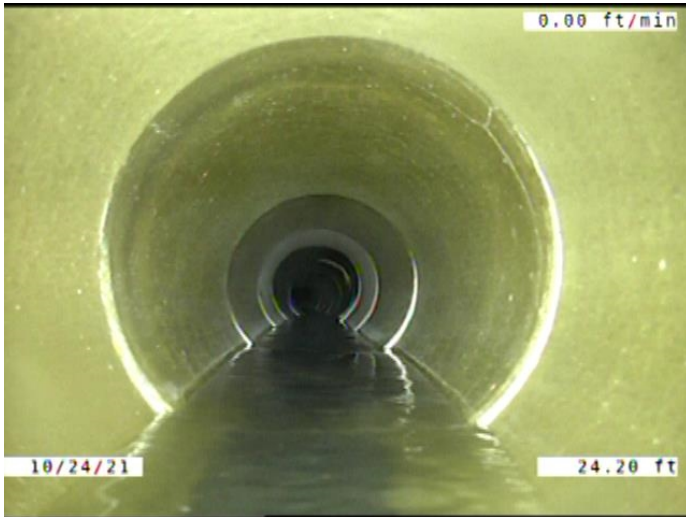
Code: **DSF**
 Description: **Deposits Settled Fine**

Distance (ft): **24.2**
 Structural Grade: **0**
 O&M Grade: **2**
 Clock Start/From: **5**
 Clock To: **7**
 1st Value:
 2nd Value:
 Value Percent: **5.000**
 Continuous Index: **S03**
 Within 8" of Joint: **YES**
 Remarks:

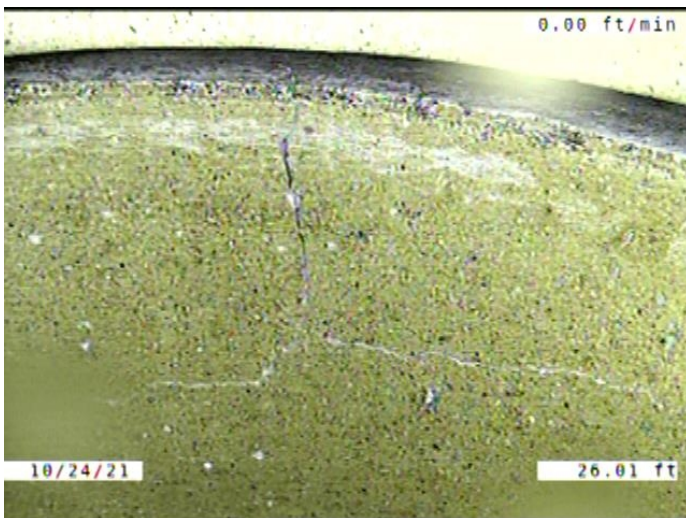
Code: **CM**
 Description: **Crack Multiple**

Distance (ft): **26.0**
 Structural Grade: **3**
 O&M Grade: **0**
 Clock Start/From: **10**
 Clock To: **3**
 1st Value:
 2nd Value:
 Value Percent:
 Continuous Index:
 Within 8" of Joint: **YES**
 Remarks:

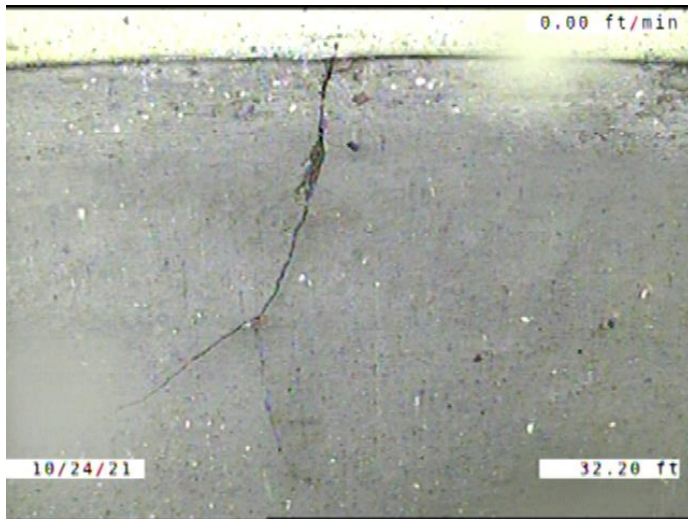
Code: **CM**
Description: **Crack Multiple**

Distance (ft): **32.2**
Structural Grade: **3**
O&M Grade: **0**
Clock Start/From: **9**
Clock To: **4**
1st Value:
2nd Value:
Value Percent:
Continuous Index:
Within 8" of Joint: **YES**
Remarks:

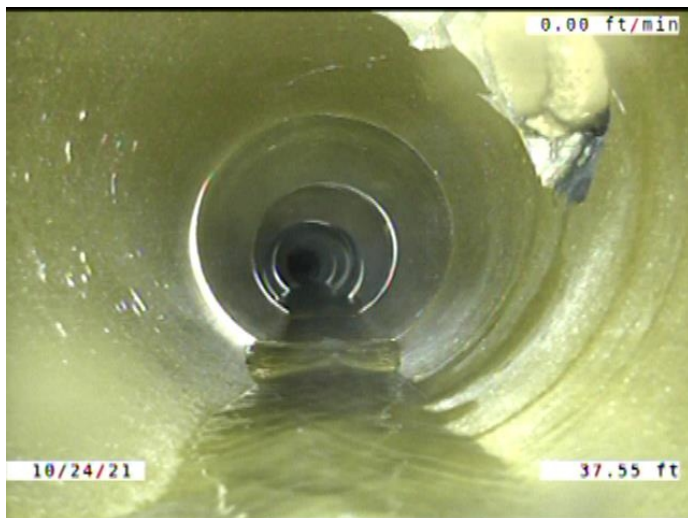
Code: **MWLS**
Description: **Miscellaneous Water Level Sag**

Distance (ft): **37.6**
Structural Grade: **2**
O&M Grade: **0**
Clock Start/From:
Clock To:
1st Value:
2nd Value:
Value Percent: **10.000**
Continuous Index: **F02**
Within 8" of Joint: **NO**
Remarks:

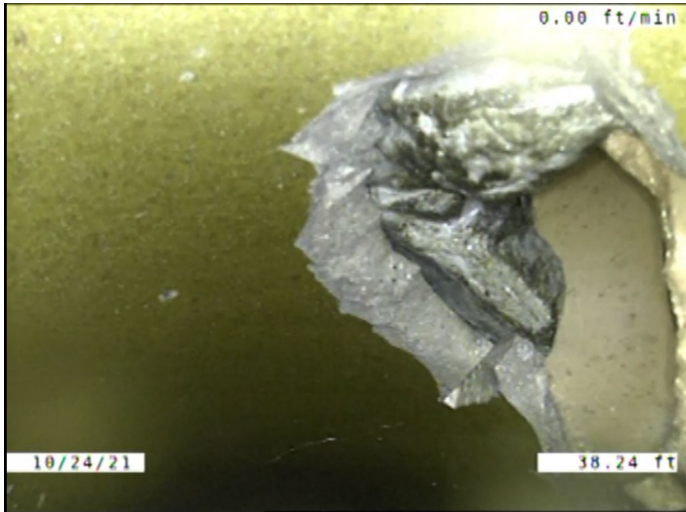
Code: **FM**
 Description: **Fracture Multiple**

Distance (ft): **38.2**
 Structural Grade: **4**
 O&M Grade: **0**
 Clock Start/From: **12**
 Clock To: **2**
 1st Value:
 2nd Value:
 Value Percent:
 Continuous Index:
 Within 8" of Joint: **YES**
 Remarks:

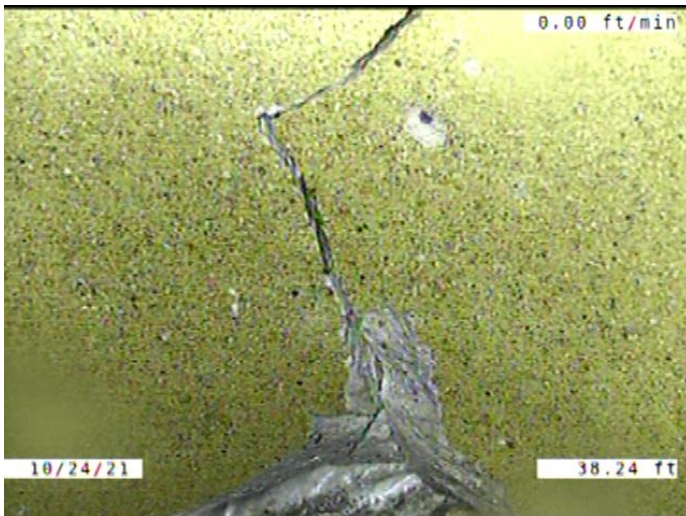
Code: **SMW**
 Description: **Surface Damage Missing Wall**

Distance (ft): **38.2**
 Structural Grade: **5**
 O&M Grade: **0**
 Clock Start/From: **11**
 Clock To: **3**
 1st Value:
 2nd Value:
 Value Percent:
 Continuous Index:
 Within 8" of Joint: **YES**
 Remarks:

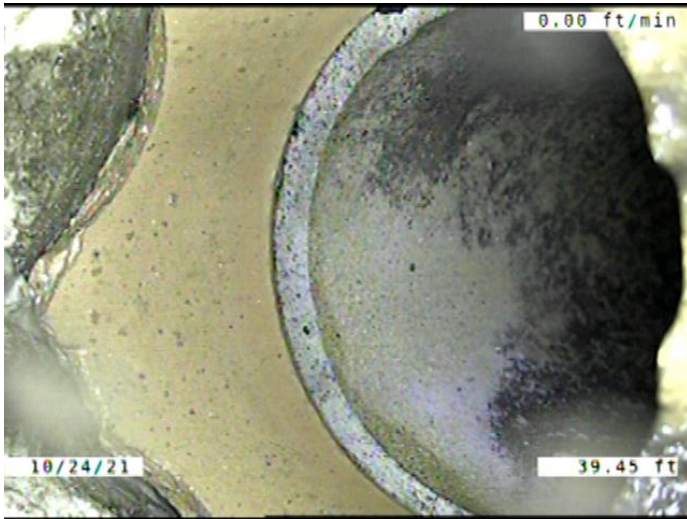
Code: **TBI**
 Description: **Tap Break-in Intruding**

Distance (ft): **39.4**
 Structural Grade: **0**
 O&M Grade: **2**
 Clock Start/From: **1**
 Clock To:
 1st Value: **4.000**
 2nd Value: **1.000**
 Value Percent:
 Continuous Index:
 Within 8" of Joint: **YES**
 Remarks:

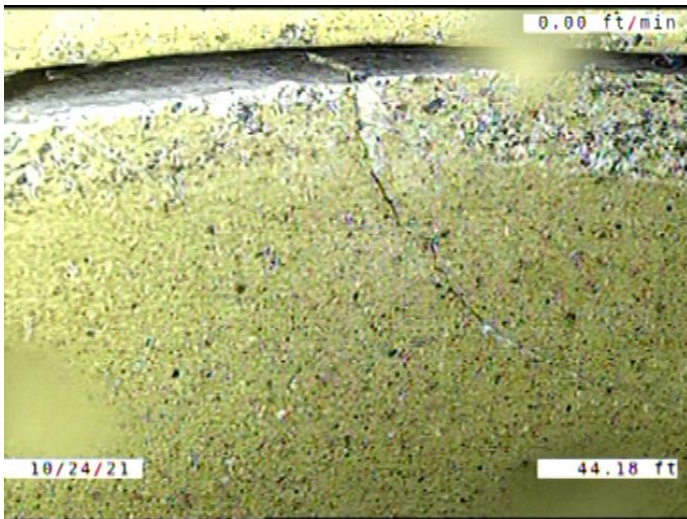
Code: **FM**
 Description: **Fracture Multiple**

Distance (ft): **44.2**
 Structural Grade: **4**
 O&M Grade: **0**
 Clock Start/From: **9**
 Clock To: **3**
 1st Value:
 2nd Value:
 Value Percent:
 Continuous Index:
 Within 8" of Joint: **YES**
 Remarks:

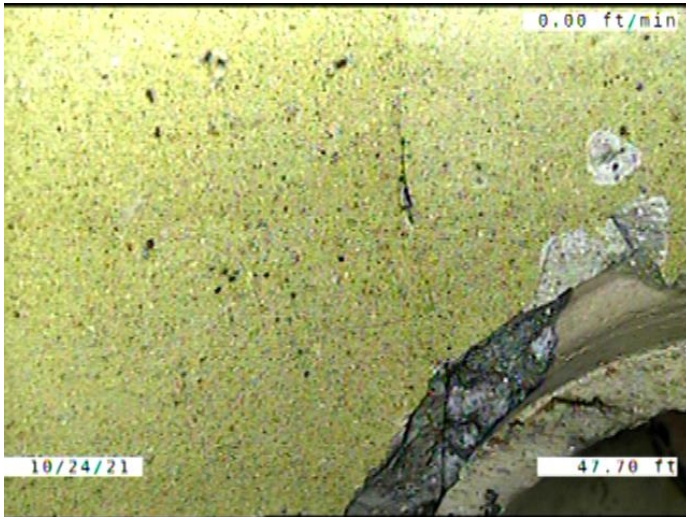
Code: **B**
 Description: **Broken**

Distance (ft): **47.7**
 Structural Grade: **4**
 O&M Grade: **0**
 Clock Start/From: **11**
 Clock To: **1**
 1st Value:
 2nd Value:
 Value Percent:
 Continuous Index:
 Within 8" of Joint: **YES**
 Remarks:

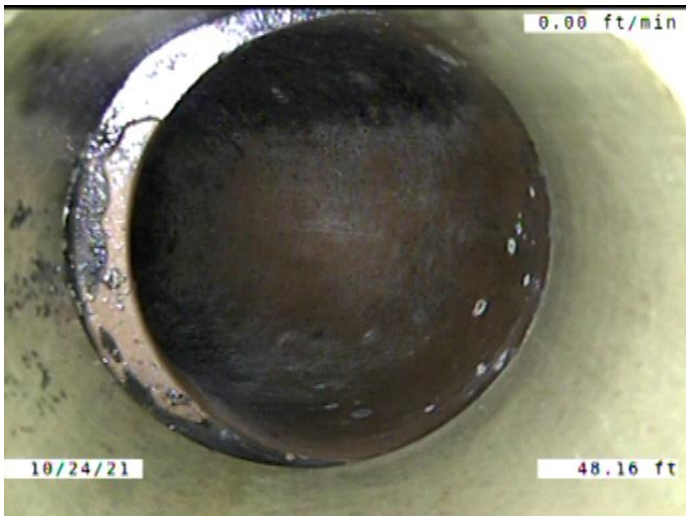
Code: **TBI**
 Description: **Tap Break-in Intruding**

Distance (ft): **48.2**
 Structural Grade: **0**
 O&M Grade: **2**
 Clock Start/From: **12**
 Clock To:
 1st Value: **4.000**
 2nd Value: **1.000**
 Value Percent:
 Continuous Index:
 Within 8" of Joint: **YES**
 Remarks:

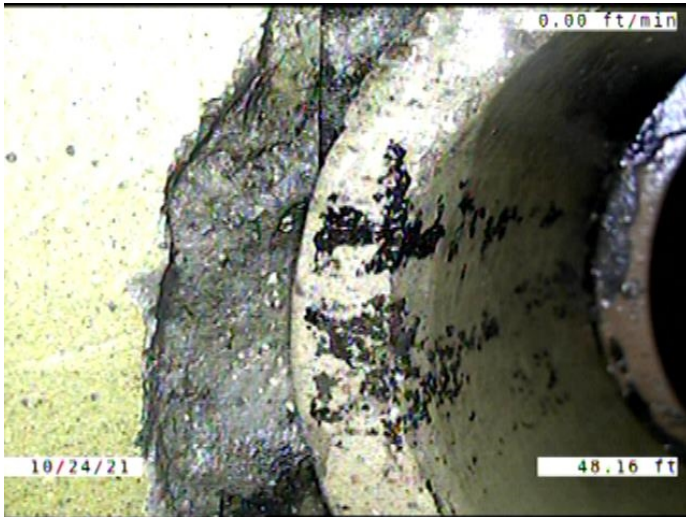
Code: **IDC**
 Description: **Infiltration Dripper Connection**

Distance (ft): **48.2**
 Structural Grade: **0**
 O&M Grade: **3**
 Clock Start/From: **11**
 Clock To: **12**
 1st Value:
 2nd Value:
 Value Percent:
 Continuous Index:
 Within 8" of Joint: **YES**
 Remarks:

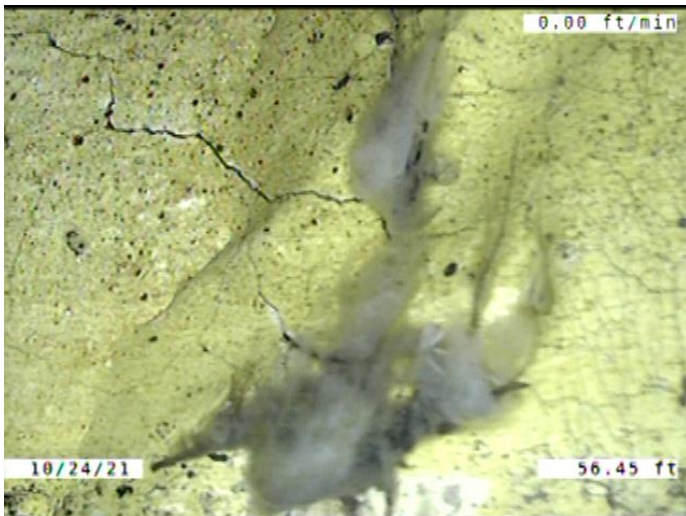
Code: **CM**
 Description: **Crack Multiple**

Distance (ft): **56.5**
 Structural Grade: **3**
 O&M Grade: **0**
 Clock Start/From: **5**
 Clock To: **11**
 1st Value:
 2nd Value:
 Value Percent:
 Continuous Index:
 Within 8" of Joint: **YES**
 Remarks:

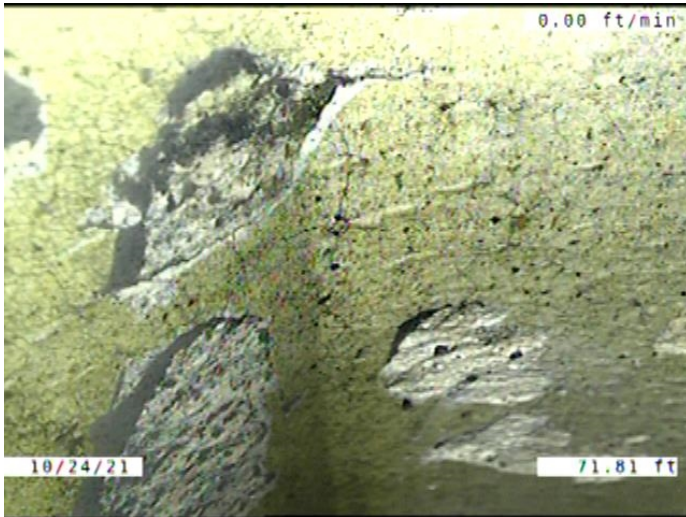
Code: **SSS**
 Description: **Surface Damage Surface Spalling**

Distance (ft): **71.8**
 Structural Grade: **2**
 O&M Grade: **0**
 Clock Start/From: **12**
 Clock To: **12**
 1st Value:
 2nd Value:
 Value Percent:
 Continuous Index:
 Within 8" of Joint: **YES**
 Remarks:

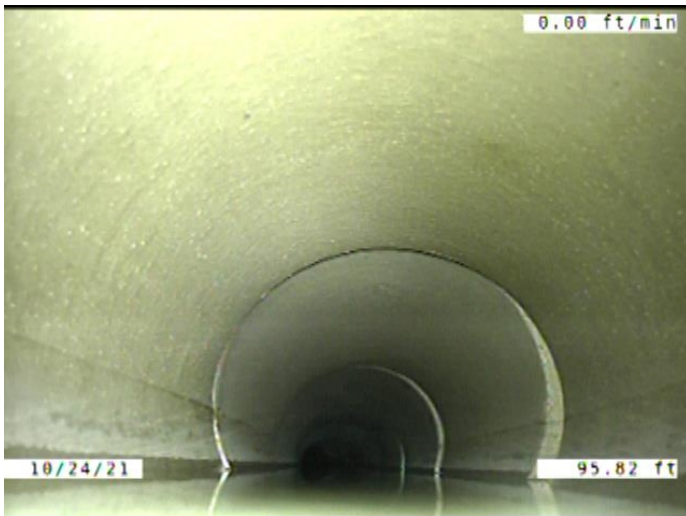
Code: **MWL**
 Description: **Miscellaneous Water Level**

Distance (ft): **95.8**
 Structural Grade: **0**
 O&M Grade: **0**
 Clock Start/From:
 Clock To:
 1st Value:
 2nd Value:
 Value Percent: **15.000**
 Continuous Index:
 Within 8" of Joint: **NO**
 Remarks:

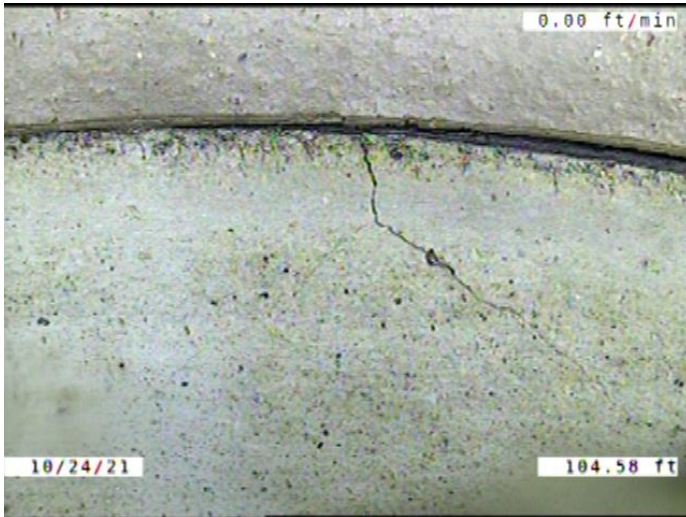
Code: **CM**
Description: **Crack Multiple**

Distance (ft): **104.6**
Structural Grade: **3**
O&M Grade: **0**
Clock Start/From: **11**
Clock To: **2**
1st Value:
2nd Value:
Value Percent:
Continuous Index:
Within 8" of Joint: **YES**
Remarks:

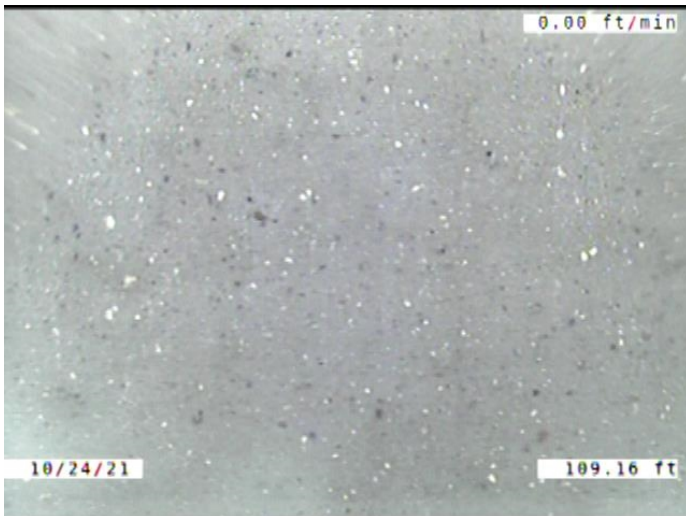
Code: **MWL**
Description: **Miscellaneous Water Level**

Distance (ft): **109.2**
Structural Grade: **0**
O&M Grade: **0**
Clock Start/From:
Clock To:
1st Value:
2nd Value:
Value Percent: **35.000**
Continuous Index:
Within 8" of Joint: **NO**
Remarks:

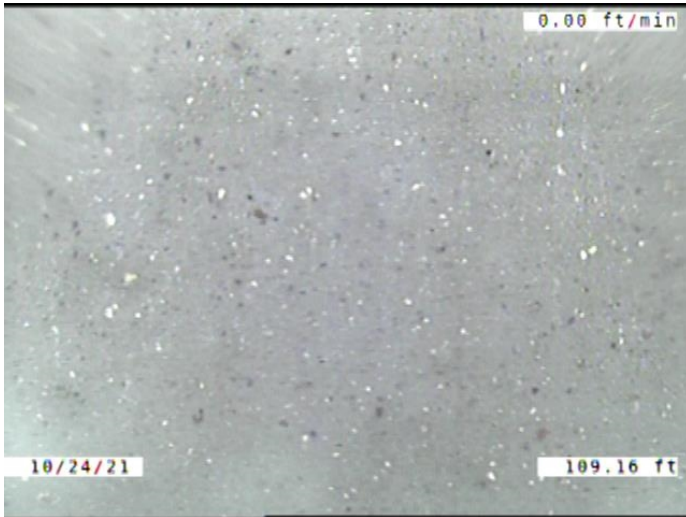
Code: **MCU**
Description: **Miscellaneous Camera Underwater**

Distance (ft): **109.2**
Structural Grade: **0**
O&M Grade: **4**
Clock Start/From:
Clock To:
1st Value:
2nd Value:
Value Percent:
Continuous Index:
Within 8" of Joint: **NO**
Remarks: **Section retelevised from 97ft**

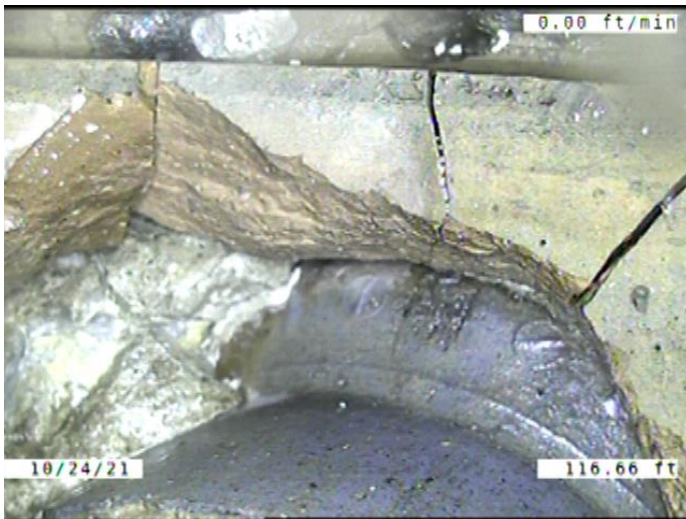
Code: **B**
Description: **Broken**

Distance (ft): **116.7**
Structural Grade: **4**
O&M Grade: **0**
Clock Start/From: **9**
Clock To: **2**
1st Value:
2nd Value:
Value Percent:
Continuous Index:
Within 8" of Joint: **YES**
Remarks:

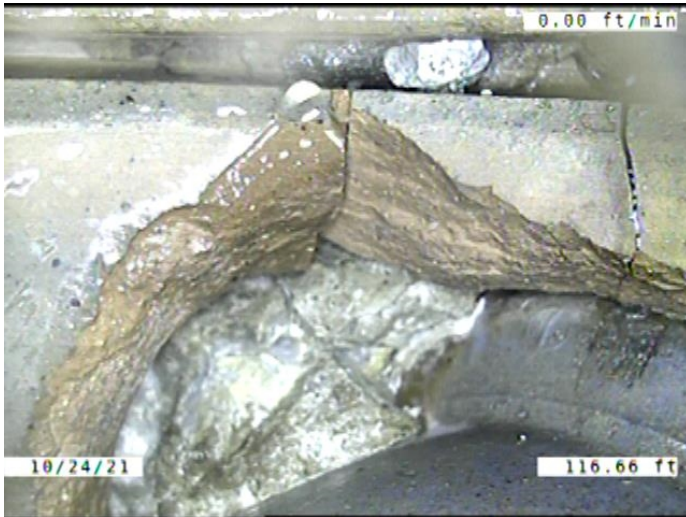
Code: **IRB**
 Description: **Infiltration Runner Barrel**

Distance (ft): **116.7**
 Structural Grade: **0**
 O&M Grade: **4**
 Clock Start/From: **12**
 Clock To: **2**
 1st Value:
 2nd Value:
 Value Percent:
 Continuous Index:
 Within 8" of Joint: **YES**
 Remarks:

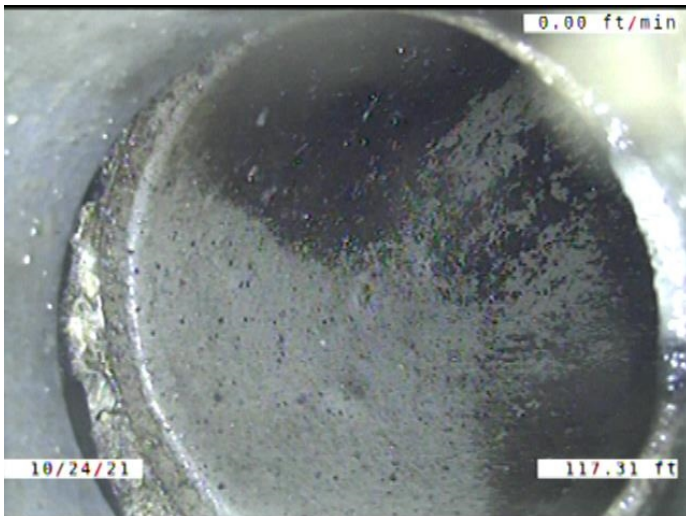
Code: **TBI**
 Description: **Tap Break-in Intruding**

Distance (ft): **117.3**
 Structural Grade: **0**
 O&M Grade: **2**
 Clock Start/From: **1**
 Clock To:
 1st Value: **4.000**
 2nd Value: **2.000**
 Value Percent:
 Continuous Index:
 Within 8" of Joint: **YES**
 Remarks:

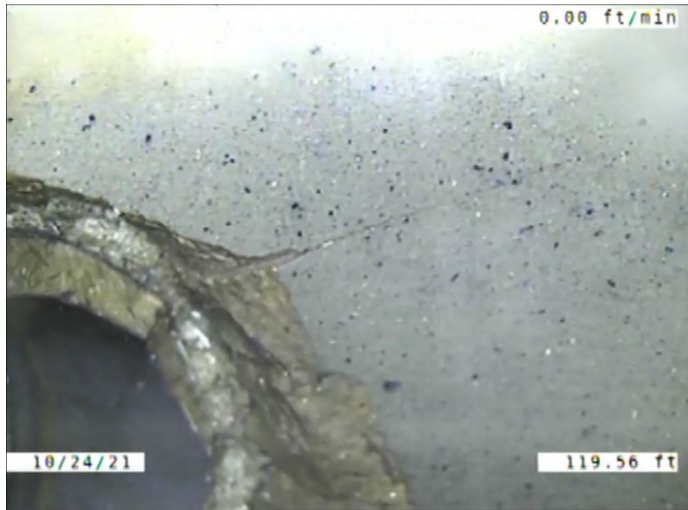
Code: **SSS**
Description: **Surface Damage Surface Spalling**

Distance (ft): **119.6**
Structural Grade: **2**
O&M Grade: **0**
Clock Start/From: **9**
Clock To: **1**
1st Value:
2nd Value:
Value Percent:
Continuous Index:
Within 8" of Joint: **NO**
Remarks:

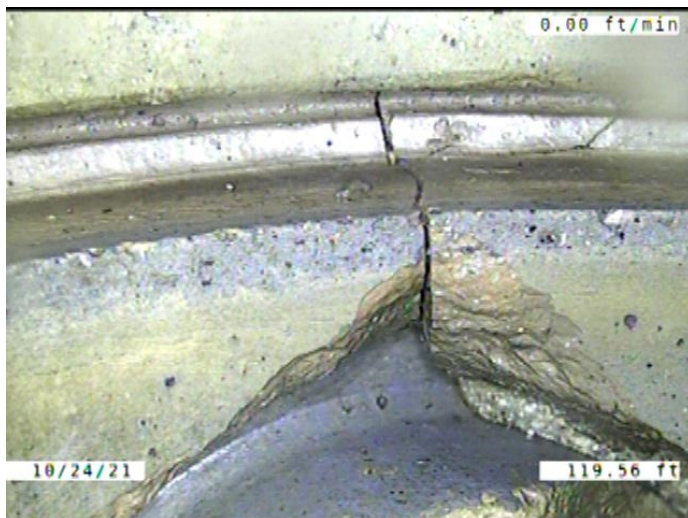
Code: **FM**
Description: **Fracture Multiple**

Distance (ft): **119.6**
Structural Grade: **4**
O&M Grade: **0**
Clock Start/From: **9**
Clock To: **1**
1st Value:
2nd Value:
Value Percent:
Continuous Index:
Within 8" of Joint: **YES**
Remarks:

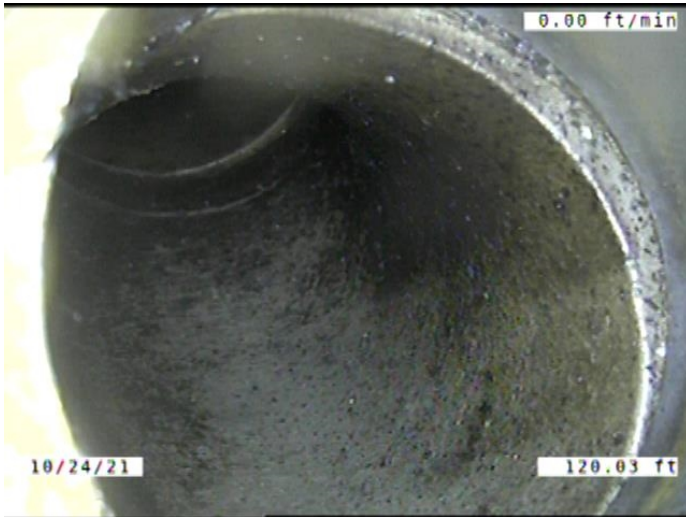
Code: **TBI**
Description: **Tap Break-in Intruding**

Distance (ft): **120.0**
Structural Grade: **0**
O&M Grade: **2**
Clock Start/From: **10**
Clock To:
1st Value: **4.000**
2nd Value: **1.000**
Value Percent:
Continuous Index:
Within 8" of Joint: **YES**
Remarks: **CONSTANTLY RUNNING WATER**

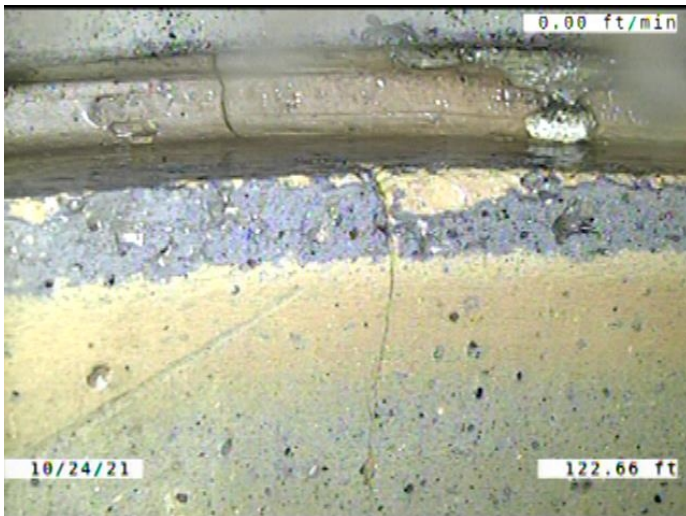
Code: **CL**
Description: **Crack Longitudinal**

Distance (ft): **122.7**
Structural Grade: **2**
O&M Grade: **0**
Clock Start/From: **10**
Clock To:
1st Value:
2nd Value:
Value Percent:
Continuous Index:
Within 8" of Joint: **YES**
Remarks:

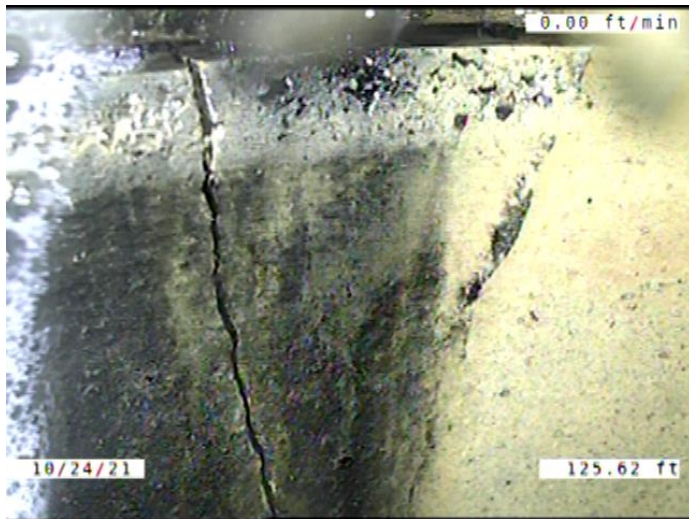
Code: **FM**
 Description: **Fracture Multiple**

Distance (ft): **125.6**
 Structural Grade: **4**
 O&M Grade: **0**
 Clock Start/From: **8**
 Clock To: **10**
 1st Value:
 2nd Value:
 Value Percent:
 Continuous Index:
 Within 8" of Joint: **YES**
 Remarks:

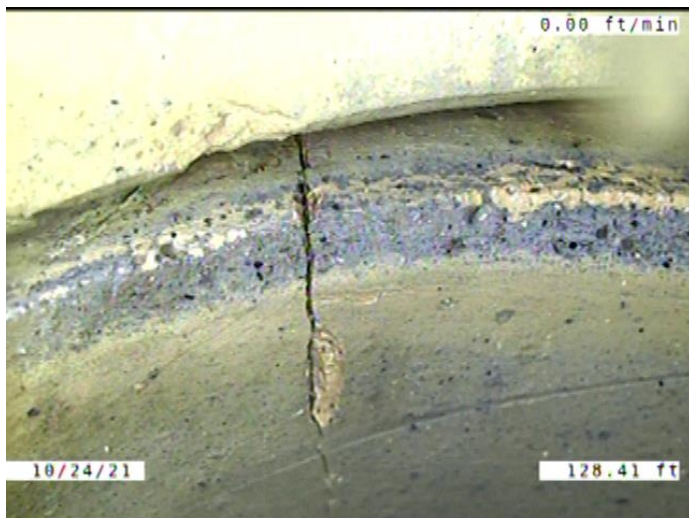
Code: **FL**
 Description: **Fracture Longitudinal**

Distance (ft): **128.4**
 Structural Grade: **3**
 O&M Grade: **0**
 Clock Start/From: **8**
 Clock To:
 1st Value:
 2nd Value:
 Value Percent:
 Continuous Index:
 Within 8" of Joint: **YES**
 Remarks:

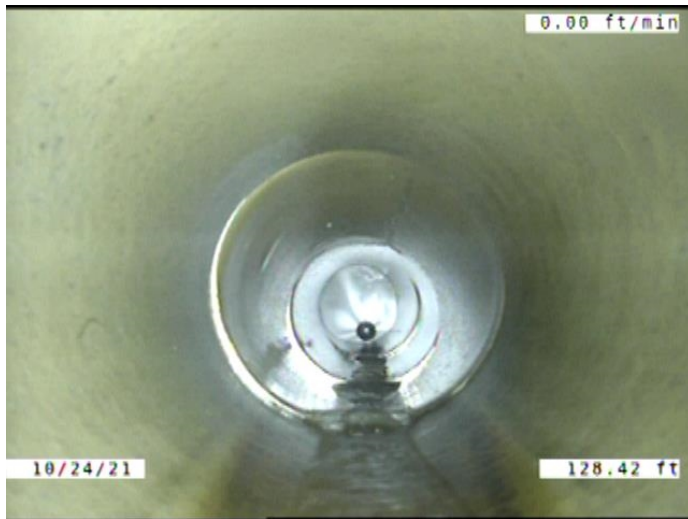
Code: **MWL**
Description: **Miscellaneous Water Level**

Distance (ft): **128.4**
Structural Grade: **0**
O&M Grade: **0**
Clock Start/From:
Clock To:
1st Value:
2nd Value:
Value Percent: **5.000**
Continuous Index:
Within 8" of Joint: **NO**
Remarks:

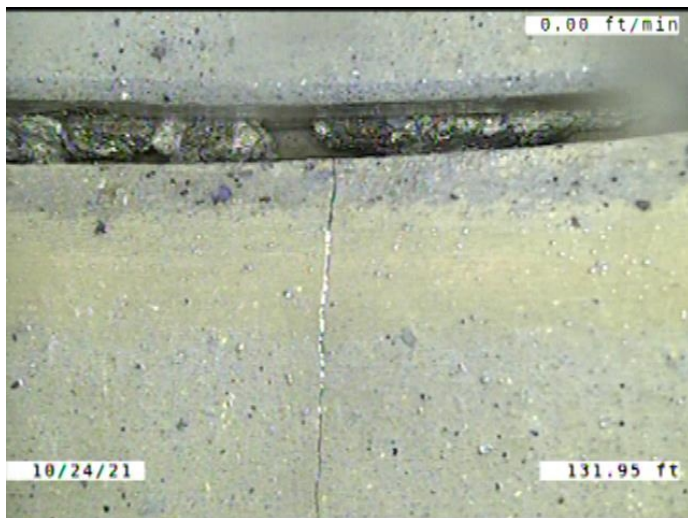
Code: **CL**
Description: **Crack Longitudinal**

Distance (ft): **131.9**
Structural Grade: **2**
O&M Grade: **0**
Clock Start/From: **2**
Clock To:
1st Value:
2nd Value:
Value Percent:
Continuous Index:
Within 8" of Joint: **YES**
Remarks:

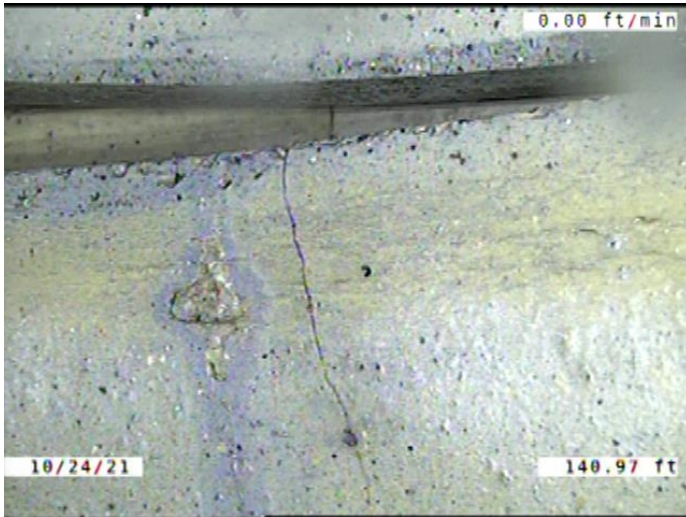
Code: **CL**
Description: **Crack Longitudinal**

Distance (ft): **141.0**
Structural Grade: **2**
O&M Grade: **0**
Clock Start/From: **2**
Clock To:
1st Value:
2nd Value:
Value Percent:
Continuous Index:
Within 8" of Joint: **YES**
Remarks:

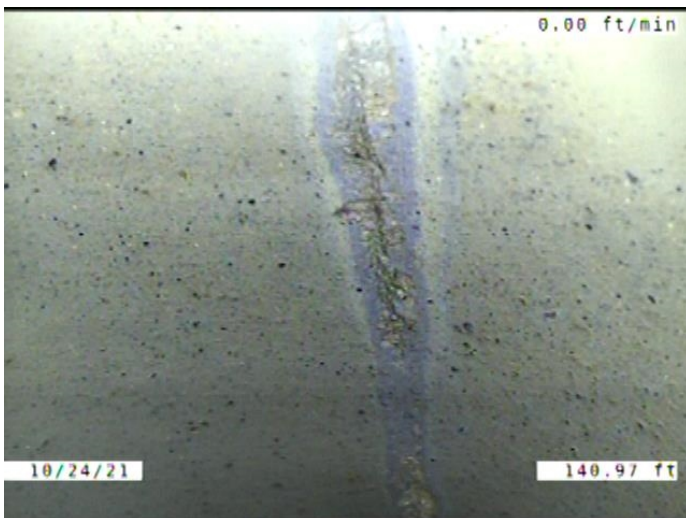
Code: **SSS**
Description: **Surface Damage Surface Spalling**

Distance (ft): **141.0**
Structural Grade: **2**
O&M Grade: **0**
Clock Start/From: **2**
Clock To:
1st Value:
2nd Value:
Value Percent:
Continuous Index:
Within 8" of Joint: **YES**
Remarks:

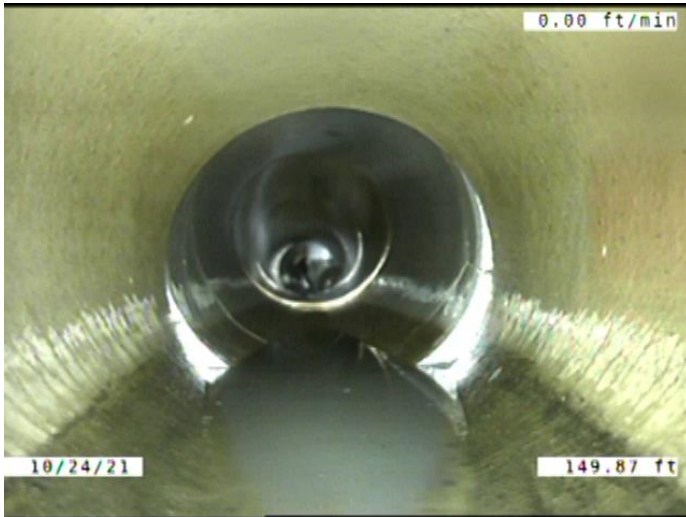
Code: **MWLS**
 Description: **Miscellaneous Water Level Sag**

Distance (ft): **149.9**
 Structural Grade: **2**
 O&M Grade: **0**
 Clock Start/From:
 Clock To:
 1st Value:
 2nd Value:
 Value Percent: **10.000**
 Continuous Index: **S04**
 Within 8" of Joint: **NO**
 Remarks:

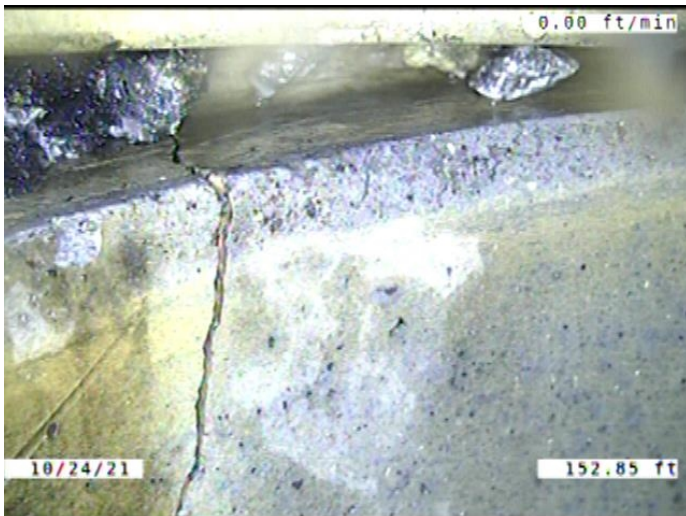
Code: **B**
 Description: **Broken**

Distance (ft): **152.9**
 Structural Grade: **4**
 O&M Grade: **0**
 Clock Start/From: **1**
 Clock To: **9**
 1st Value:
 2nd Value:
 Value Percent:
 Continuous Index:
 Within 8" of Joint: **YES**
 Remarks:

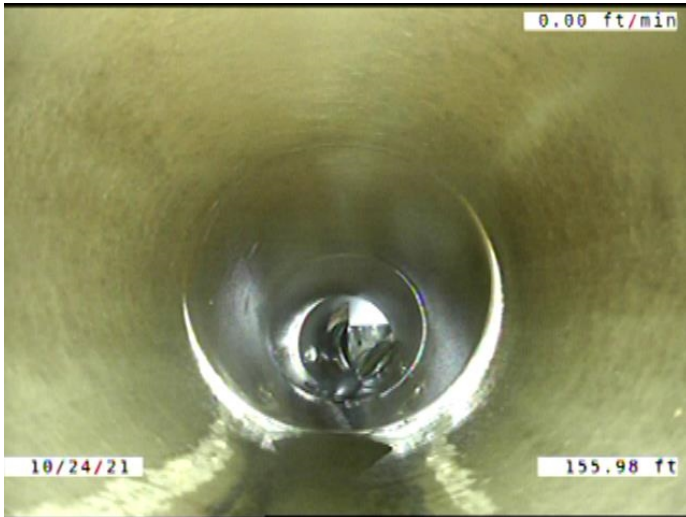
Code: **MWLS**
 Description: **Miscellaneous Water Level Sag**

Distance (ft): **156.0**
 Structural Grade: **2**
 O&M Grade: **0**
 Clock Start/From:
 Clock To:
 1st Value:
 2nd Value:
 Value Percent: **10.000**
 Continuous Index: **F04**
 Within 8" of Joint: **NO**
 Remarks:

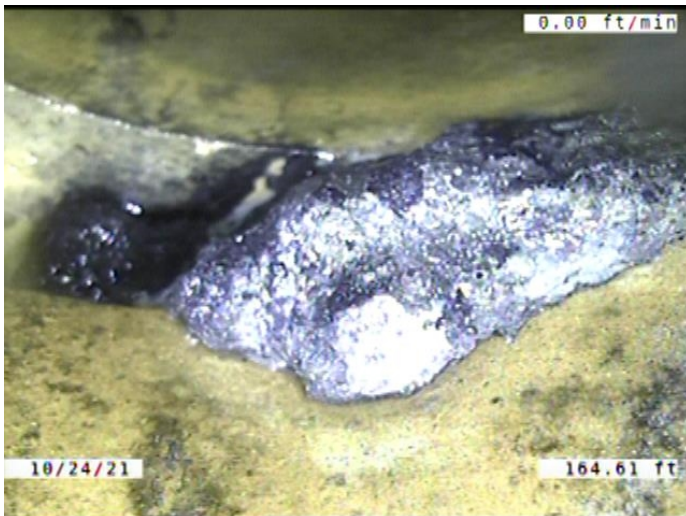
Code: **DAE**
 Description: **Deposits Attached Encrustation**

Distance (ft): **164.6**
 Structural Grade: **0**
 O&M Grade: **2**
 Clock Start/From: **5**
 Clock To: **7**
 1st Value:
 2nd Value:
 Value Percent: **5.000**
 Continuous Index:
 Within 8" of Joint: **YES**
 Remarks:

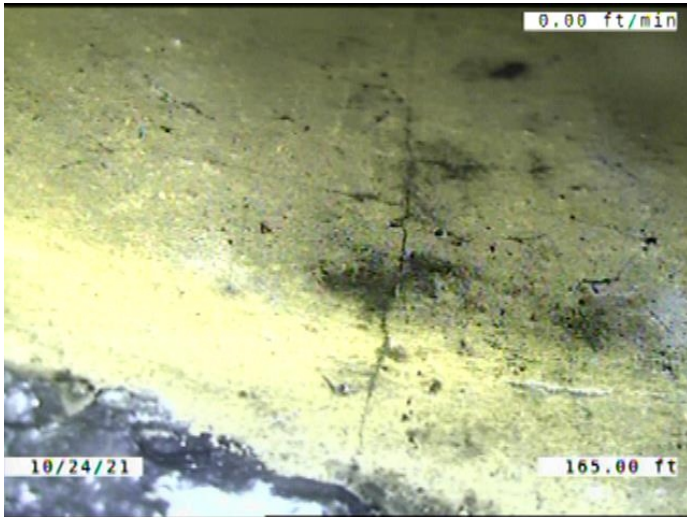
Code: **CM**
 Description: **Crack Multiple**

Distance (ft): **165.0**
 Structural Grade: **3**
 O&M Grade: **0**
 Clock Start/From: **5**
 Clock To: **7**
 1st Value:
 2nd Value:
 Value Percent:
 Continuous Index:
 Within 8" of Joint: **YES**
 Remarks:

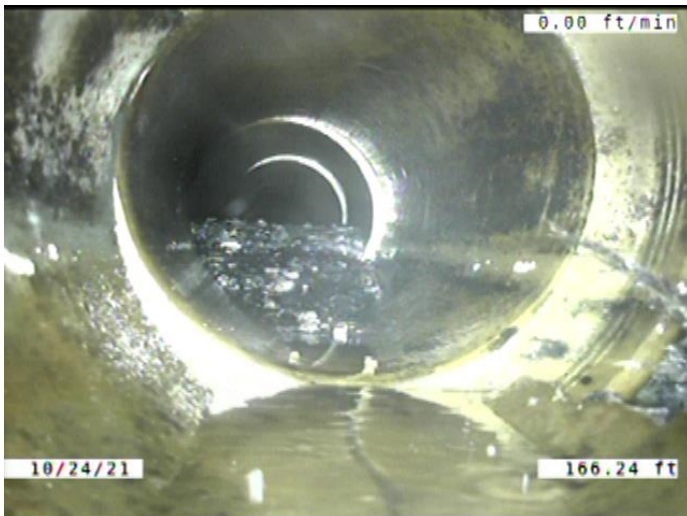
Code: **DSF**
 Description: **Deposits Settled Fine**

Distance (ft): **166.2**
 Structural Grade: **0**
 O&M Grade: **2**
 Clock Start/From: **5**
 Clock To: **7**
 1st Value:
 2nd Value:
 Value Percent: **5.000**
 Continuous Index: **F03**
 Within 8" of Joint: **YES**
 Remarks:

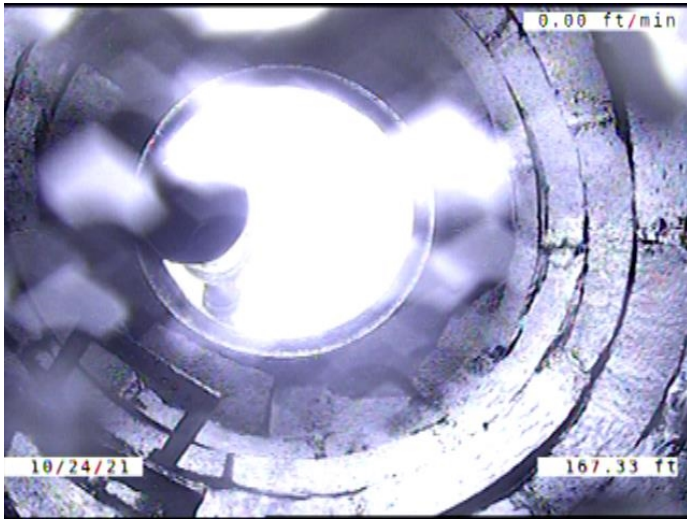
Code:	AMH
Description:	Manhole
Distance (ft):	167.3
Structural Grade:	0
O&M Grade:	0
Clock Start/From:	
Clock To:	
1st Value:	
2nd Value:	
Value Percent:	
Continuous Index:	
Within 8" of Joint:	NO
Remarks:	M-404-007
