Profile/Photo Observation Report

Date: 10/24/2021 Weather: **PACP 7.0** Coding: Pipe Length (ft): 167.3 Owner: **City of Hobart** Pre Clean: **Heavy Cleaning** P.O.#: S. Bucklin PSR: P-404-008-007 YES502259 Surveyor:

Street: North Wabash Street Flow Control: Not Controlled

US MH: M-404-008 DS MH: M-404-007 Total Length Surveyed (ft): 167.3

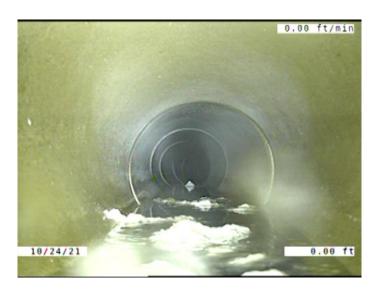
Code: MWL

Description: Miscellaneous Water Level

Distance (ft): .0
Structural Grade: 0
O&M Grade: 0

Value Percent: 5.000

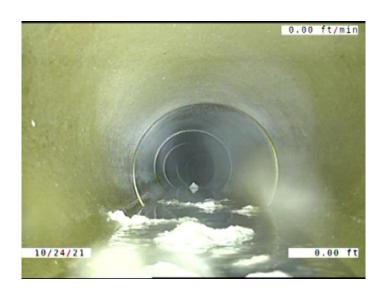
Code: **DSF**

Description: Deposits Settled Fine

Distance (ft): .0
Structural Grade: 0
O&M Grade: 2
Clock Start/From: 5
Clock To: 7

Value Percent: 5.000
Continuous Index: S01
Within 8" of Joint: YES

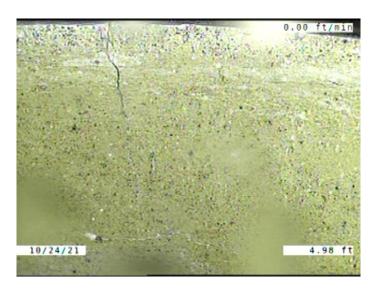
Code: CM

Description: Crack Multiple

Distance (ft): 5.0
Structural Grade: 3
O&M Grade: 0
Clock Start/From: 1
Clock To: 4
1st Value:
2nd Value:
Value Percent:

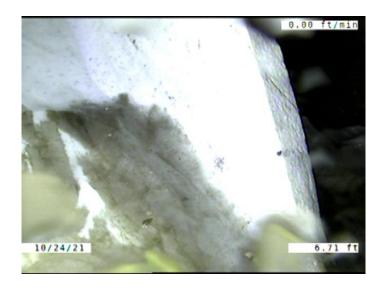
Code: OBM

Description: Obstruction Pipe Material in Invert

Distance (ft): 6.7
Structural Grade: 0
O&M Grade: 2
Clock Start/From: 5
Clock To: 7

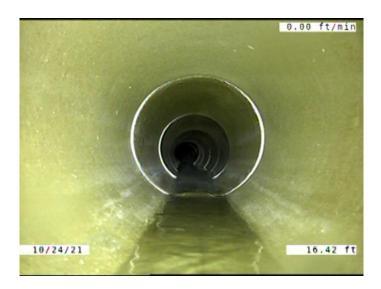
Code: **DSF**

Description: **Deposits Settled Fine**

Distance (ft): 16.4 Structural Grade: 0 2 O&M Grade: Clock Start/From: 5 Clock To: 7

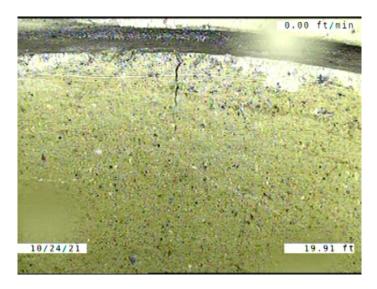
CM Code:

Description: **Crack Multiple**

Distance (ft): 19.9 Structural Grade: 3 O&M Grade: 0 Clock Start/From: 10 2 Clock To: 1st Value: 2nd Value: Value Percent: Continuous Index: Within 8" of Joint:

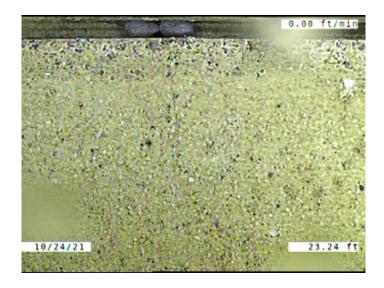
Code: CL

Description: **Crack Longitudinal**

Distance (ft): 23.2 Structural Grade: 2 O&M Grade: 0 Clock Start/From: 2

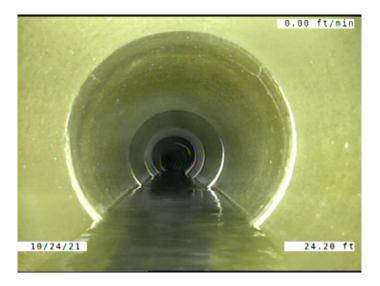
MWLS Code:

Description: **Miscellaneous Water Level Sag**

Distance (ft): 24.2 Structural Grade: 2 O&M Grade: 0

Value Percent: 10.000 Continuous Index: **S02** Within 8" of Joint: NO

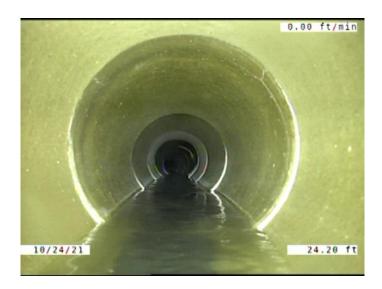
Code: **DSF**

Description: Deposits Settled Fine

Distance (ft): 24.2
Structural Grade: 0
O&M Grade: 2
Clock Start/From: 5
Clock To: 7

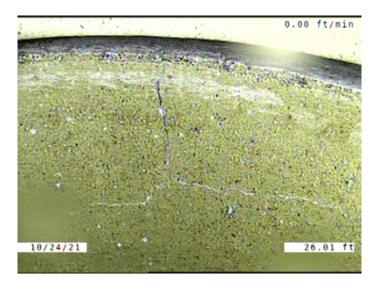
Code: CM

Description: Crack Multiple

Distance (ft): 26.0
Structural Grade: 3
O&M Grade: 0
Clock Start/From: 10
Clock To: 3
1st Value:
2nd Value:
Value Percent:

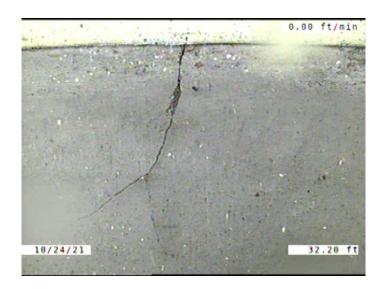
Code: CM

Description: **Crack Multiple**

Distance (ft): 32.2 Structural Grade: 3 0 O&M Grade: Clock Start/From: 9 Clock To: 4

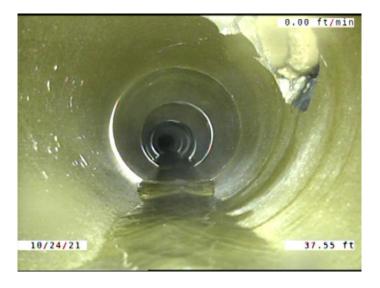
Code: **MWLS**

Description: **Miscellaneous Water Level Sag**

Distance (ft): 37.6 Structural Grade: 2 O&M Grade: 0

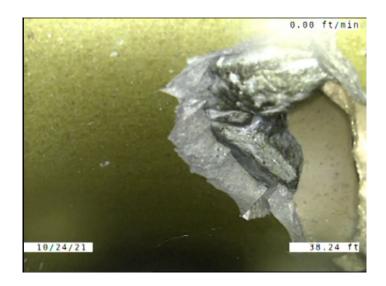
Code: FΜ

Description: **Fracture Multiple**

Distance (ft): 38.2 Structural Grade: 4 O&M Grade: 0 Clock Start/From: 12 Clock To: 2 1st Value: 2nd Value:

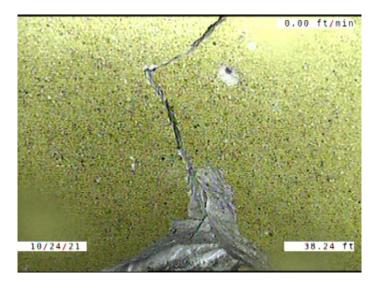
Code: **SMW**

Description: **Surface Damage Missing Wall**

Distance (ft): 38.2 Structural Grade: 5 O&M Grade: 0 Clock Start/From: 11 3 Clock To: 1st Value: 2nd Value: Value Percent: Continuous Index: Within 8" of Joint: YES

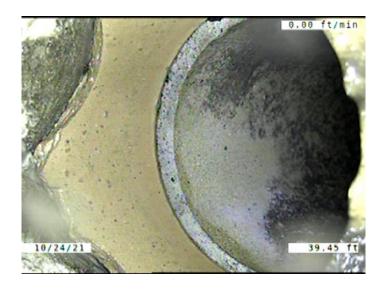
Code: **TBI**

Description: Tap Break-in Intruding

Distance (ft): 39.4
Structural Grade: 0

O&M Grade: 2

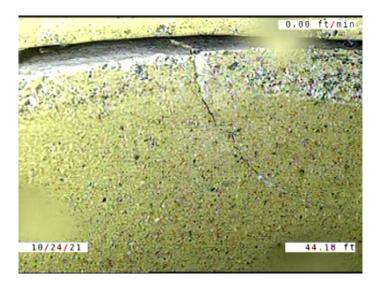
Code: FM

Description: Fracture Multiple

Distance (ft): 44.2
Structural Grade: 4

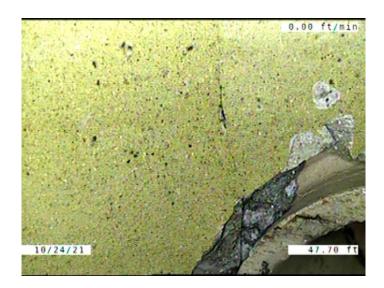
Code: B
Description: Broken

Distance (ft): 47.7 Structural Grade: 4 O&M Grade: 0 Clock Start/From: 11 Clock To: 1 1st Value: 2nd Value: Value Percent: Continuous Index: Within 8" of Joint: YES

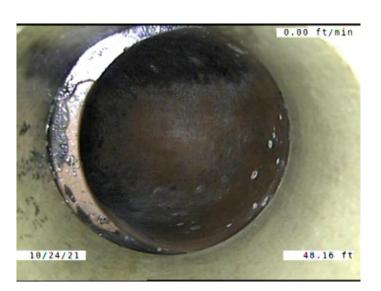
Code: TBI

Description: Tap Break-in Intruding

Distance (ft): 48.2
Structural Grade: 0
O&M Grade: 2
Clock Start/From: 12

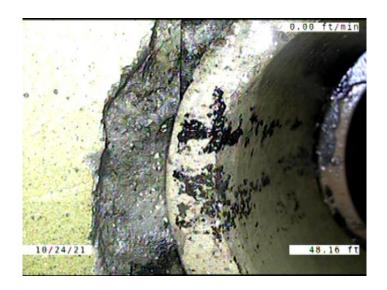
Code: IDC

Description: Infiltration Dripper Connection

Distance (ft): 48.2
Structural Grade: 0
O&M Grade: 3
Clock Start/From: 11
Clock To: 12

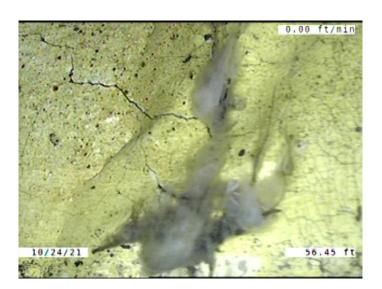
Code: CM

Description: Crack Multiple

Distance (ft): 56.5
Structural Grade: 3
O&M Grade: 0
Clock Start/From: 5
Clock To: 11
1st Value:

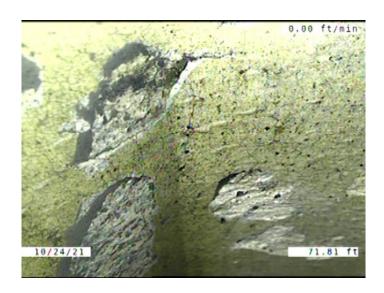
Code: SSS

Description: Surface Damage Surface Spalling

Distance (ft): 71.8
Structural Grade: 2
O&M Grade: 0
Clock Start/From: 12
Clock To: 12

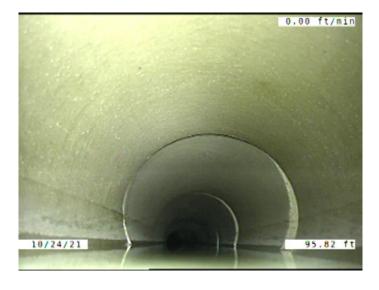
Code: MWL

Description: Miscellaneous Water Level

Distance (ft): 95.8
Structural Grade: 0

Value Percent: 15.000

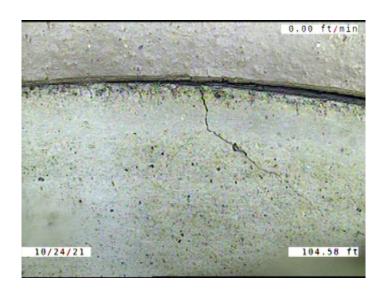
Code: CM

Description: Crack Multiple

Distance (ft): 104.6
Structural Grade: 3

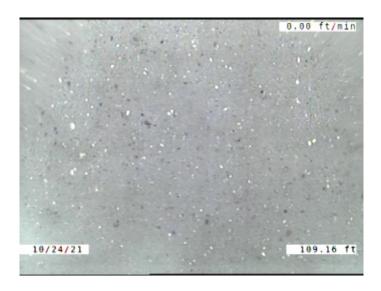
Code: MWL

Description: Miscellaneous Water Level

Distance (ft): 109.2
Structural Grade: 0

Value Percent: 35.000

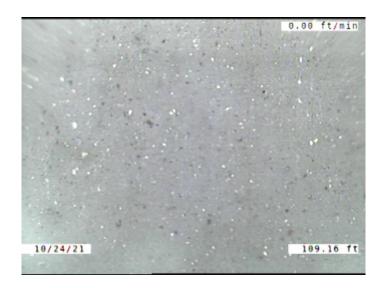
Code: MCU

Description: Miscellaneous Camera Underwater

Distance (ft): 109.2
Structural Grade: 0
O&M Grade: 4

Remarks: Section retelevised from 97ft

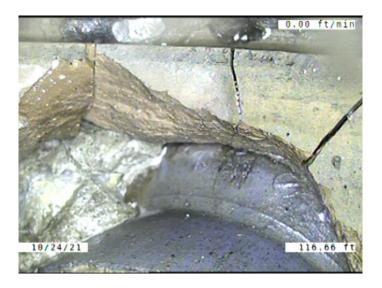
Code: B

Description: Broken

Distance (ft): 116.7
Structural Grade: 4

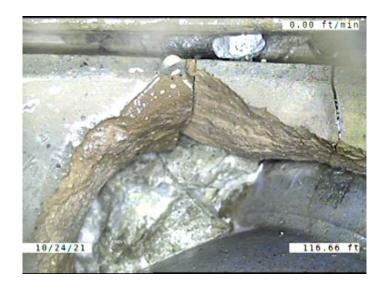
Code: IRB

Description: Infiltration Runner Barrel

Distance (ft): 116.7
Structural Grade: 0
O&M Grade: 4
Clock Start/From: 12
Clock To: 2

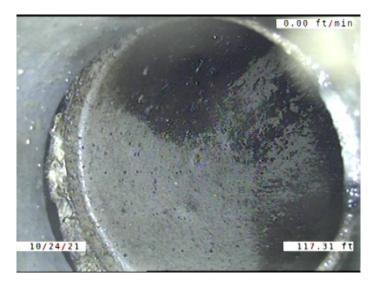
Code: TBI

Description: Tap Break-in Intruding

Distance (ft): 117.3
Structural Grade: 0
O&M Grade: 2
Clock Start/From: 1

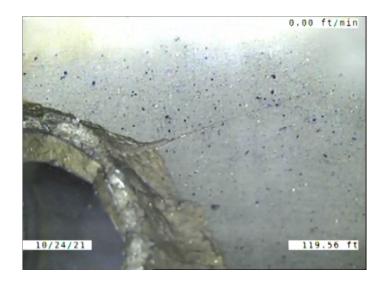
Code: SSS

Description: Surface Damage Surface Spalling

Distance (ft): 119.6
Structural Grade: 2
O&M Grade: 0
Clock Start/From: 9
Clock To: 1

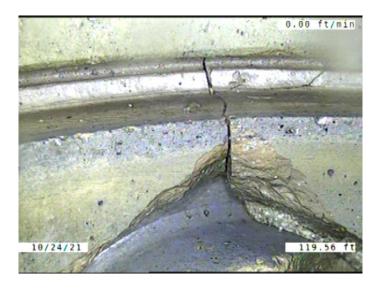
Code: FM

Description: Fracture Multiple

Distance (ft): 119.6
Structural Grade: 4

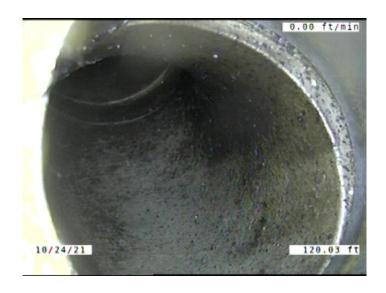
Code: TBI

Description: Tap Break-in Intruding

Distance (ft): 120.0
Structural Grade: 0
O&M Grade: 2
Clock Start/From: 10

Remarks: CONSTANTLY RUNNING WATER

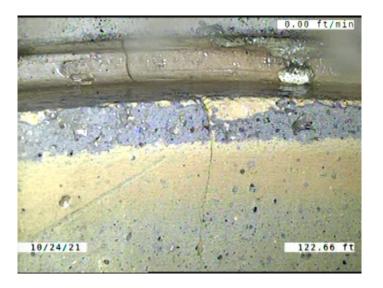
Code: CL

Description: Crack Longitudinal

Distance (ft): 122.7
Structural Grade: 2
O&M Grade: 0
Clock Start/From: 10

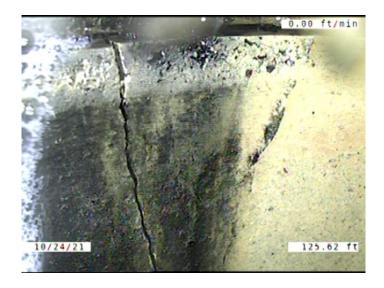
Code: FM

Description: Fracture Multiple

Distance (ft): 125.6
Structural Grade: 4
O&M Grade: 0
Clock Start/From: 8
Clock To: 10

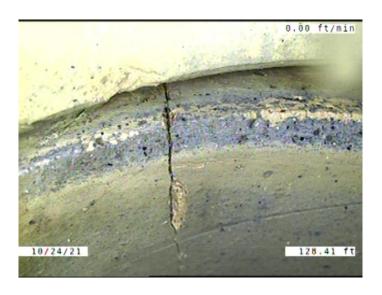
Code: FL

Description: Fracture Longitudinal

Distance (ft): 128.4
Structural Grade: 3
O&M Grade: 0
Clock Start/From: 8
Clock To: 1st Value: 2nd Value:

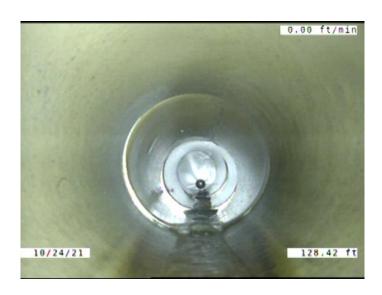
Code: MWL

Description: Miscellaneous Water Level

Distance (ft): 128.4
Structural Grade: 0
O&M Grade: 0

Value Percent: 5.000

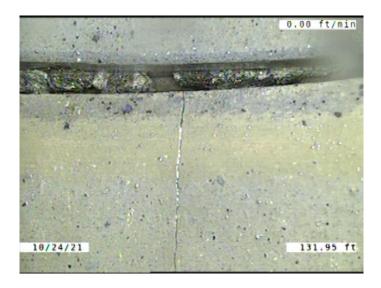
Code: CL

Description: Crack Longitudinal

Distance (ft): 131.9
Structural Grade: 2
O&M Grade: 0
Clock Start/From: 2

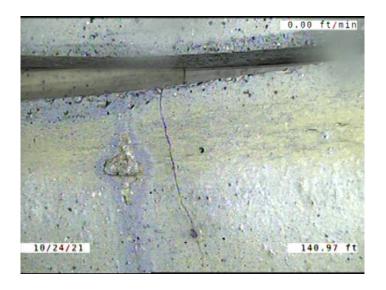
Code: CL

Description: Crack Longitudinal

Distance (ft): 141.0
Structural Grade: 2
O&M Grade: 0

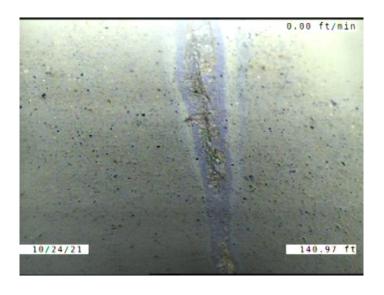
Code: SSS

Description: Surface Damage Surface Spalling

Distance (ft): 141.0
Structural Grade: 2
O&M Grade: 0

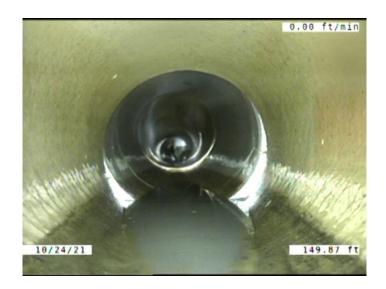
Code: MWLS

Description: Miscellaneous Water Level Sag

Distance (ft): 149.9
Structural Grade: 2
O&M Grade: 0

Value Percent: 10.000
Continuous Index: S04
Within 8" of Joint: NO

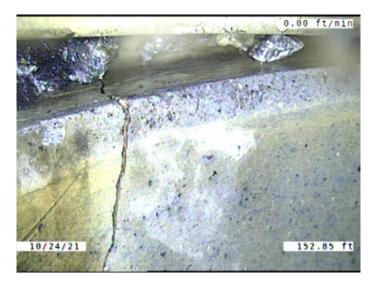
Code: B

Description: Broken

Distance (ft): 152.9
Structural Grade: 4

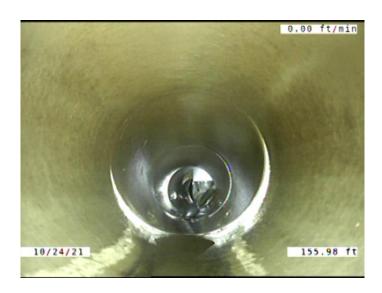
Code: MWLS

Description: Miscellaneous Water Level Sag

Distance (ft): 156.0
Structural Grade: 2
O&M Grade: 0

Value Percent: 10.000
Continuous Index: F04
Within 8" of Joint: NO

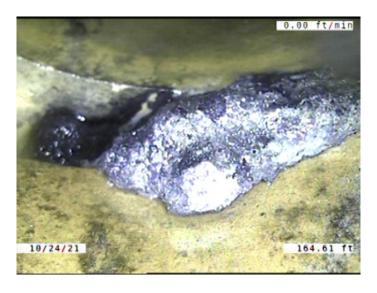
Code: DAE

Description: Deposits Attached Encrustation

Distance (ft): 164.6
Structural Grade: 0
O&M Grade: 2
Clock Start/From: 5
Clock To: 7
1st Value:

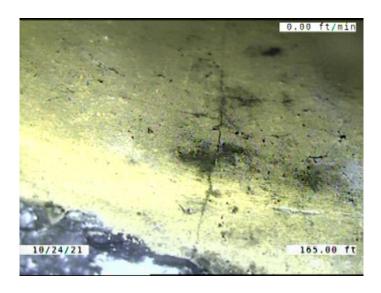
Code: CM

Description: Crack Multiple

Distance (ft): 165.0 Structural Grade: 3

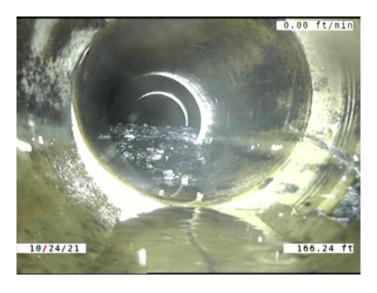
Code: **DSF**

Description: Deposits Settled Fine

Distance (ft): 166.2
Structural Grade: 0
O&M Grade: 2
Clock Start/From: 5
Clock To: 7
